Annual Inspection Report Jeffrey Energy Center Inactive Bottom Ash Pond

Westar Energy

Jeffrey Energy Center

June 2017

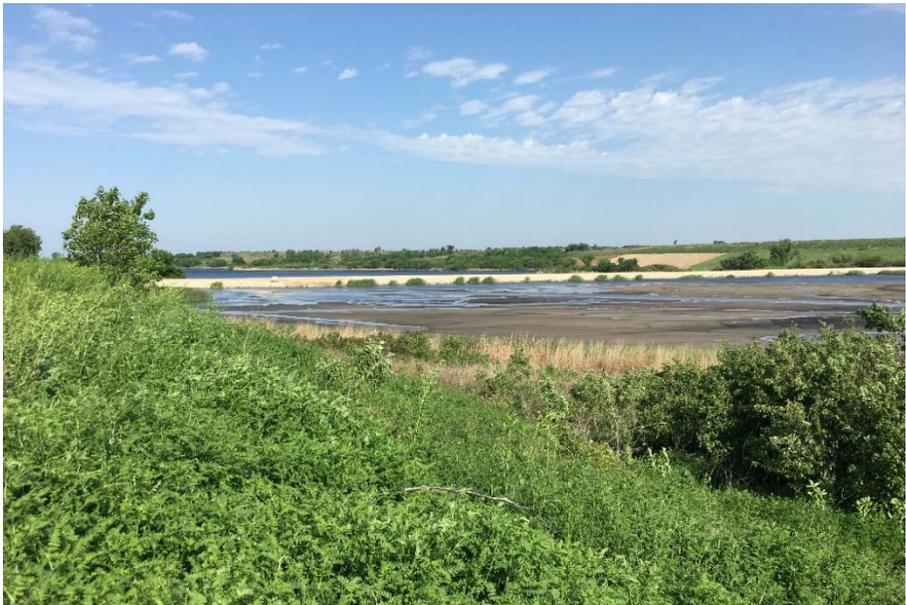
<p>Photograph No. 1</p> <p>Date: May 16, 2017</p> <p>Direction: Northwest</p>

<p>Description: Observing Bottom Ash Pond and the surrounding vegetation on the south slope.</p>

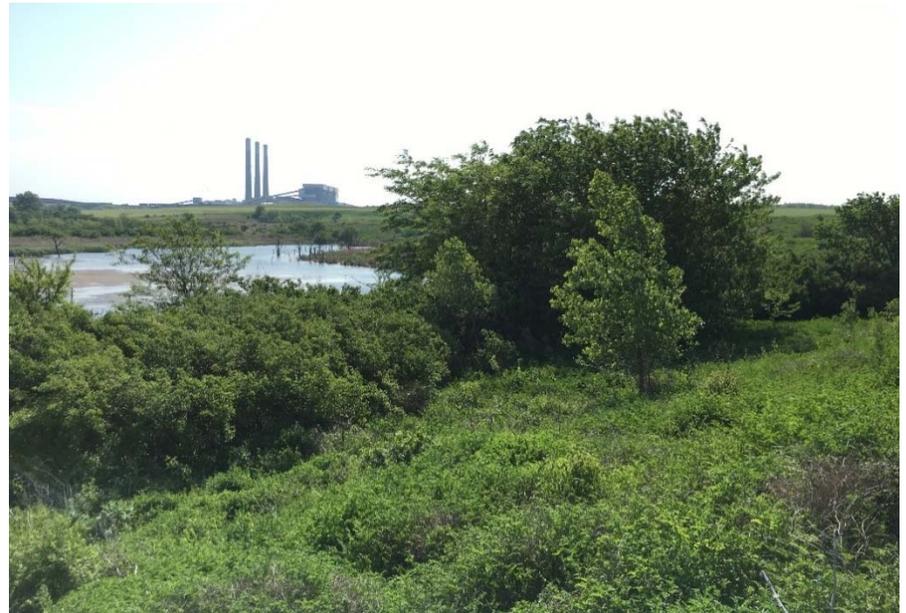
<p>Photograph No. 2</p> <p>Date: May 16, 2017</p> <p>Direction: Northeast</p>

<p>Description: Observing the eastern edge of the Bottom Ash Pond. Vegetation is well established.</p>

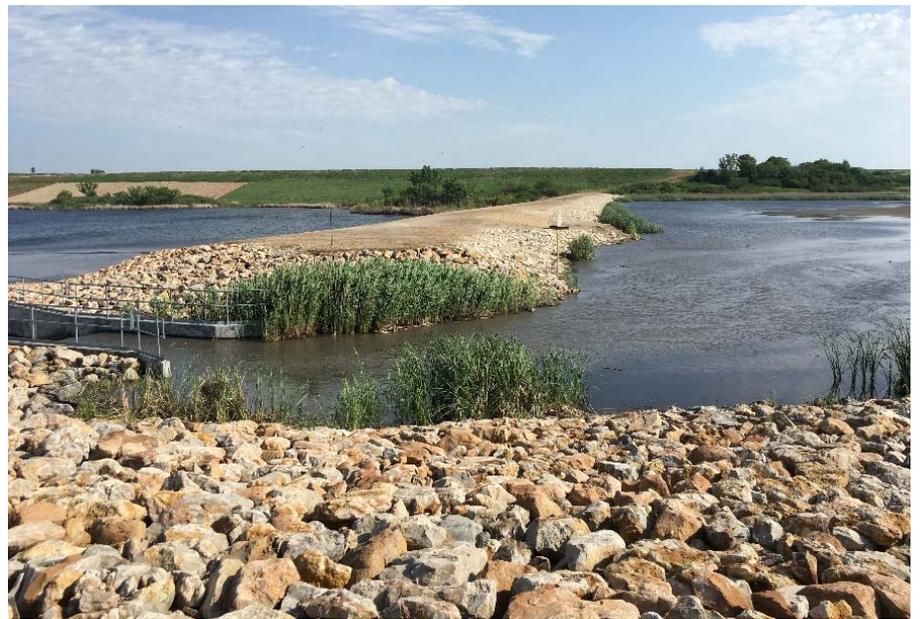
<p>Photograph No. 3</p> <p>Date: May 16, 2017</p> <p>Direction: North</p>

At the time of inspection, stormwater conveyance systems such as the Pond stormwater drainage channels and the Pond Dam spillway were operating as designed. Photographs 3 through 5 in **Appendix A**, depict the spillway's location with discharge appropriately moving from the Pond to Tower Hill Lake. No signs of erosion or malfunction were detected in these features.

<p>Description: Looking at spillway and dam between both the Bottom Ash Pond and Tower Hill Lake. Slopes are rip-rap lined. Some vegetation. No noticeable erosion.</p>

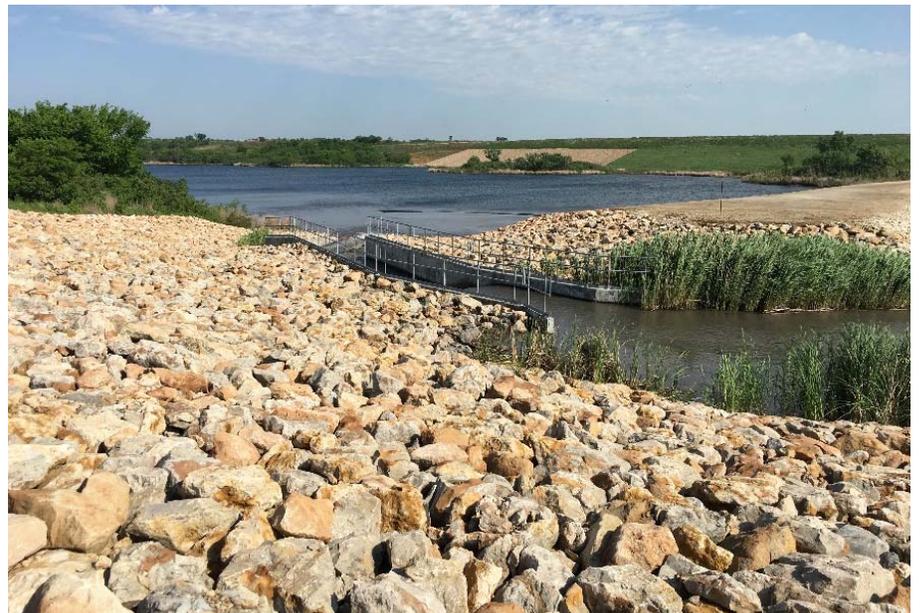
<p>Photograph No. 4</p> <p>Date: May 16, 2017</p> <p>Direction: Northwest</p>

<p>Description: Looking at spillway from Bottom Ash Pond to Tower Hill Lake. No evidence of erosion or malfunction.</p>

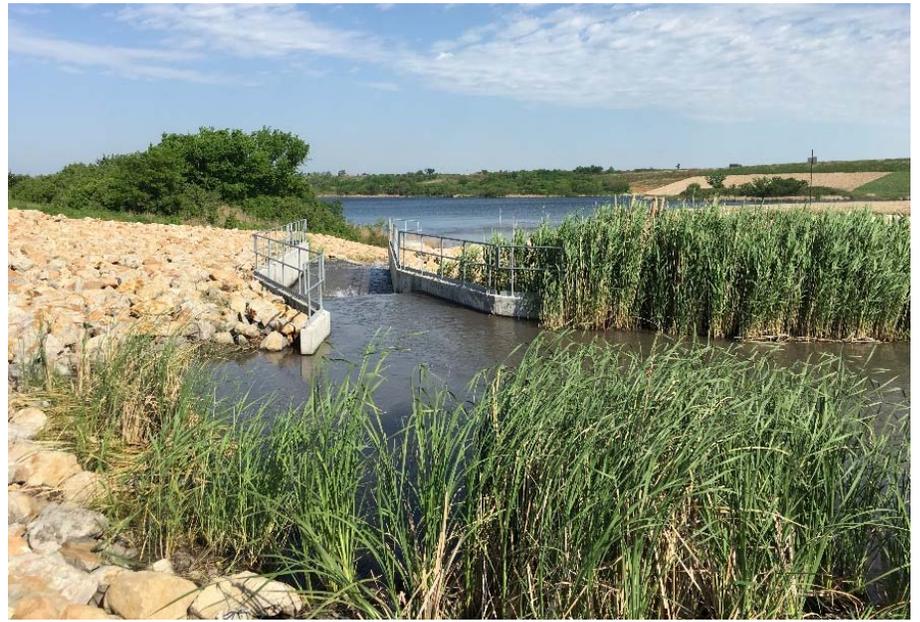
<p>Photograph No. 5</p> <p>Date: May 16, 2017</p> <p>Direction: Northwest</p>

<p>Description: Looking at spillway from Bottom Ash Pond to Tower Hill Lake. No evidence of erosion or malfunction. Some vegetation present</p>

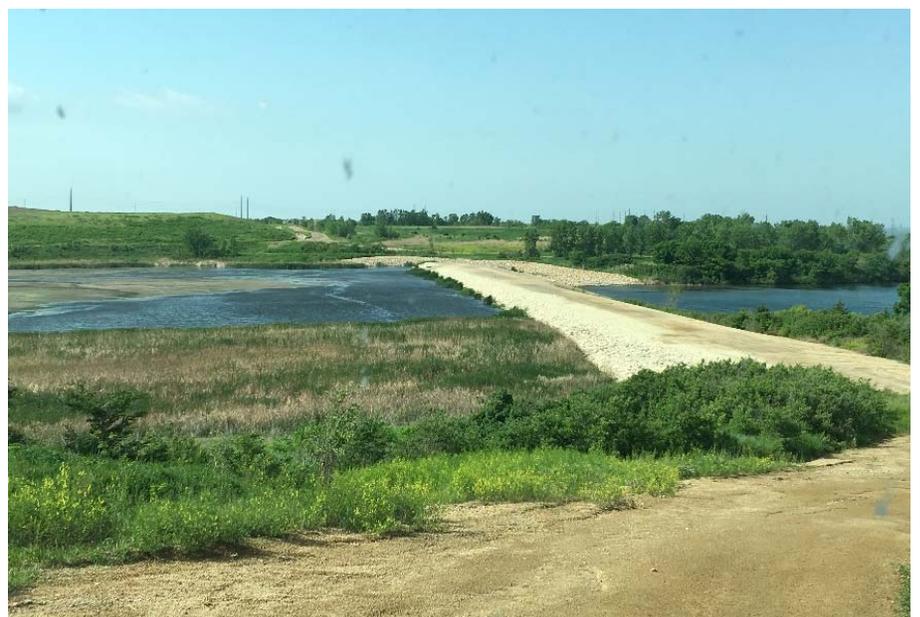
<p>Photograph No. 6</p> <p>Date: May 16, 2017</p> <p>Direction: Southwest</p>

<p>Description: Looking at the dam from the access road crossing. No evidence of erosion or distress. Established vegetation present.</p>

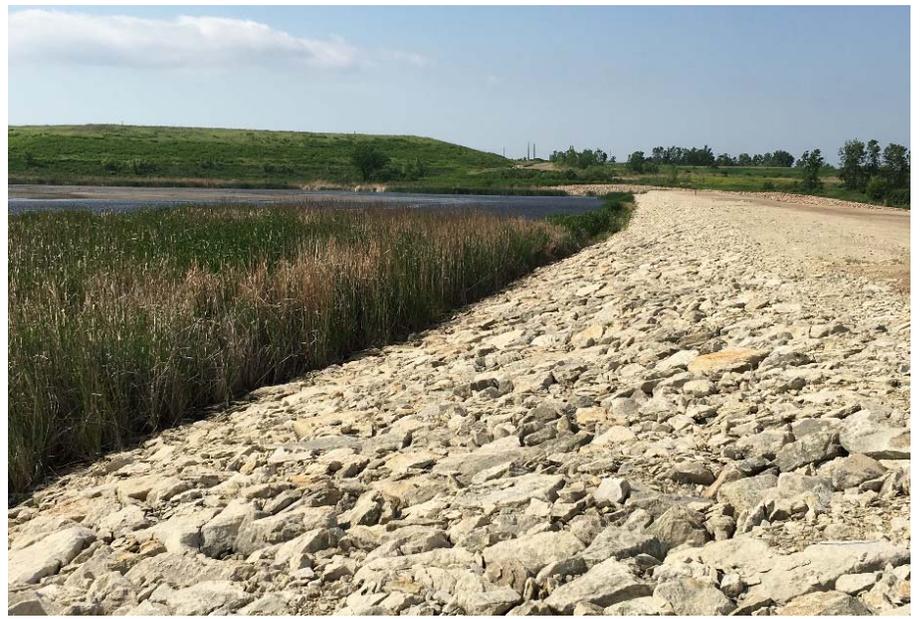
<p>Photograph No. 7</p> <p>Date: May 16, 2017</p> <p>Direction: Southwest</p>

<p>Description: Observing the upstream side of the dam separating the Bottom Ash Pond and Tower Hill Lake. No significant erosion. present. Established vegetation present.</p>

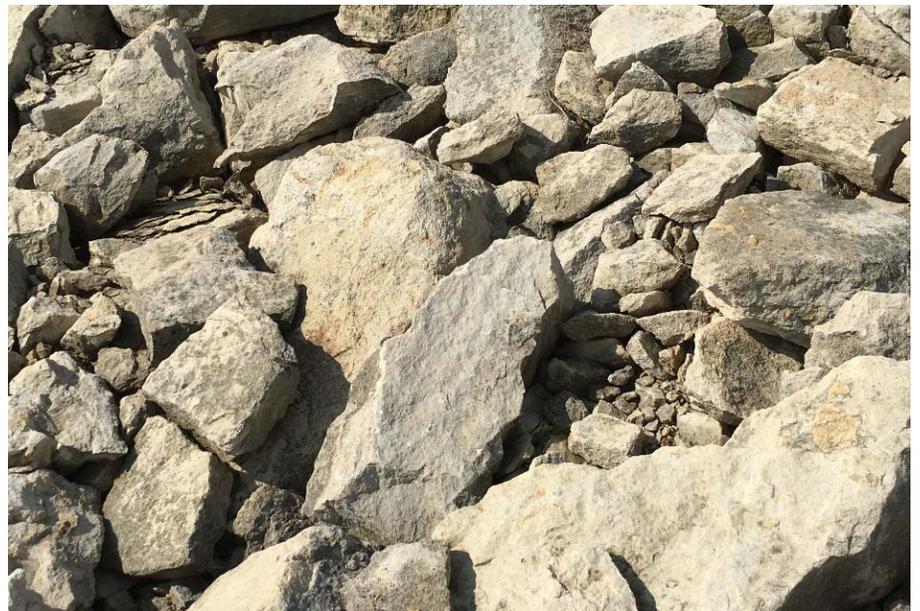
<p>Photograph No. 8</p> <p>Date: May 16, 2017</p> <p>Direction: -</p>

<p>Description: Observing rip-rap present on the upstream slope of the dam.</p>

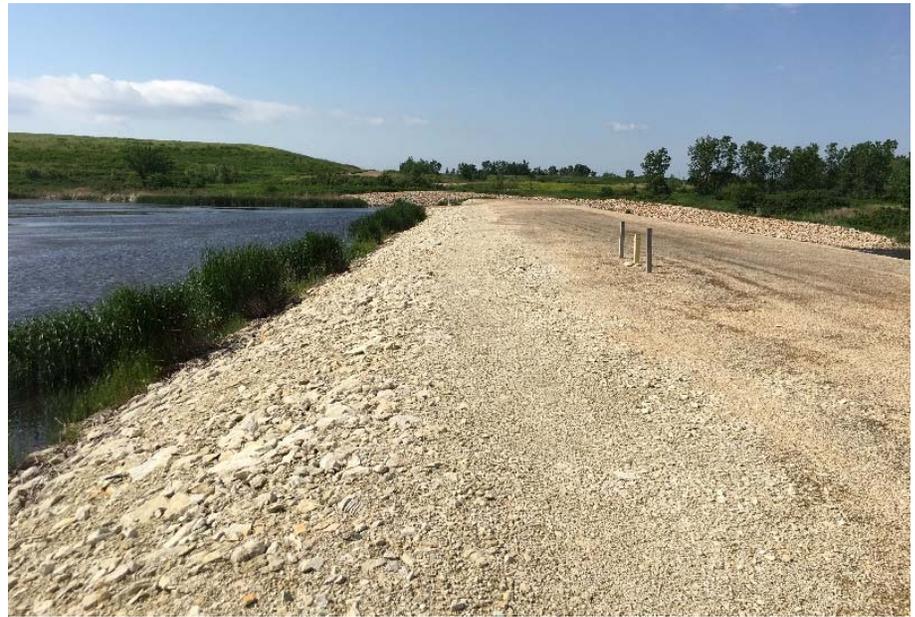
<p>Photograph No. 9</p> <p>Date: May 16, 2017</p> <p>Direction: Southwest</p>

<p>Description: Observing the dam separating the Bottom Ash Pond and Tower Hill Lake on the downstream slope. No significant erosion present. Established vegetation present.</p>

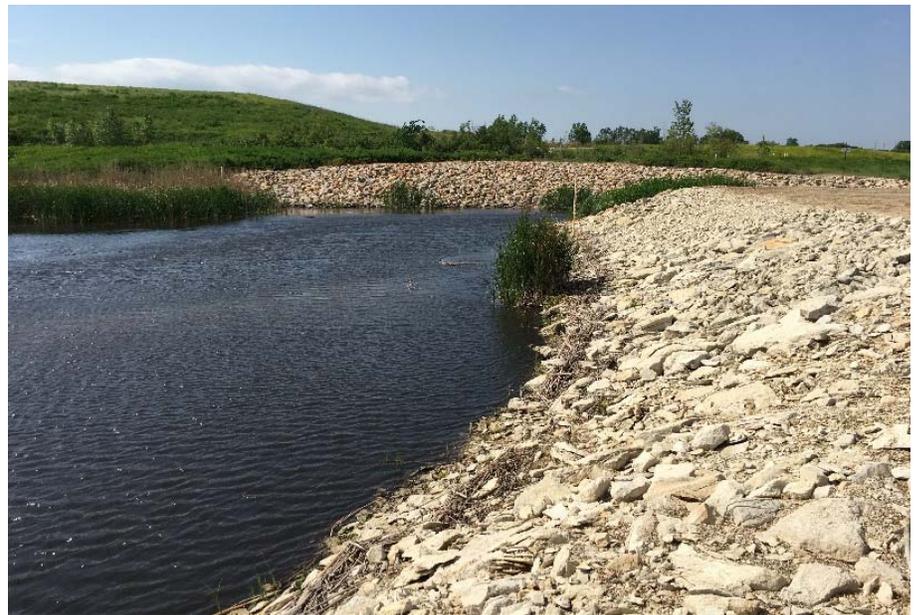
<p>Photograph No. 10</p> <p>Date: May 16, 2017</p> <p>Direction: Southwest</p>

<p>Description: Observing the berm separating the Bottom Ash Pond and Tower Hill Pond on the upstream slope. No significant erosion present. Established vegetation present.</p>

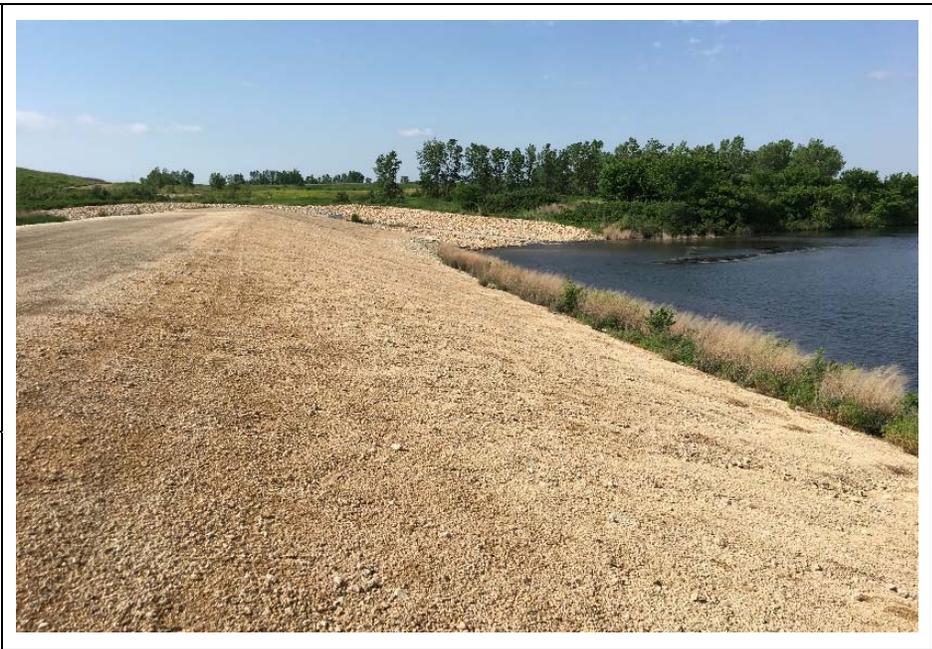
<p>Photograph No. 11</p> <p>Date: May 16, 2017</p> <p>Direction: Southwest</p>

<p>Description: Observing the downstream slope of the dam separating the Bottom Ash Pond and Tower Hill Lake. No erosion in this location.</p>

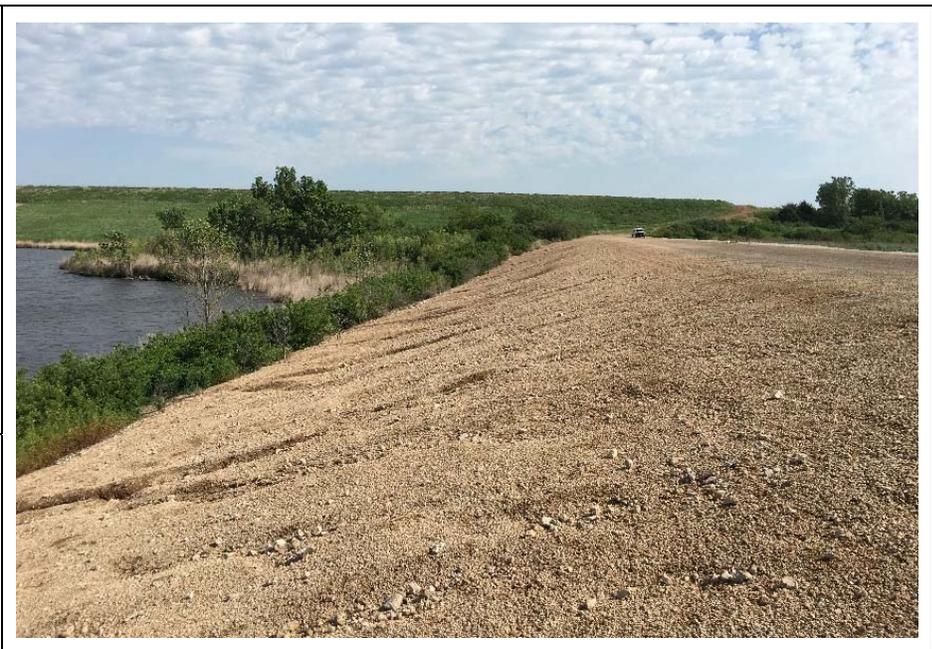
<p>Photograph No. 12</p> <p>Date: May 16, 2017</p> <p>Direction: Northeast</p>

During the on-site inspection the Pond Dam slope appearance, slope stability, and overall Pond conditions were assessed. During the inspection, the only location that may provide slope stability concerns is the Pond Dam's western side (downstream slope), which separates the Pond from Tower Hill Lake. Erosion rills were observed on the downstream slope of Pond Dam. Photographs 12 through 15 in **Appendix A** depict the observed erosion rills on the downstream slope of the Pond Dam.

<p>Description: Observing minor erosion of the dam separating the Bottom Ash Pond and Tower Hill Lake on the downstream slope. Established vegetation present.</p>

- Fill in and regrade the erosion rills on downstream slope of the Pond Dam as part of clean closure capping construction. Placement of rip-rap may be considered after filling and regrading to provide additional erosion protection;
- Continue to monitor and maintain rip-rap on the upstream slope;
- Continue proper management of the inflow control system and gradient flowing to the outlet structure; and
- Continue to monitor all conveyance features for signs of erosion, damage, obstructions, or malfunction.

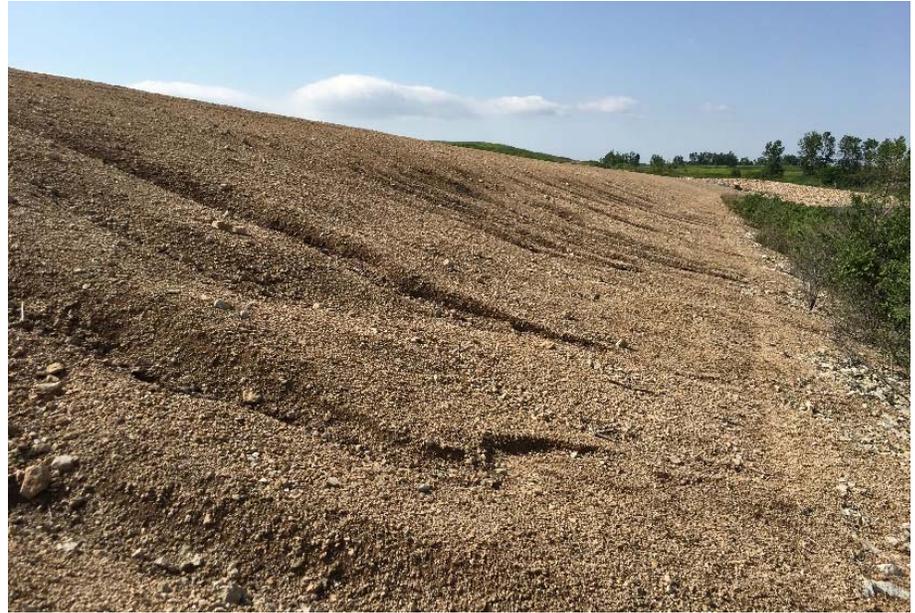
<p>Photograph No. 13</p> <p>Date: May 16, 2017</p> <p>Direction: South</p>

<p>Description: Observing erosion rills on the dam separating the Bottom Ash Pond and Tower Hill Lake on the downstream slope.</p>

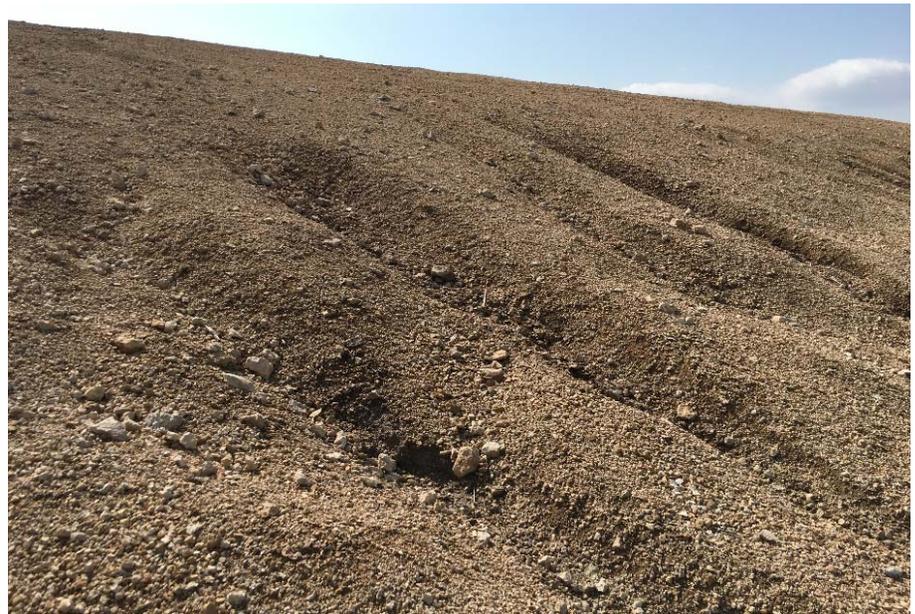
<p>Photograph No. 14</p> <p>Date: May 16, 2017</p> <p>Direction: Southeast</p>

<p>Description: Observing the erosion rills on the dam separating the Bottom Ash Pond and Tower Hill Lake on the downstream slope.</p>

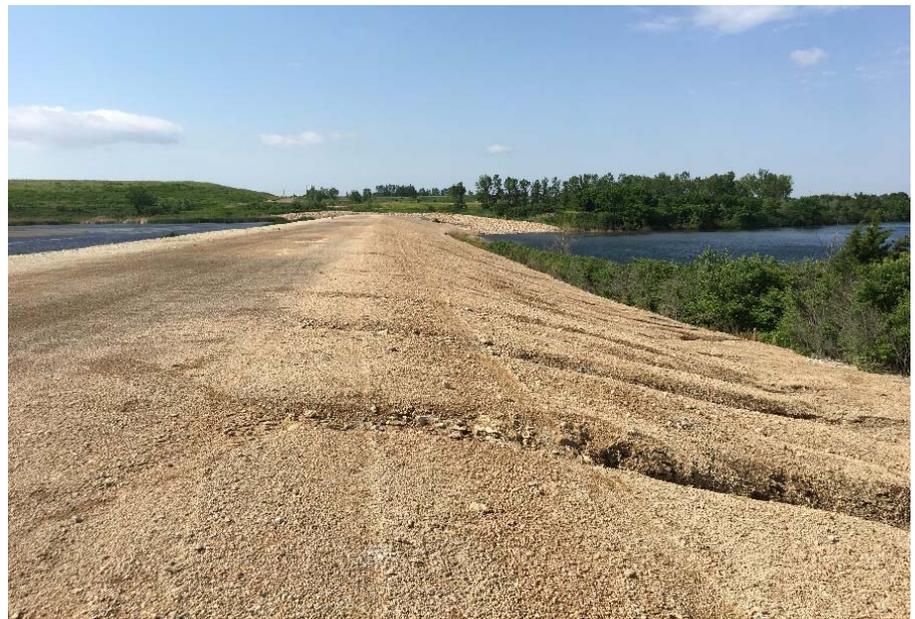
<p>Photograph No. 15</p> <p>Date: May 16, 2017</p> <p>Direction: Southwest</p>

A wide-angle photograph showing a long, straight dam made of light-colored gravel and sand. The dam runs from the foreground towards the background, separating two bodies of water. On the right side, there is a significant erosion gully or rill that has formed in the gravel, running parallel to the dam. The background shows a line of green trees under a clear blue sky with a few wispy clouds.
<p>Description: Observing the dam that separates the Bottom Ash Pond from Tower Hill Lake. Erosion rills on downstream slope.</p>
