Annual Inspection Report Jeffrey Energy Center Fly Ash Landfill

Westar Energy

Jeffrey Energy Center

January 2017

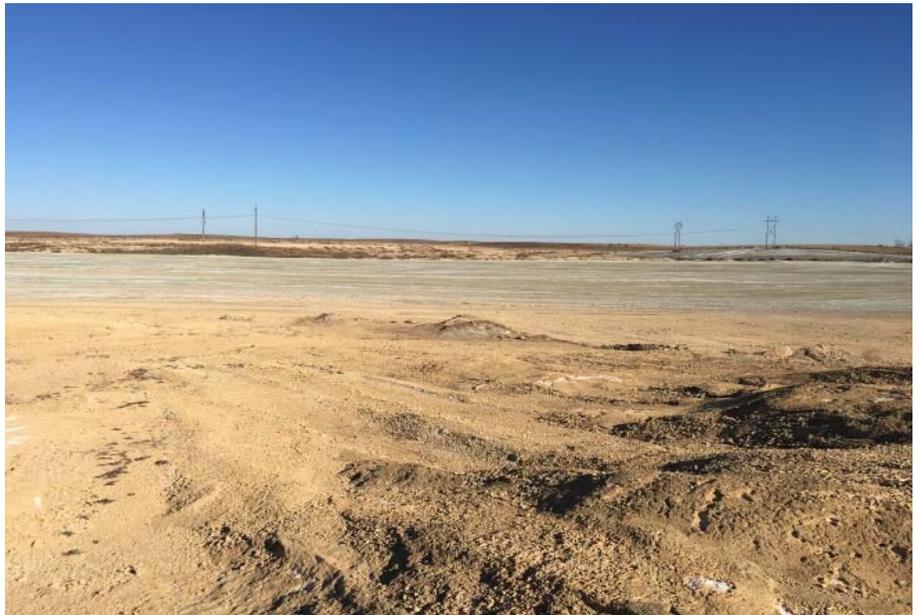
<p>Photograph No. 1</p> <p>Date: November 29, 2016</p> <p>Direction: Northwest</p>

<p>Description: Observing active fly ash area operations and maintenance. No evidence of ponding or airborne dust.</p>

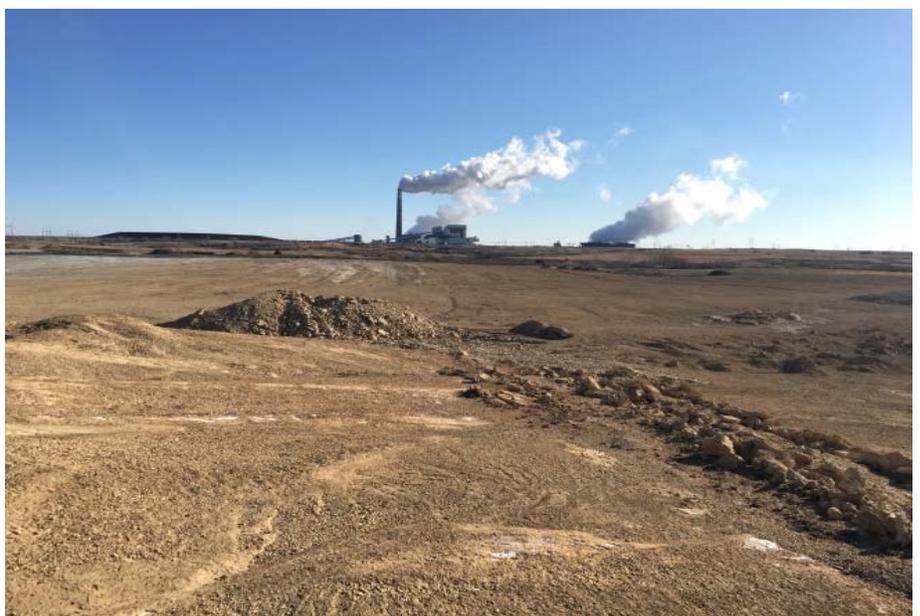
<p>Photograph No. 2</p> <p>Date: November 29, 2016</p> <p>Direction: East</p>

<p>Description: Observing active fly ash area operations and maintenance. No evidence of ponding or airborne dust.</p>

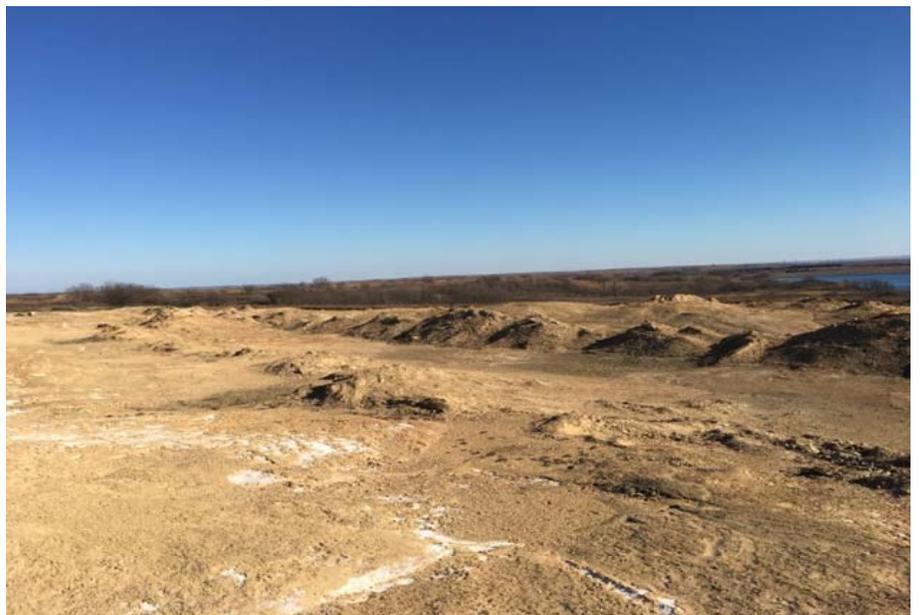
<p>Photograph No. 3</p> <p>Date: November 29, 2016</p> <p>Direction: Southeast</p>

<p>Description: Recently graded area in foreground. Small piles in background are fly ash piles that are older and not yet graded.</p>

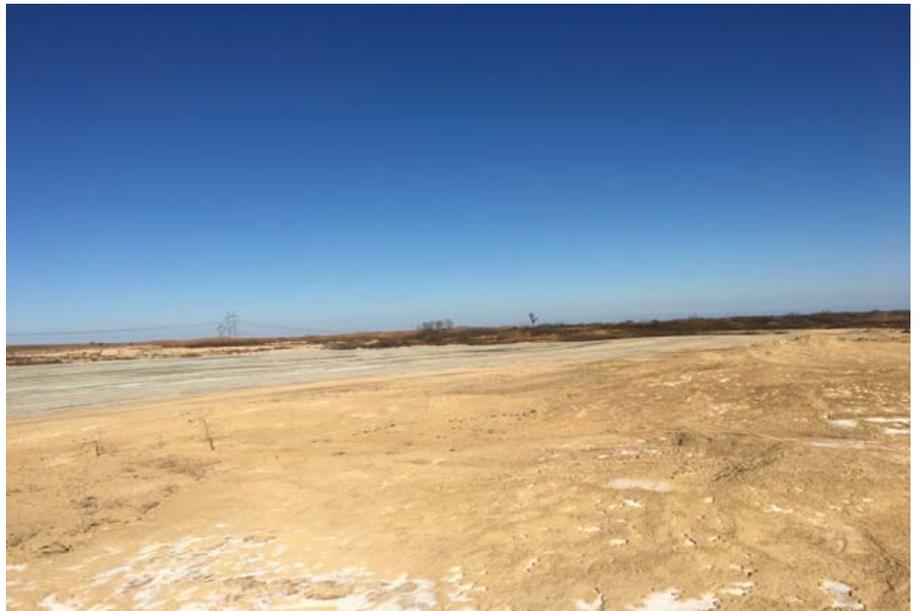
<p>Photograph No. 4</p> <p>Date: November 29, 2016</p> <p>Direction: Northwest</p>

<p>Description: Observing active fly ash area operations and maintenance. No evidence of ponding or airborne dust.</p>

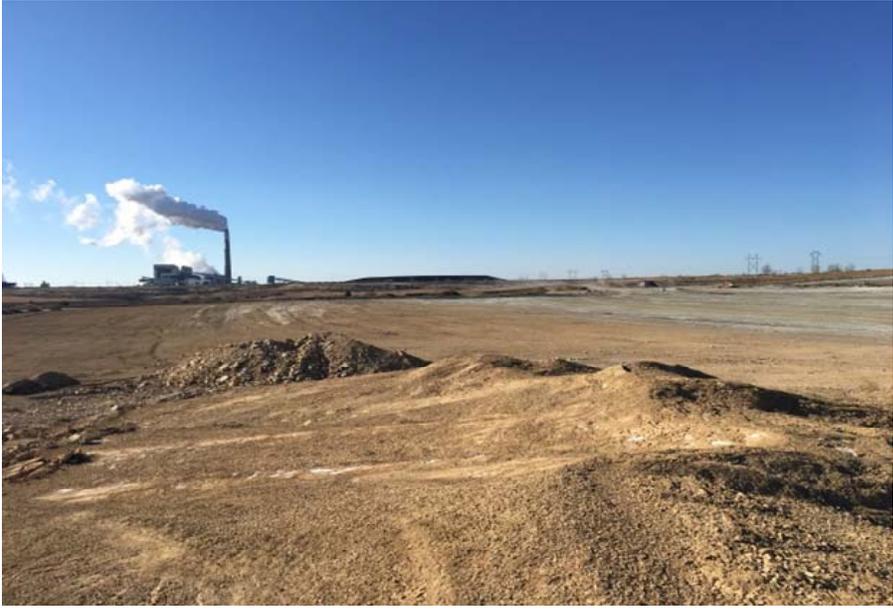
<p>Photograph No. 5</p> <p>Date: November 29, 2016</p> <p>Direction: West</p>

<p>Description: Standing on older fly ash with active, graded area in background. No evidence of ponding or airborne dust.</p>

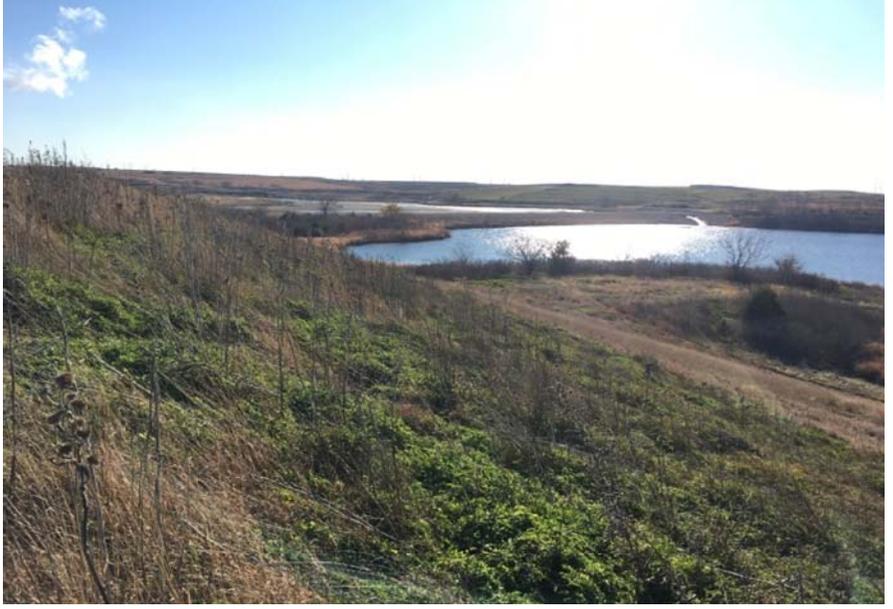
<p>Photograph No. 6</p> <p>Date: November 29, 2016</p> <p>Direction: East</p>

<p>Description: Observing landfill side slope. Vegetation is well-established and maintained. No evidence of erosion or malfunction at this location.</p>

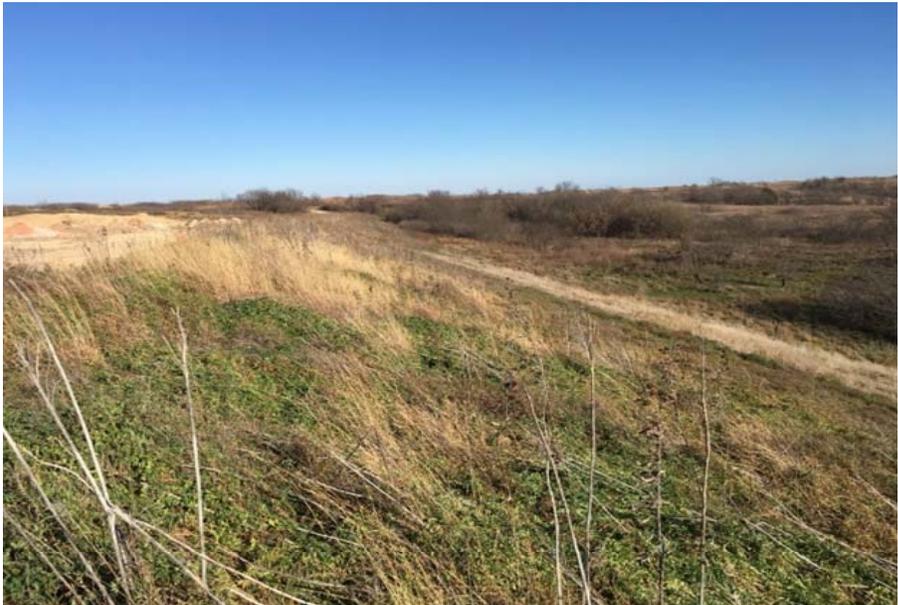
<p>Photograph No. 7</p> <p>Date: November 29, 2016</p> <p>Direction: East</p>

A wide-angle photograph showing a landfill side slope. The foreground is dominated by tall, dry, yellowish-brown grasses and some green weeds. A dirt path or road runs diagonally across the middle ground. The background shows a flat landscape with sparse vegetation under a clear blue sky.
<p>Description: Observing landfill side slope. Vegetation is well-established and maintained. No evidence of erosion or malfunction at this location.</p>

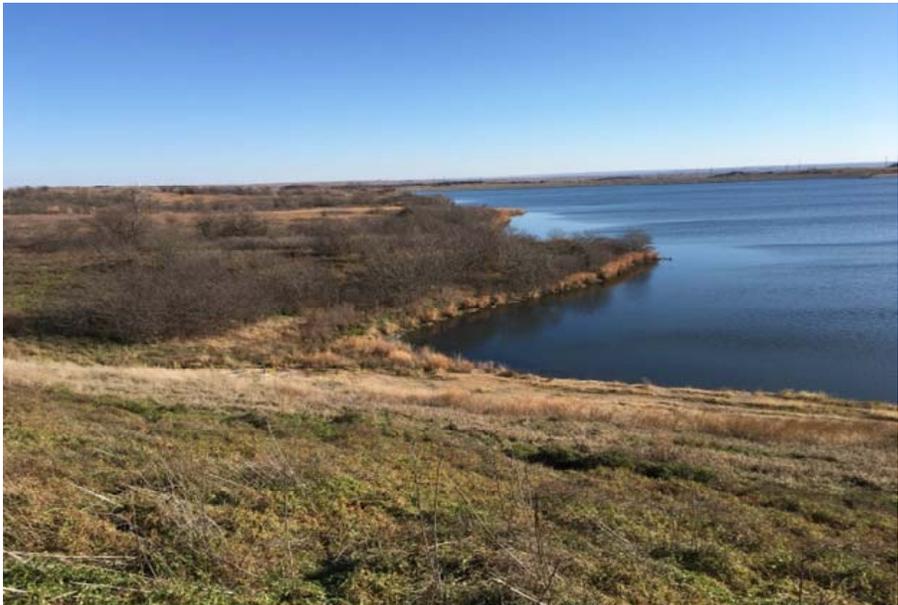
<p>Photograph No. 8</p> <p>Date: November 29, 2016</p> <p>Direction: South</p>

A photograph showing a landfill side slope that meets a body of water, identified as Tower Hill Lake. The foreground has dry, yellowish grass. The middle ground shows a dense line of green and brown shrubs and trees along the water's edge. The lake is a deep blue, and the sky is clear and blue.
<p>Description: Observing landfill side slope with healthy vegetation growing towards Tower Hill Lake. No evidence of sloughing or erosion at this location.</p>

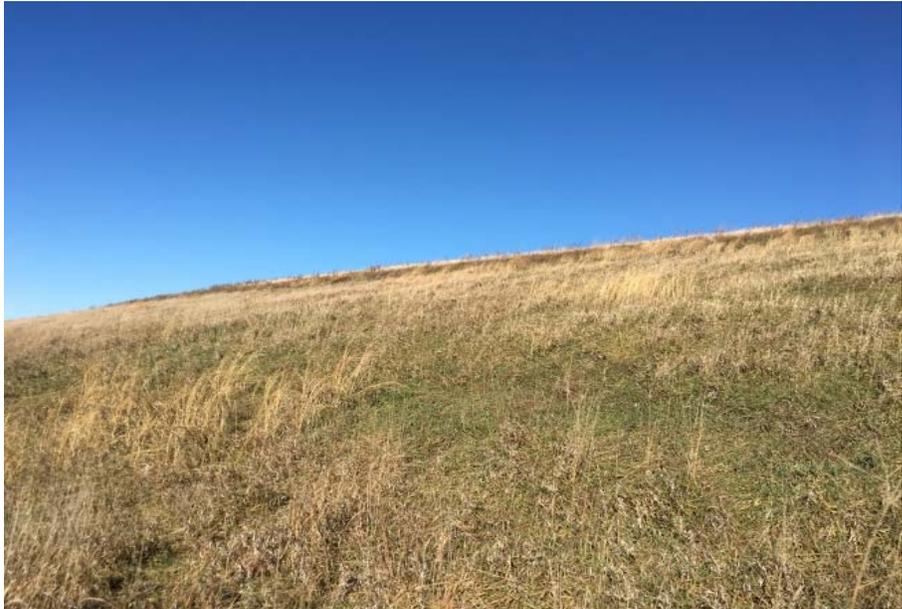
<p>Photograph No. 9</p> <p>Date: November 29, 2016</p> <p>Direction: Northwest</p>

<p>Description: Observing landfill up slope. Vegetation is well-established and maintained. No evidence of erosion or malfunction at this location.</p>

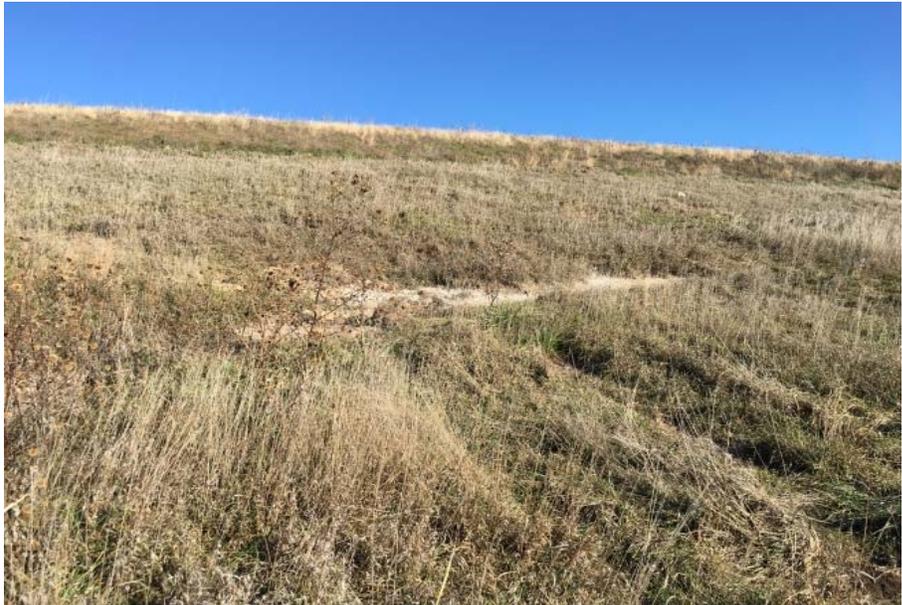
<p>Photograph No. 10</p> <p>Date: November 29, 2016</p> <p>Direction: North</p>

<p>Description: Observing erosion gullies on landfill side slope that will need repair.</p>

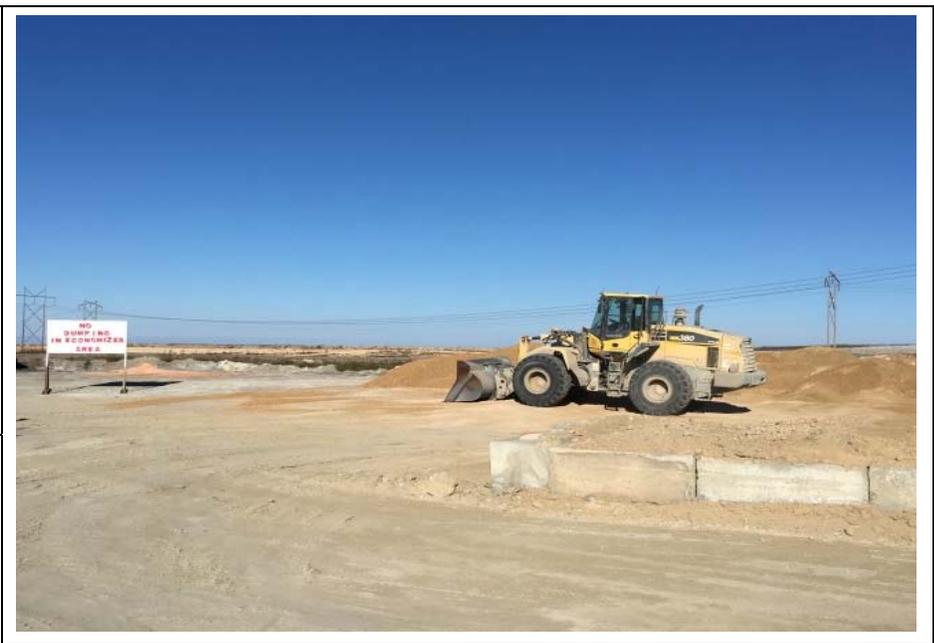
<p>Photograph No. 15</p> <p>Date: November 29, 2016</p> <p>Direction: Northwest</p>

<p>Description: Observing the designated economizer ash disposal area. No dust present, despite windy conditions.</p>

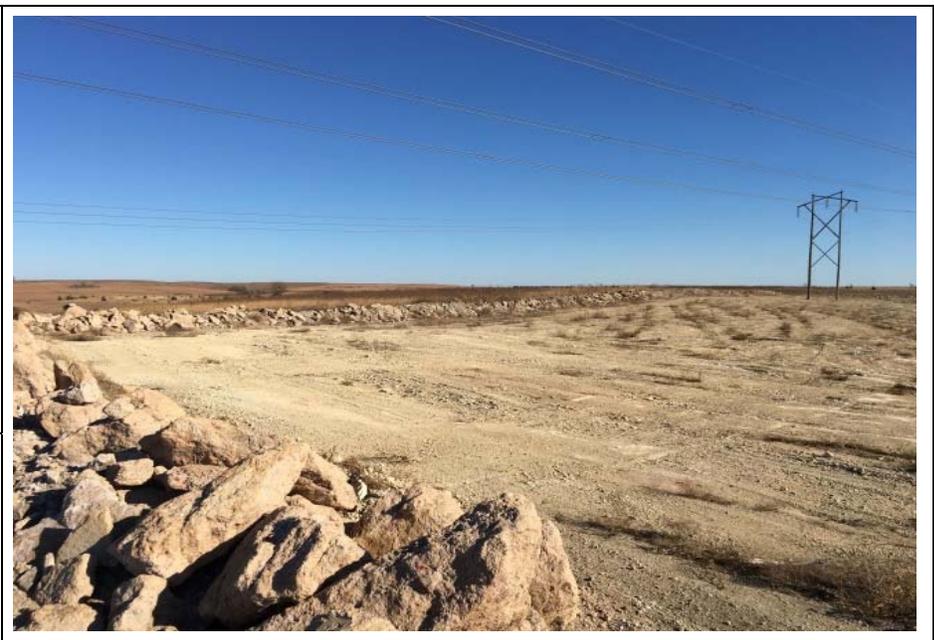
<p>Photograph No. 16</p> <p>Date: November 29, 2016</p> <p>Direction: Northeast</p>

<p>Description: Observing the stormwater diversion berm section.</p>

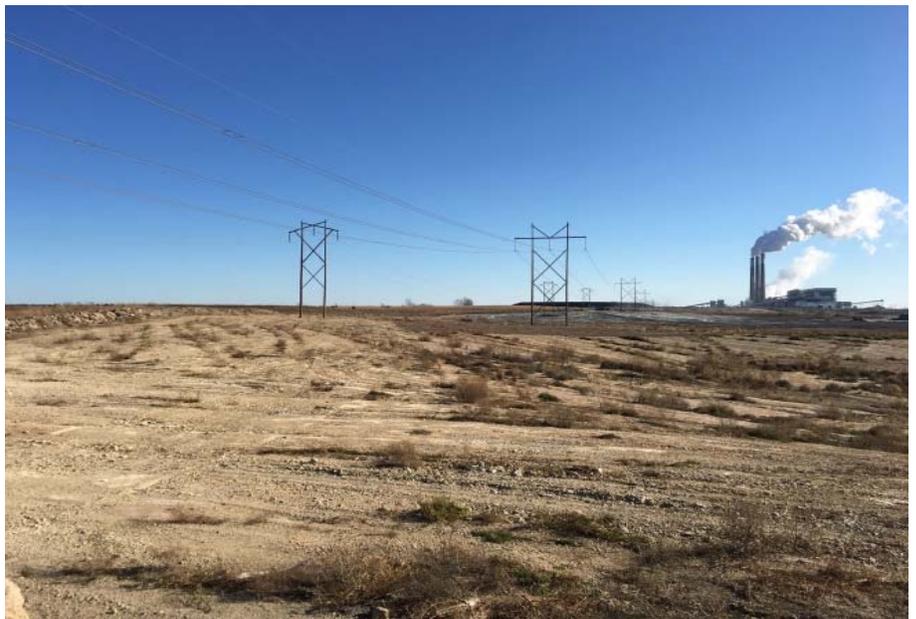
<p>Photograph No. 17</p> <p>Date: November 29, 2016</p> <p>Direction: East</p>

<p>Description: Observing the active fly ash disposal area.</p>

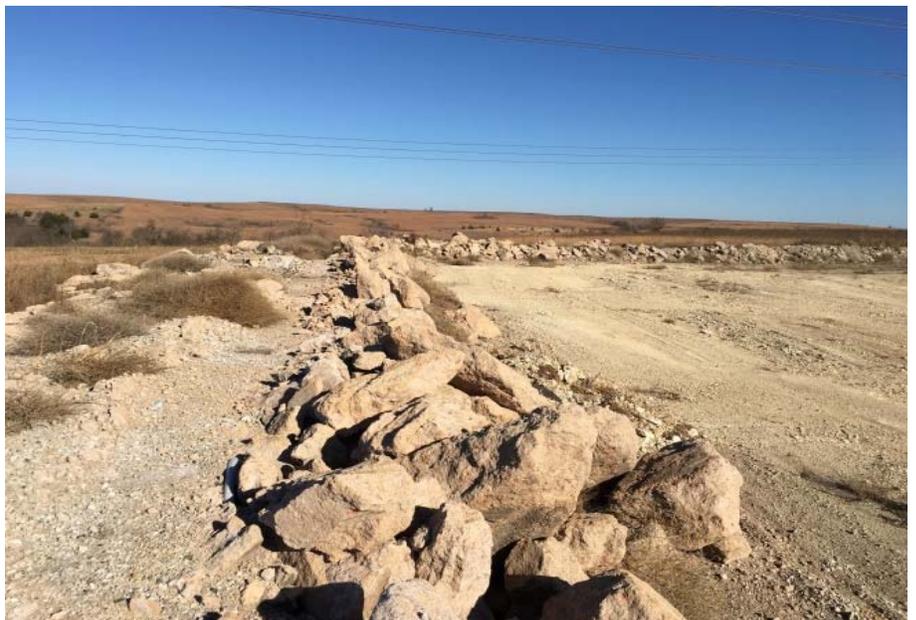
<p>Photograph No. 18</p> <p>Date: November 29, 2016</p> <p>Direction: Northeast</p>

<p>Description: Observing the stormwater diversion berm section.</p>

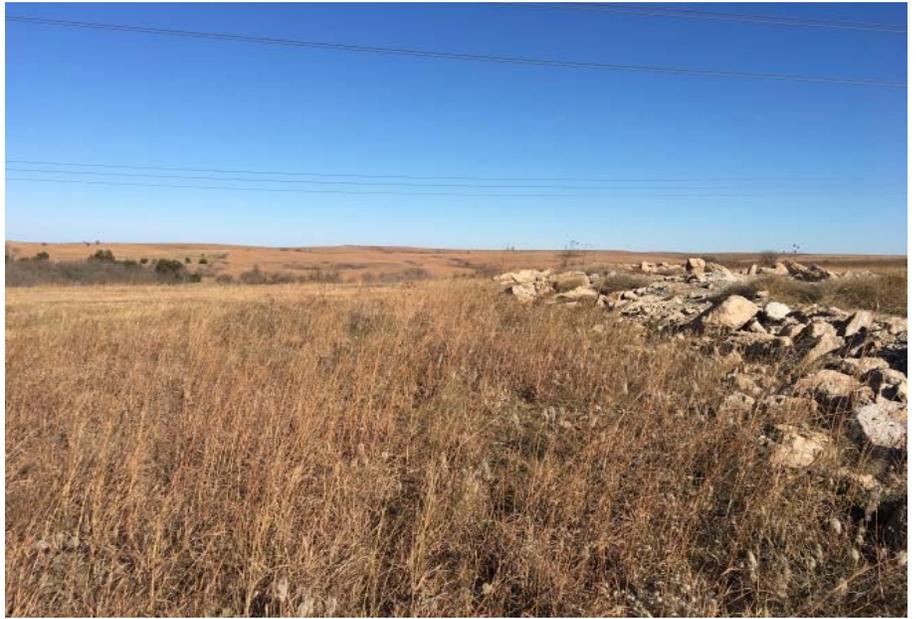
<p>Photograph No. 19</p> <p>Date: November 29, 2016</p> <p>Direction: Northeast</p>

<p>Description: Observing the outside of the stormwater diversion berm section. Vegetation is well-established and maintained. No evidence of erosion or malfunction.</p>

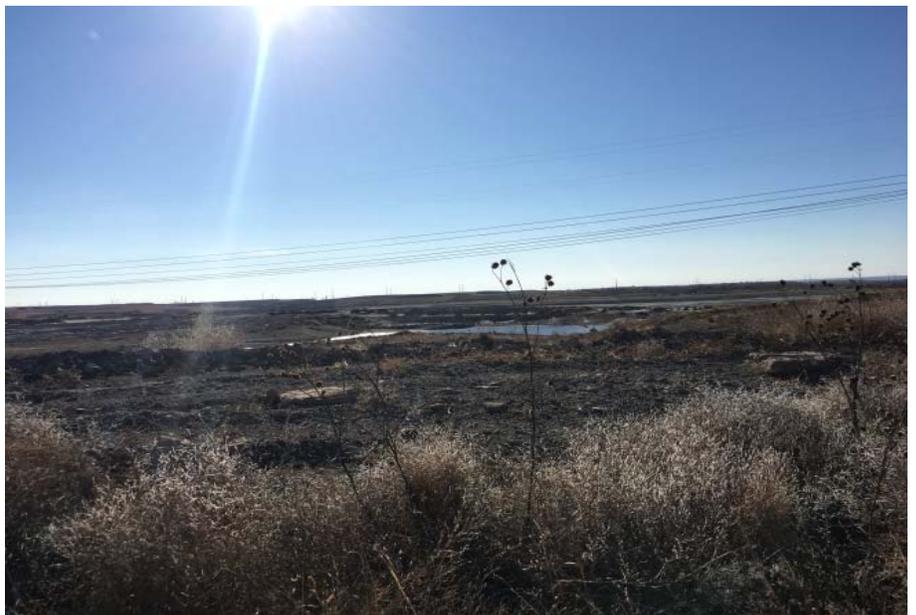
<p>Photograph No. 20</p> <p>Date: November 29, 2016</p> <p>Direction: South</p>

<p>Description: Overview of Fly Ash Area 1 and Tower Hill Lake.</p>

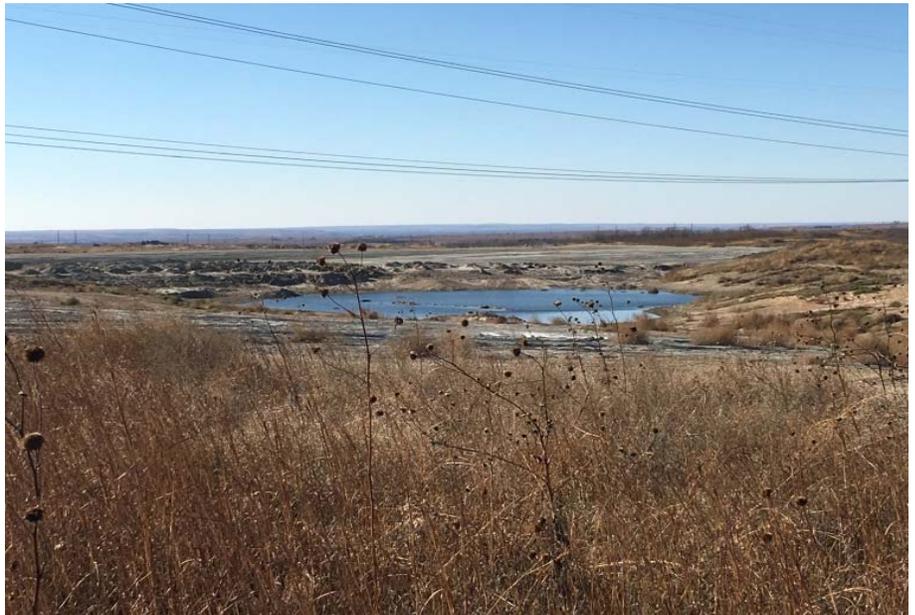
<p>Photograph No. 21</p> <p>Date: November 29, 2016</p> <p>Direction: Southwest</p>

<p>Description: Overview of Fly Ash Area 1 and Tower Hill Lake.</p>

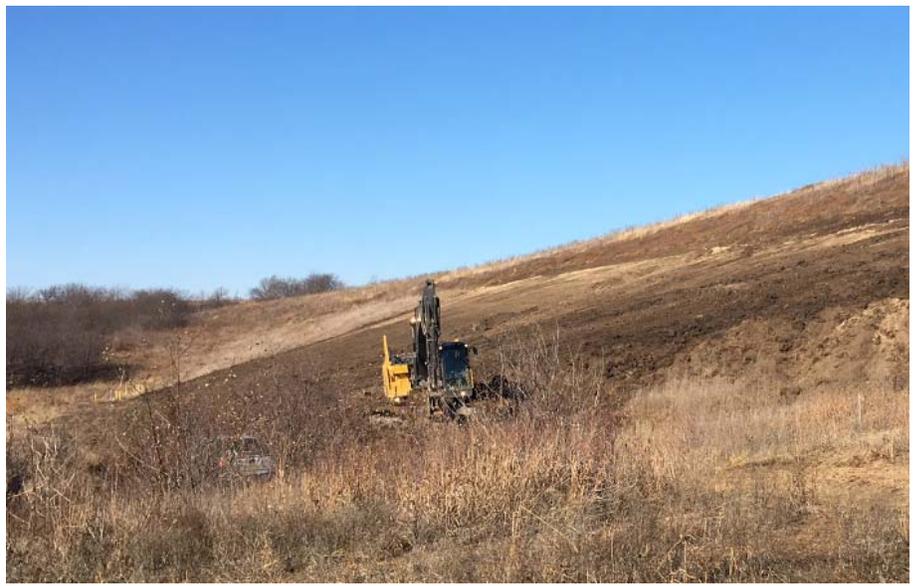
<p>Photograph No. 22</p> <p>Date: December 27 – 30, 2016</p> <p>Direction: Northwest</p>

Based on a review of the weekly inspection reports, it was noted throughout this past year that sloughing has been observed along the south berm. Following the annual inspection, the areas of sloughing along the south berm were undergoing stabilization, as shown in Photograph 22. Additionally, it was noted that small animal burrows were observed throughout the year. These burrows are documented and monitored following an observation.

Based on a review of the previous annual inspection report, it noted that there were two areas of shallow sloughing on the south berm. Following the annual inspection, stabilization of the sloughing areas are being performed. Photographs 12 and 13 depict the sloughing areas along the south berm. Photograph 22 depicts on-going repairs of the sloughing.

Based on observations noted during the 2015 annual inspection, areas of sloughing were being prepared for stabilization. Following the annual inspection, proper stabilization of the sloughing areas continue. Based on discussions on the date of inspection, it is CB&I's understanding that Westar intends to complete these repairs during the 2016/2017 construction season. Repairs will generally include regrading as necessary and the placement of riprap in sloughing areas to prevent future erosion that may result from seepage. This approach is appropriate to address the area of sloughing on the southern berm. Photographs 12 and 13 depict sloughing areas along the south berm. Photograph 22 depicts on-going repairs of the sloughing.

<p>Description: Overview of sloughing repairs along south berm.</p>

- Continue repairs of sloughing areas as described in previous text (see Photographs 12, 13, and 22).
- Continue to stabilize filled in gaps along the perimeter berm to minimize stormwater flow onto active areas during large storm events as observed (see Photograph 23).
- Continue to monitor erosion controls, animal burrows, and vegetative cover on a weekly basis.
- Continue proper management of the active landfill areas.
- Continue to monitor all stormwater conveyance features for signs of erosion or malfunction on a weekly basis.

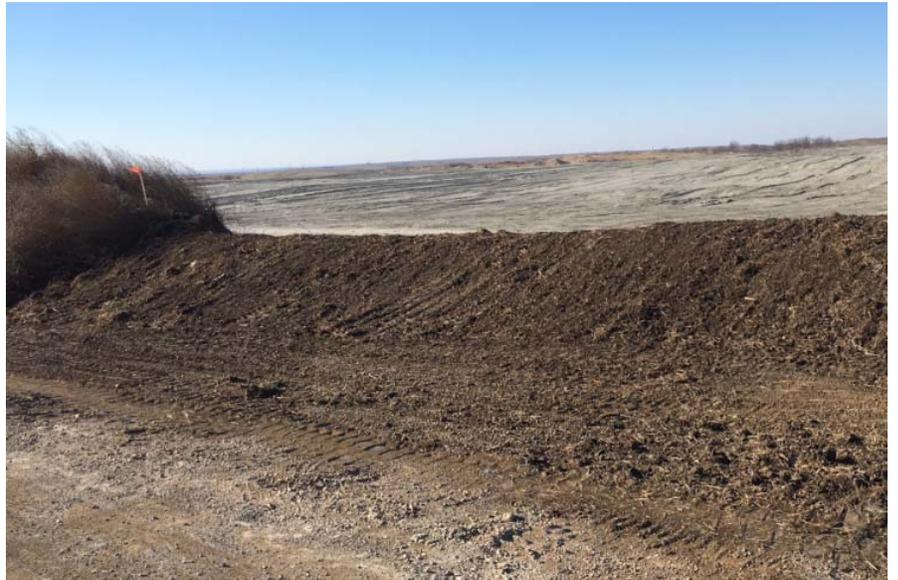
Photograph No. 23

Environmental control systems at the Fly Ash Area 1 are functioning as designed. It was noted that gaps in the perimeter berm surrounding the active landfill area have potential to allow stormwater to flow into the active area. Gaps in the perimeter berm were currently being filled to provide adequate protection to ensure stormwater does not flow onto the active area. The contact water management system is believed to be in good operating condition and functioning as intended.

Observing filling of the perimeter berm gaps along eastern border.
