Annual Inspection Report Lawrence Energy Center Industrial Landfill #0847

Westar Company

CB&I Environmental & Infrastructure, Inc.

January 2017

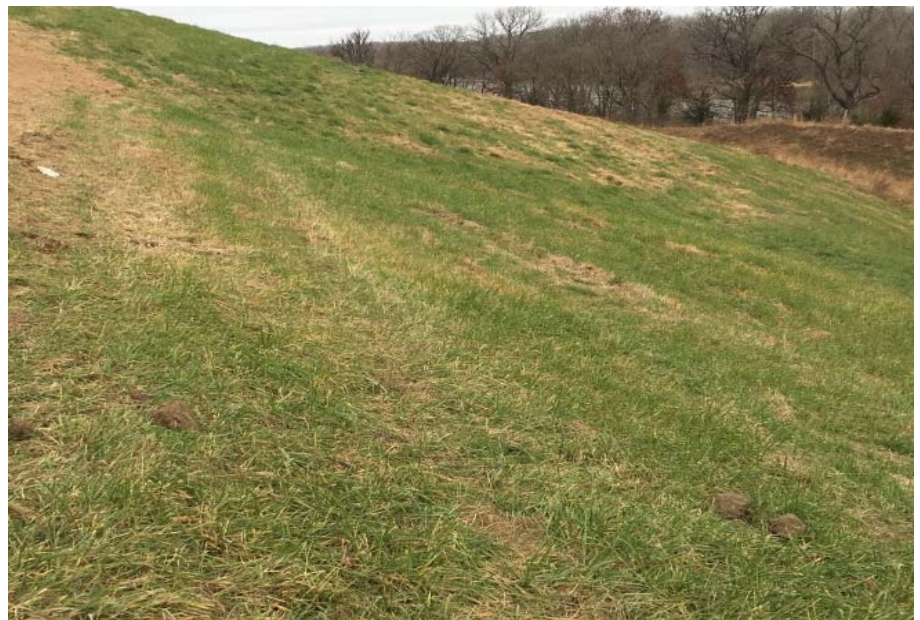
<p>Photograph No. 7</p> <p>Date: November 30, 2016</p> <p>Direction: Northwest</p>

<p>Description: Observing Cell 2 final cover system. Vegetation is well-established and maintained. No evidence of erosion or sloughing.</p>

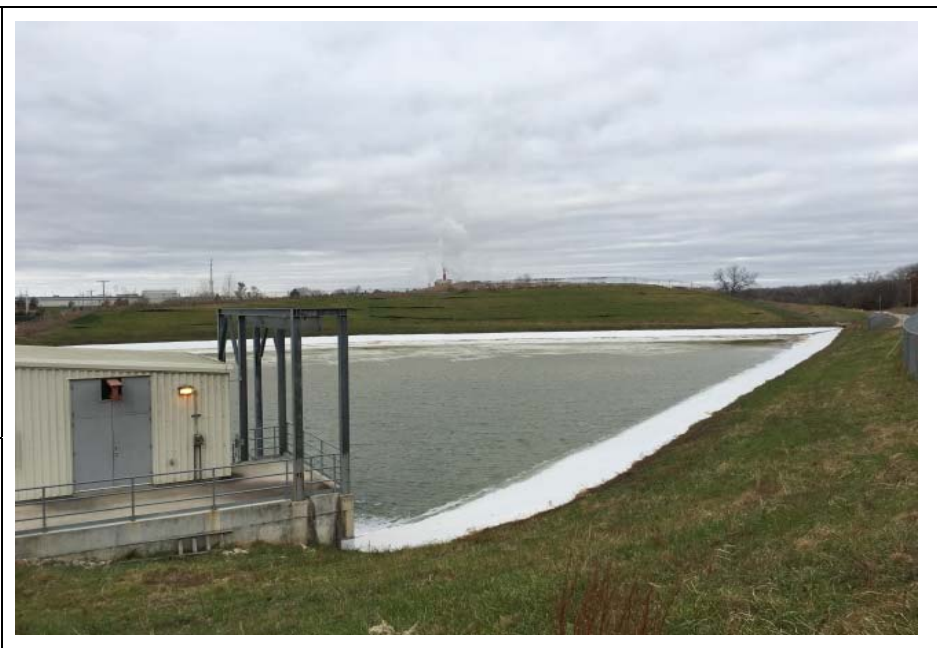
<p>Photograph No. 13</p> <p>Date: November 30, 2016</p> <p>Direction: Northwest</p>

<p>Description: Overview of the contact water basin.</p>

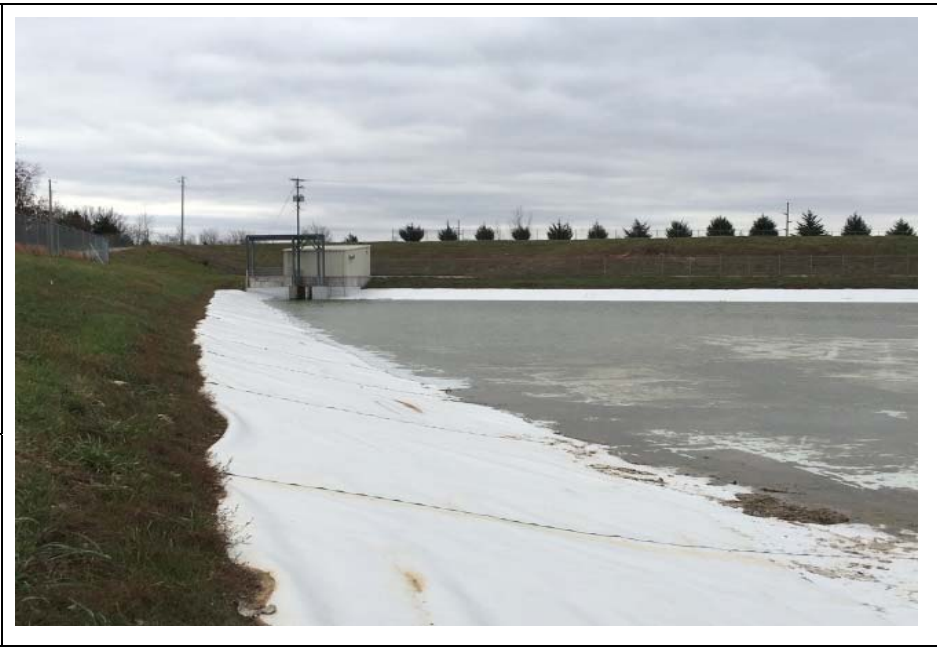
<p>Photograph No. 14</p> <p>Date: November 30, 2016</p> <p>Direction: Southeast</p>

<p>Description: Observing the contact water basin liner system with leak detection. No evidence of leaks or malfunctions.</p>

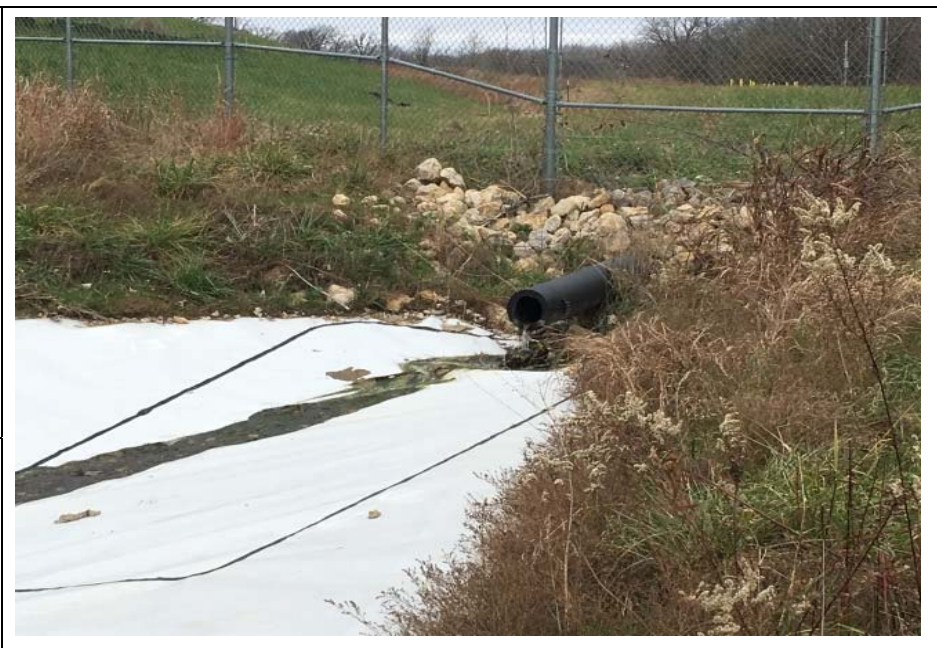
<p>Photograph No. 15</p> <p>Date: November 30, 2016</p> <p>Direction: Northwest</p>

<p>Description: Observing the inlet of contact water basin. No evidence of erosion or malfunction.</p>

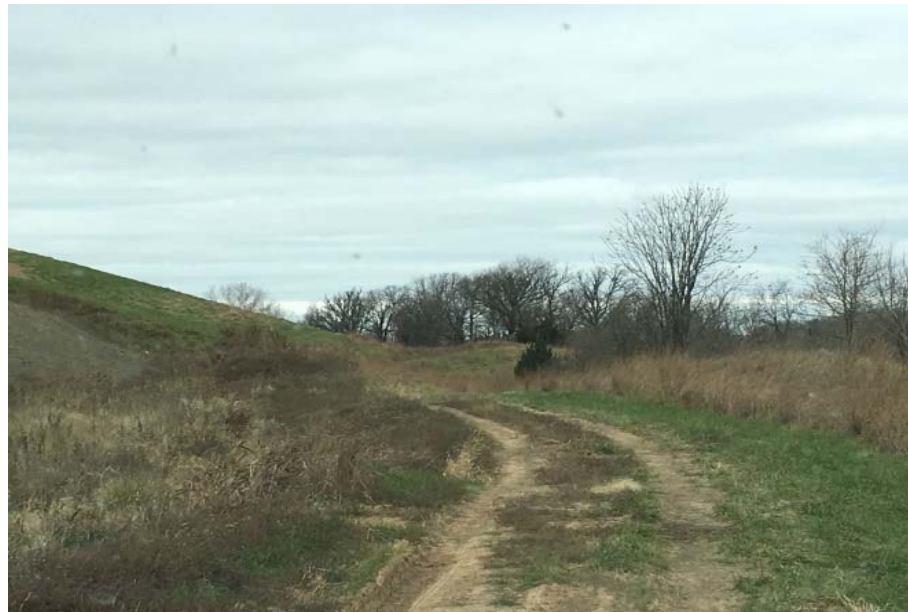
<p>Photograph No. 18</p> <p>Date: November 30, 2016</p> <p>Direction: West</p>

<p>Description: Observing the final cover at Cell 2. Vegetation is well-established and maintained. No evidence of erosion or sloughing.</p>

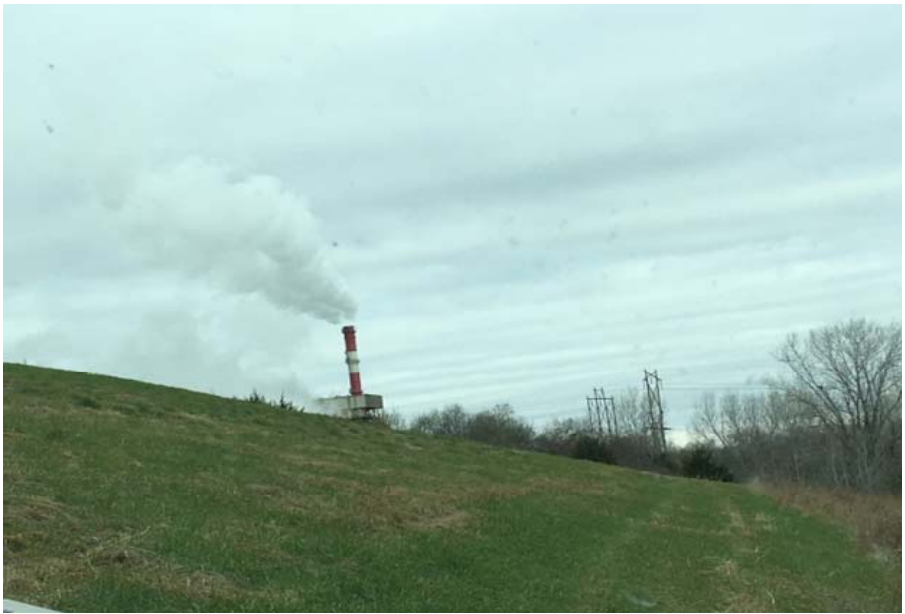
<p>Photograph No. 19</p> <p>Date: November 30, 2016</p> <p>Direction: Northwest</p>

<p>Description: Observing the exterior berm at Cell 3. Vegetation is well-established and maintained. No evidence of erosion or sloughing.</p>
