Annual Inspection Report  
Lawrence Energy Center  
Inactive Units - Ash Pond Area 2, Ash Pond Area 3,  
and Ash Pond 4

Prepared for:  
Westar Energy  
Lawrence Energy Center  
Lawrence, Kansas

Prepared by:  
CB&I Environmental & Infrastructure, Inc.

June 2017

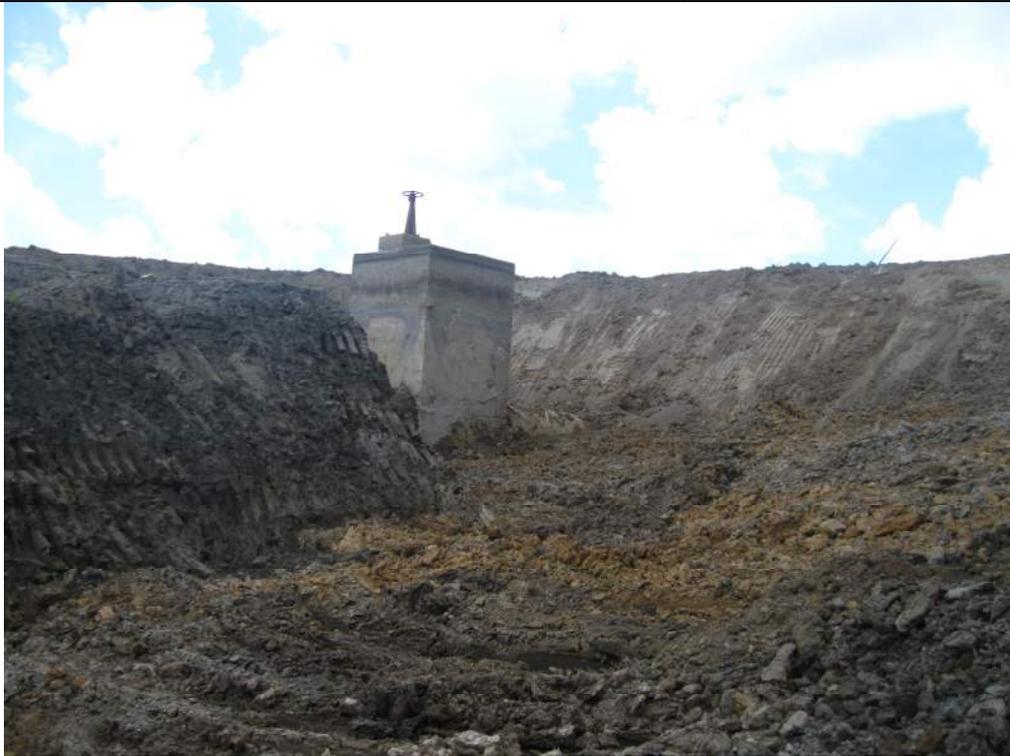
<p>Pond 4 Clean Closure</p>	<p>LEC – Bottom Ash Pond 4</p>	<p>Photo No: 20160819 - 1</p>
<p>DESCRIPTION: Concrete structure, west side of the impoundment. To be removed.</p>

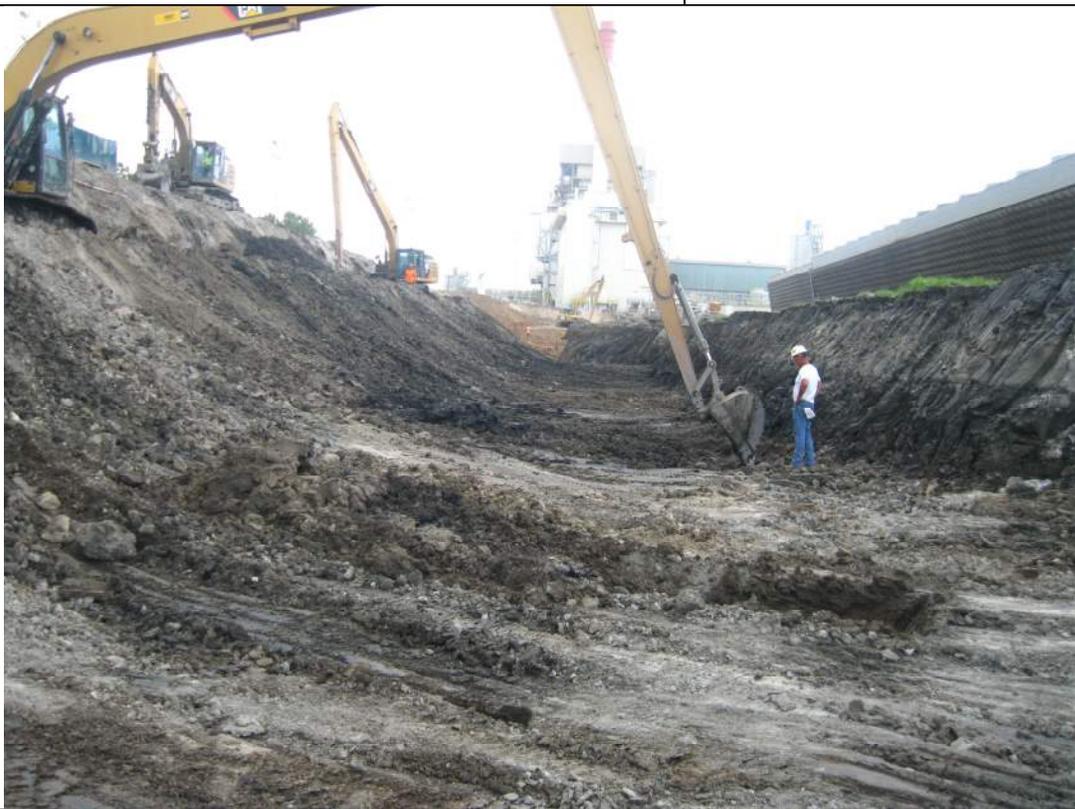
An area east of the concrete structure had a subgrade that was not easy to distinguish from the native soil or the native soil had been dumped or slid on top of some of the bottom ash. Dan had a backhoe excavate a pit within the area so I could observe the black material that was below a gray sandy soil. We had discussed whether the black material was native or composed of ash. As the excavation was still open, water drainage was observed seeping from the black material and the material appeared to have more sand than the underlying gray material. We agreed the black material should be considered to be bottom ash and needs to be removed.

<p>19 August 2016</p>		
<p>Pond 4 Clean Closure</p>	<p>LEC – Bottom Ash Pond 4</p>	<p>Photo No: 20160819 - 2</p>
<p>DESCRIPTION: Excavating test pits to observe bottom ash</p>

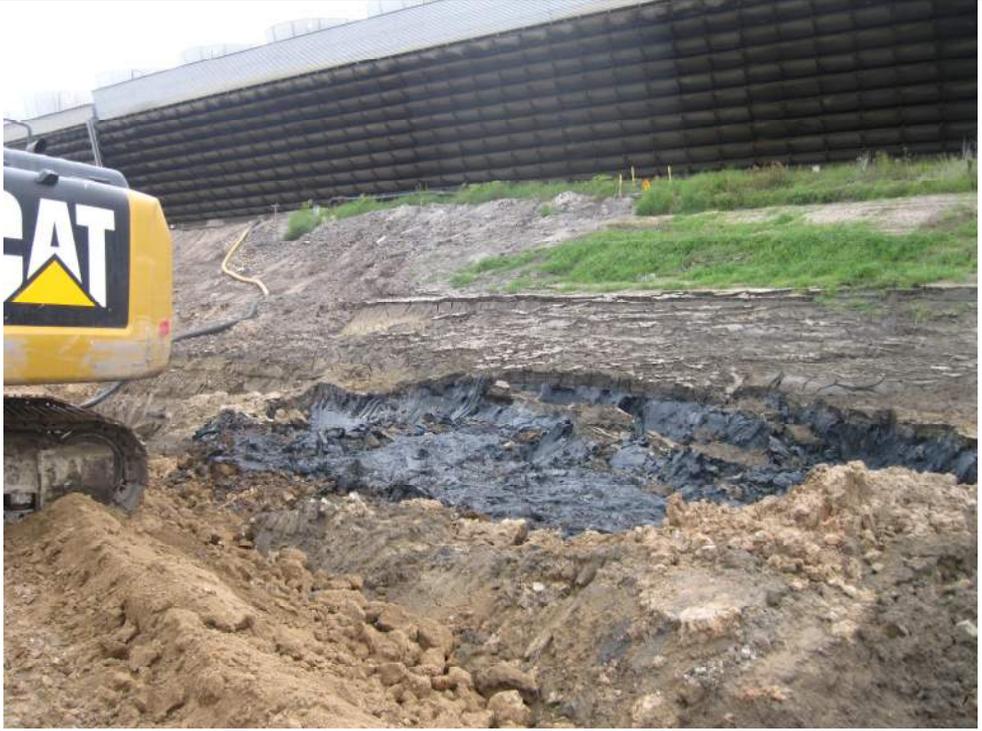
23 August 2016		
Pond 4 Clean Closure	LEC – Bottom Ash Pond 4	Photo No: 20160823 - 2
<p>DESCRIPTION: Bottom ash may look dry at the surface but is still flowable below the crust.</p>

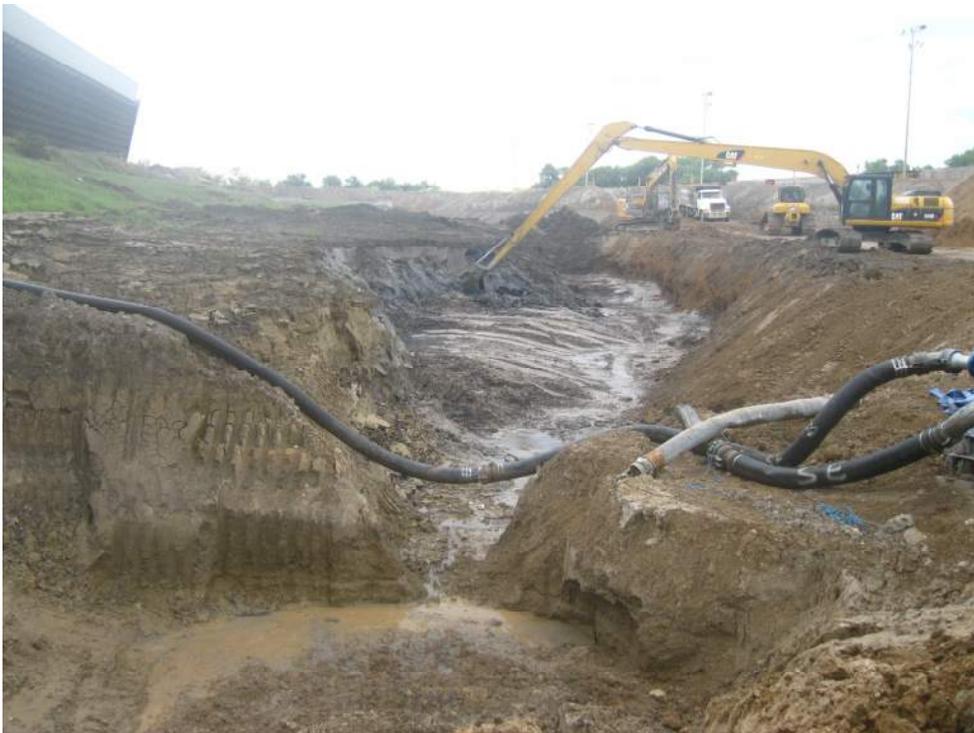
Pond 4 Clean Closure	LEC – Bottom Ash Pond 4	Photo No: 20160824 - 1
DESCRIPTION: SE Corner – Cleaning area of bottom ash slides

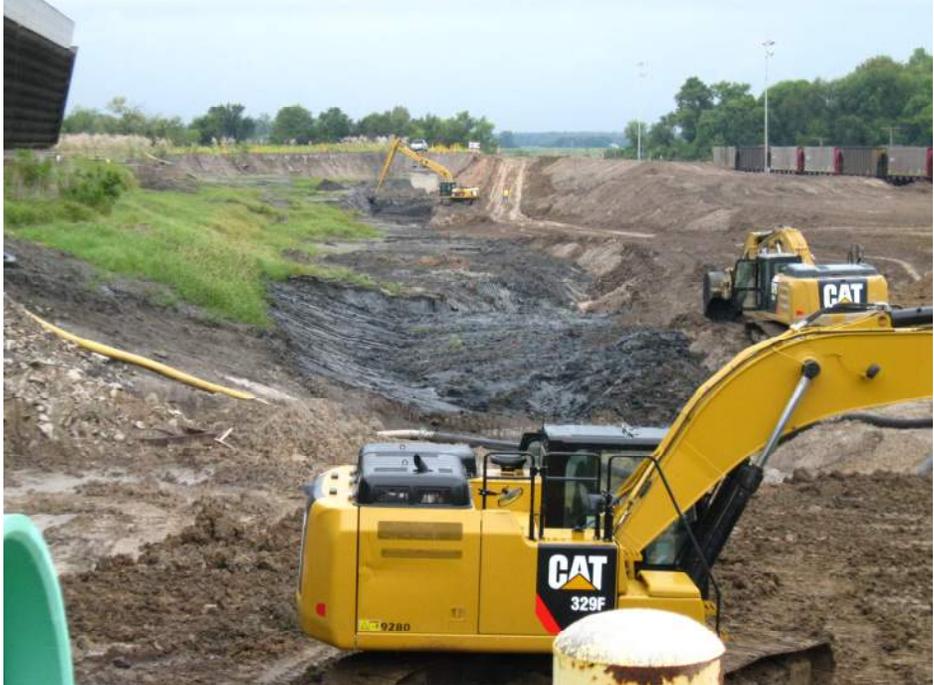
13 September 2016		
Pond 4 Clean Closure	LEC – Bottom Ash Pond 4	Photo No: 20160913 - 2
<p>DESCRIPTION: Area to the east that has had slump failure of south embankment area</p>

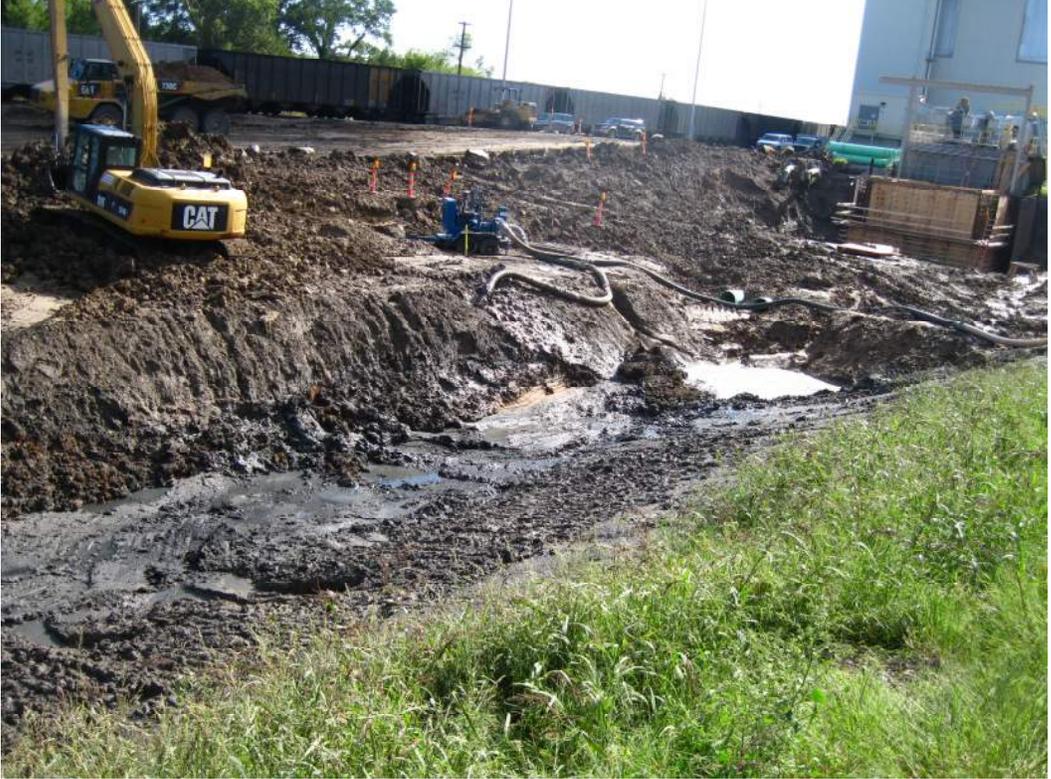
17 September 2016		
Pond 4 Clean Closure	LEC – Bottom Ash Pond 4	Photo No: 20160917 - 2
DESCRIPTION: Wet subgrade due to surface water runoff from recent rains.

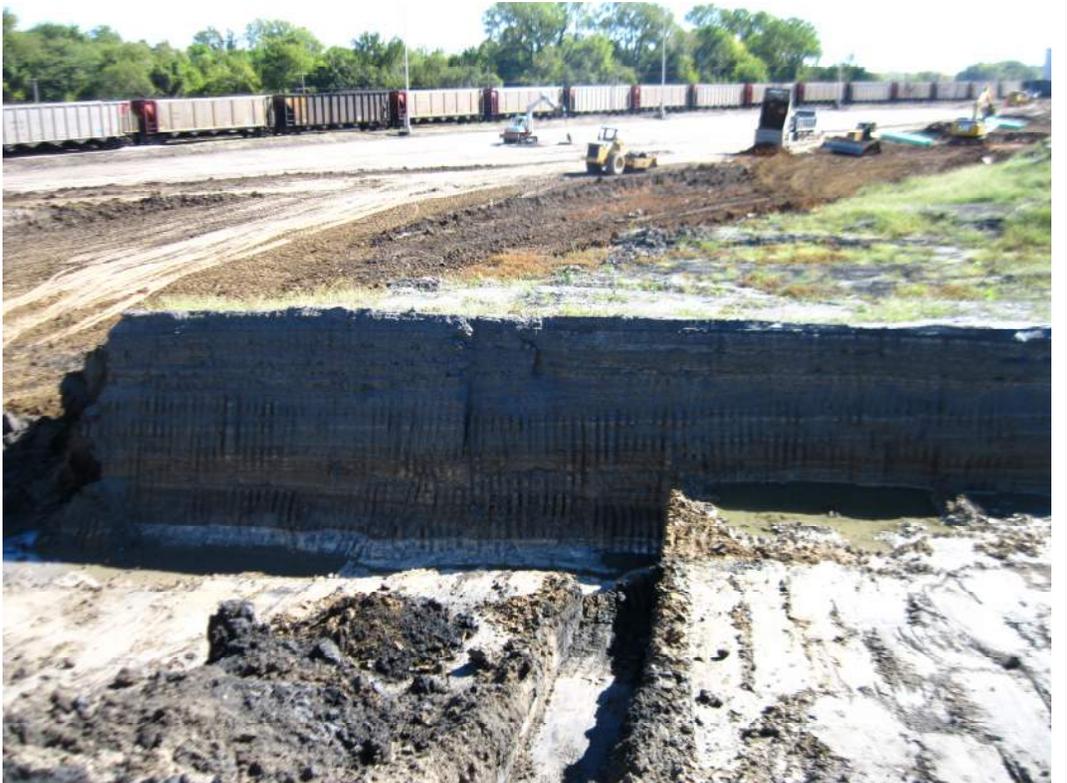
Arrived at site at 10:30 a.m. Schmidtlein Excavating had excavated along the west portion of the pond that is west of the cooling tower. The excavation appeared to be a reasonable depth, but black coal dust and bottom ash were observed at the base of the excavation. We agreed that the area was not a complete removal of the bottom ash in this area and additional excavation would be required. No additional areas of the pond were observed to be cleaned during this site visit.

Pond 4 Clean Closure	LEC – Bottom Ash Pond 4	Photo No: 20160927 - 1
<p>DESCRIPTION: Found black coal dust in bottom of excvation.</p>

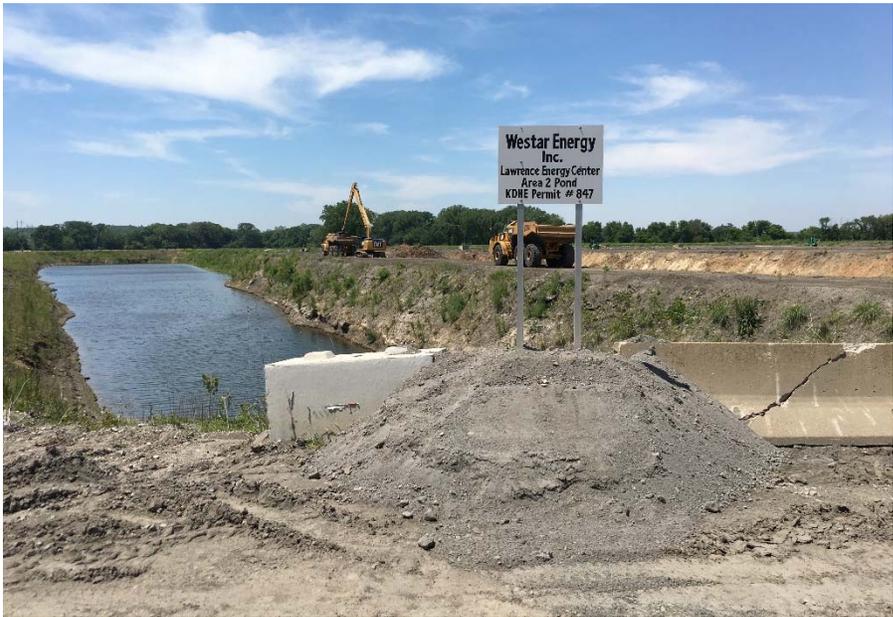
<p><b>Photograph No. 1</b></p> <p><b>Date:</b> May 15, 2017</p> <p><b>Direction:</b> Northwest</p>

<p><b>Description:</b> Observing Pond 501. Some vegetation is present on the side slopes. Site road is in good condition.</p>

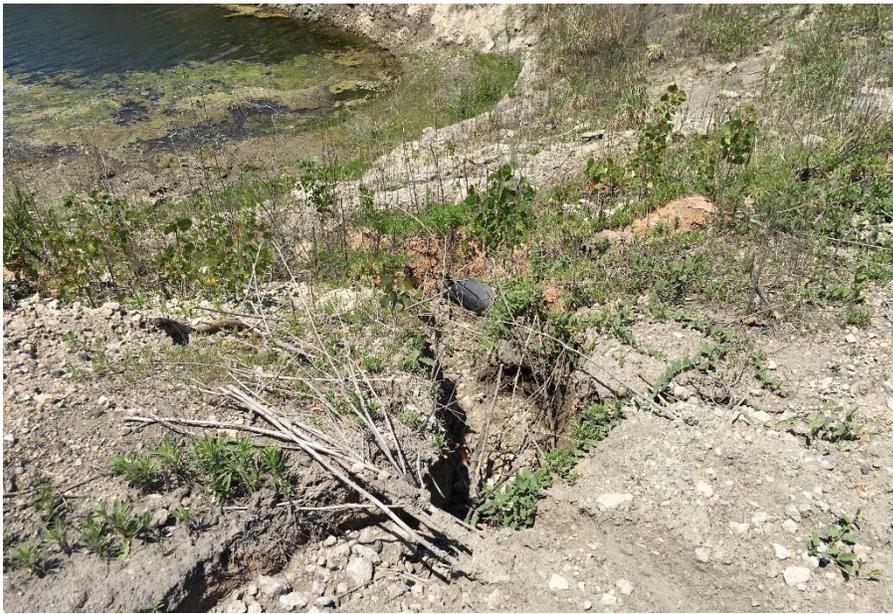
<p><b>Photograph No. 2</b></p> <p><b>Date:</b> May 15, 2017</p> <p><b>Direction:</b> Northwest</p>

<p><b>Description:</b> Observing Pond 501. Erosion is present within pond, but does not impact stability of impoundment.</p>

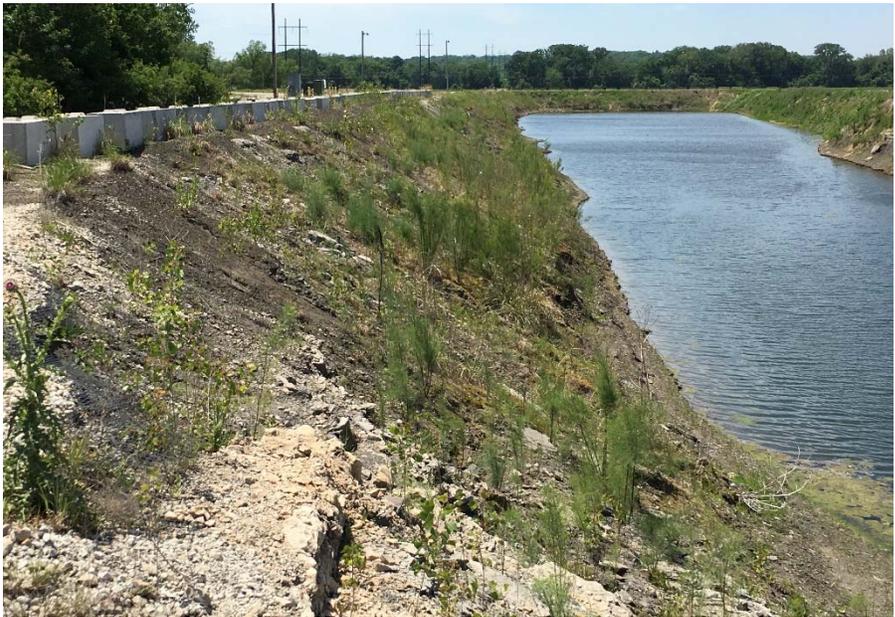
<p><b>Photograph No. 3</b></p> <p><b>Date:</b> May 15, 2017</p> <p><b>Direction:</b> West</p>

<p><b>Description:</b> Pond 501 interior side slopes contain some vegetation. Erosion is present, but does not affect stability of regulated impoundment.</p>

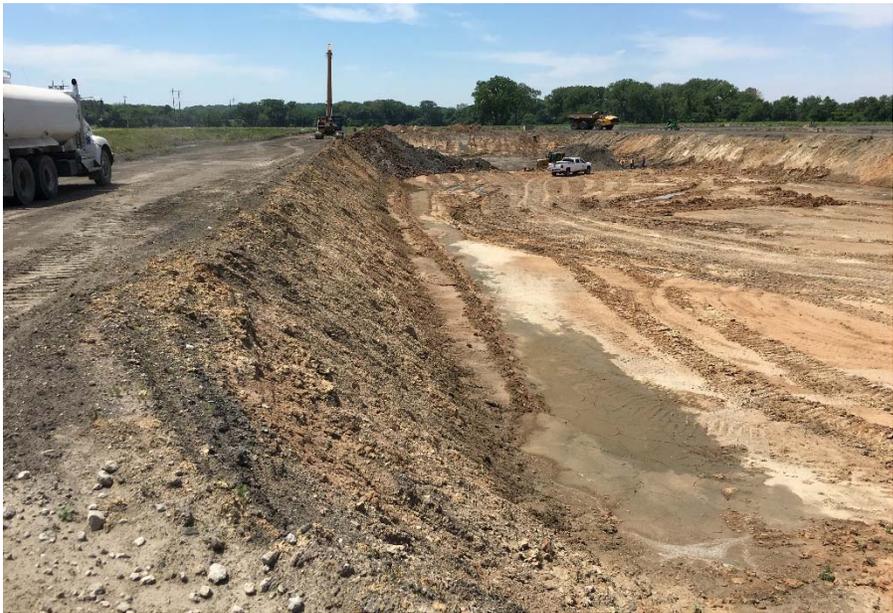
<p><b>Photograph No. 5</b></p> <p><b>Date:</b> May 15, 2017</p> <p><b>Direction:</b> West</p>

<p><b>Description:</b> Clean closure activities ongoing in Pond 502. Side slopes appear stable. Site road is in good condition.</p>

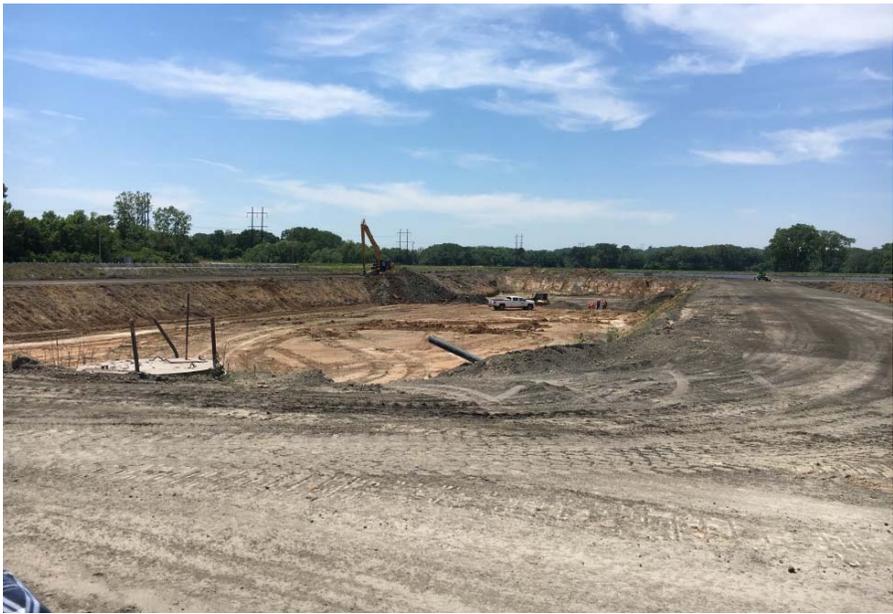
<p><b>Photograph No. 6</b></p> <p><b>Date:</b> May 15, 2017</p> <p><b>Direction:</b> Southwest</p>

<p><b>Description:</b> Clean closure activities ongoing in Pond 502. Site roads surrounding Pond 502 are in stable condition.</p>

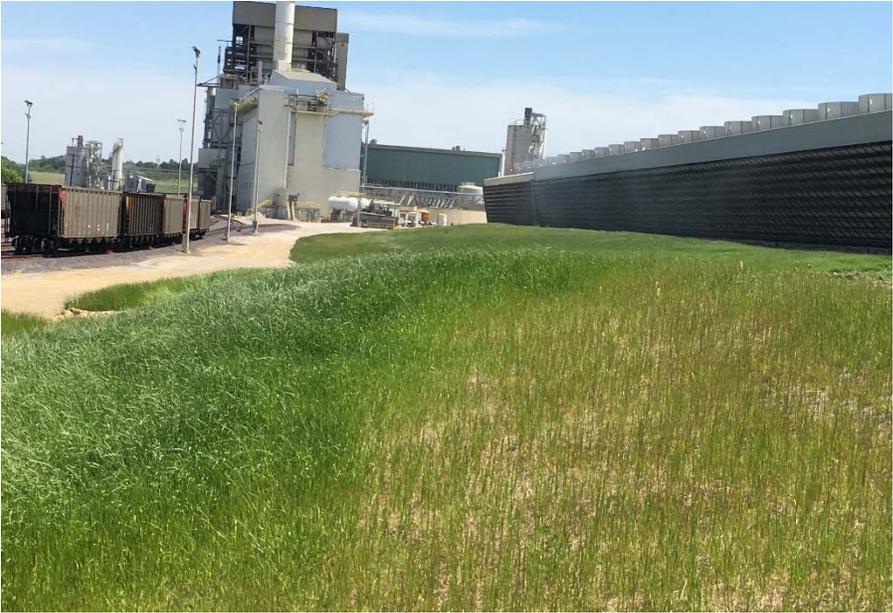
<p><b>Photograph No. 15</b></p> <p><b>Date:</b> May 15, 2017</p> <p><b>Direction:</b> Southeast</p>

<p><b>Description:</b> Impoundment outer northern side slope (north of Pond 401). Very good condition - significant vegetative growth present. No erosion present.</p>

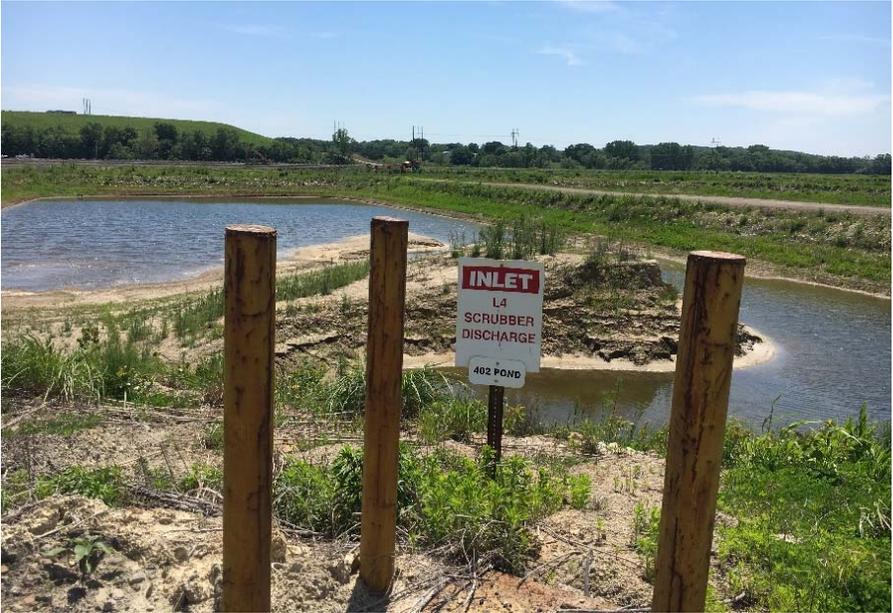
<p><b>Photograph No. 18</b></p> <p><b>Date:</b> May 15, 2017</p> <p><b>Direction:</b> Southwest</p>

<p><b>Description:</b> Pond 402 inlet. Mild to moderate vegetation present on side slopes. Moderate erosion within pond, but does not impact stability of impoundment.</p>

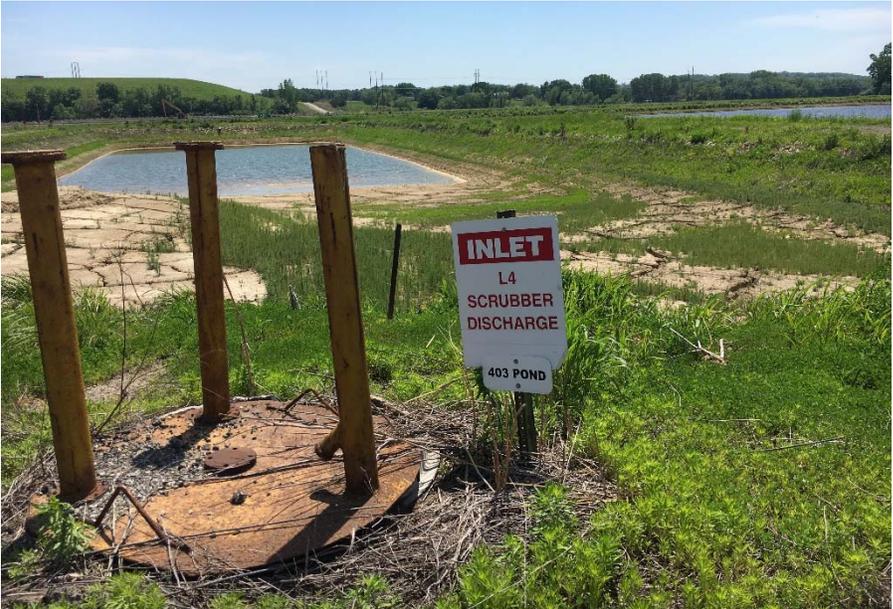
<p><b>Photograph No. 20</b></p> <p><b>Date:</b> May 15, 2017</p> <p><b>Direction:</b> South</p>

<p><b>Description:</b> Pond 403 inlet. Moderate erosion and mud cracking within pond, but does not impact stability of impoundment.</p>
