## Initial Safety Factor Assessment Lawrence Energy Center

Inactive Units - Ash Pond Area 2, Ash Pond Area 3,  
and Ash Pond 4

Westar Energy

April 2018

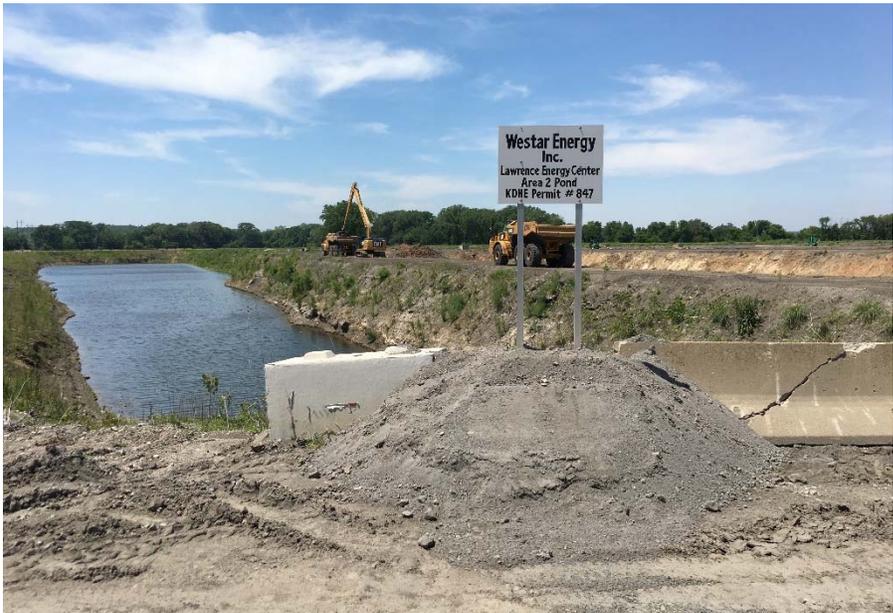
<p><b>Photograph No. 1</b></p> <p><b>Date:</b> May 15, 2017</p> <p><b>Direction:</b> Northwest</p>

<p><b>Description:</b> Observing Pond 501. Some vegetation is present on the side slopes. Site road is in good condition.</p>

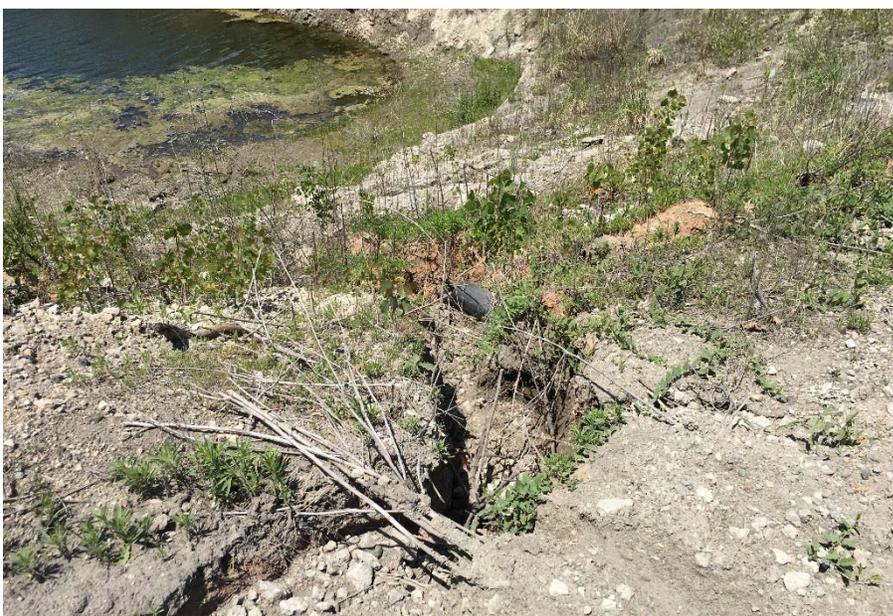
<p><b>Photograph No. 2</b></p> <p><b>Date:</b> May 15, 2017</p> <p><b>Direction:</b> Northwest</p>

<p><b>Description:</b> Observing Pond 501. Erosion is present within pond, but does not impact stability of impoundment.</p>

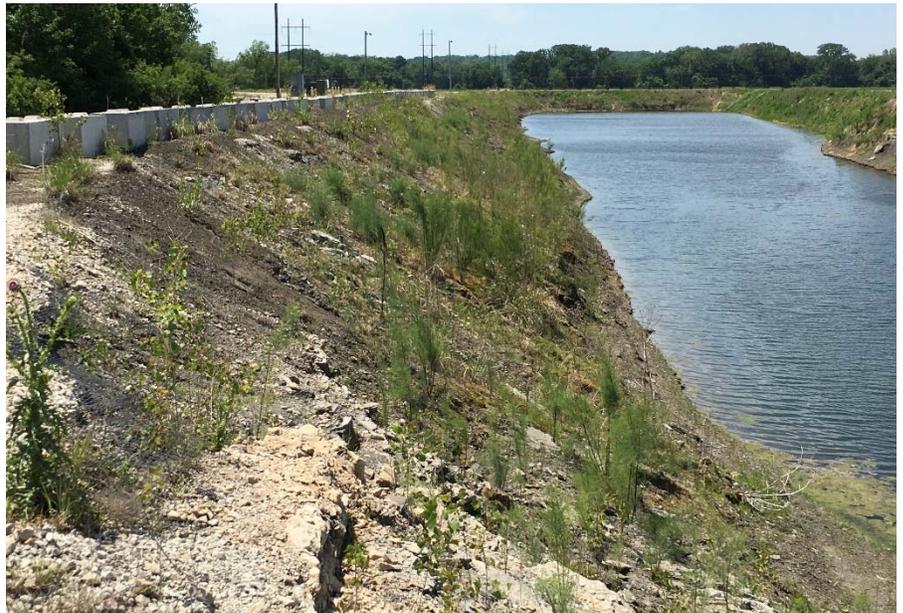
**Photograph No. 3**

Pond 501 interior side slopes contain some vegetation. Erosion is present, but does not affect stability of regulated impoundment.

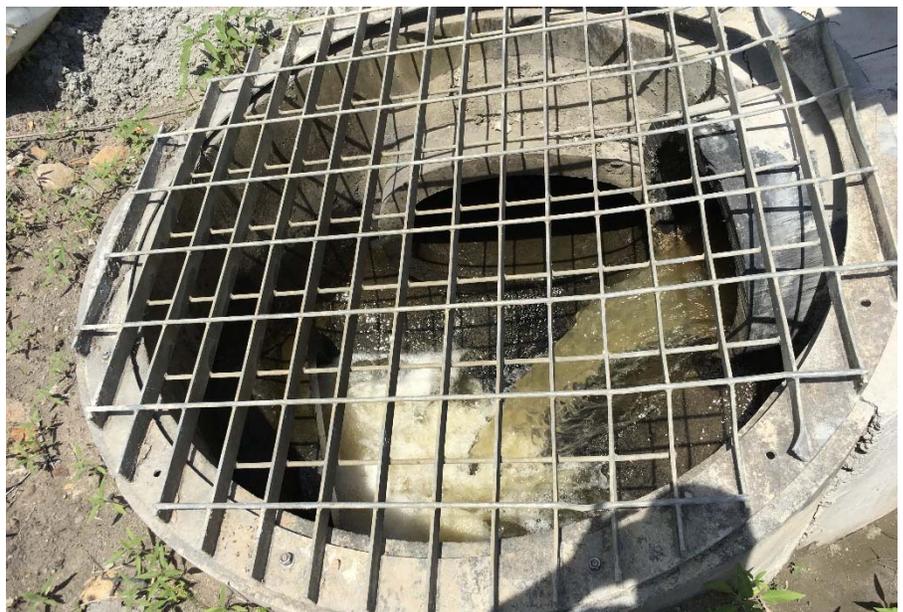
**Photograph No. 4**

Manhole inlet where process water enters impounded pond network.

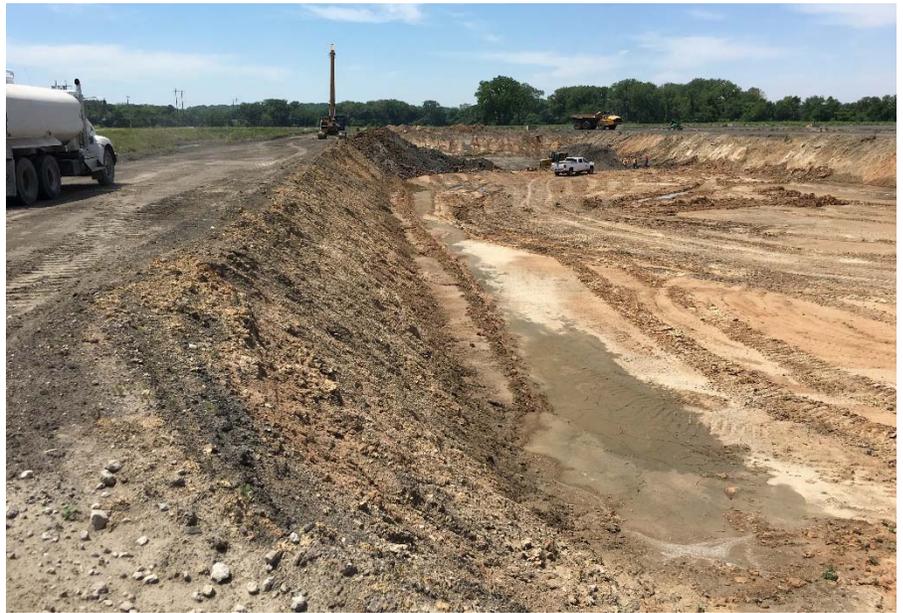
**Photograph No. 5**

**Description:**  
Clean closure activities ongoing in Pond 502. Side slopes appear stable. Site road is in good condition.

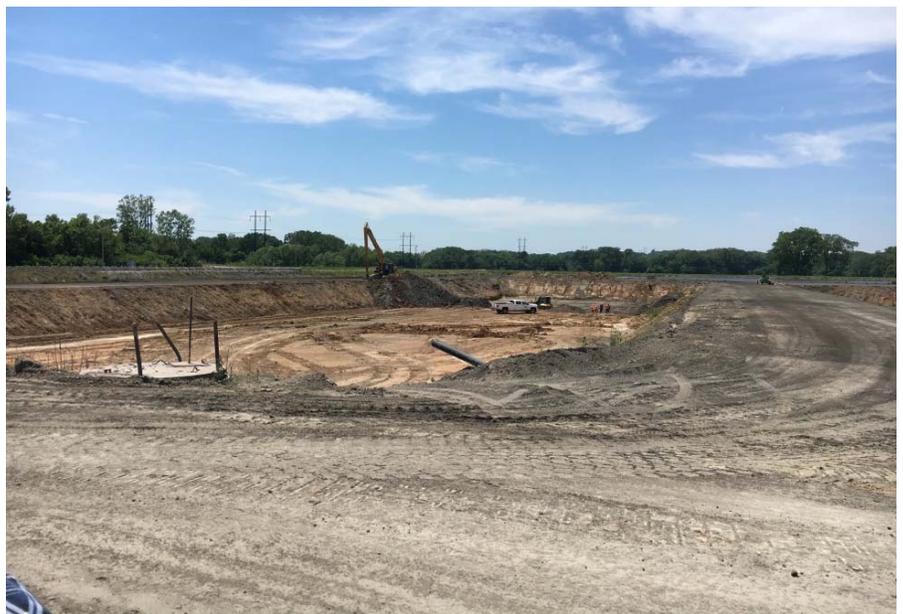
**Photograph No. 6**

**Description:**  
Clean closure activities ongoing in Pond 502. Site roads surrounding Pond 502 are in stable condition.

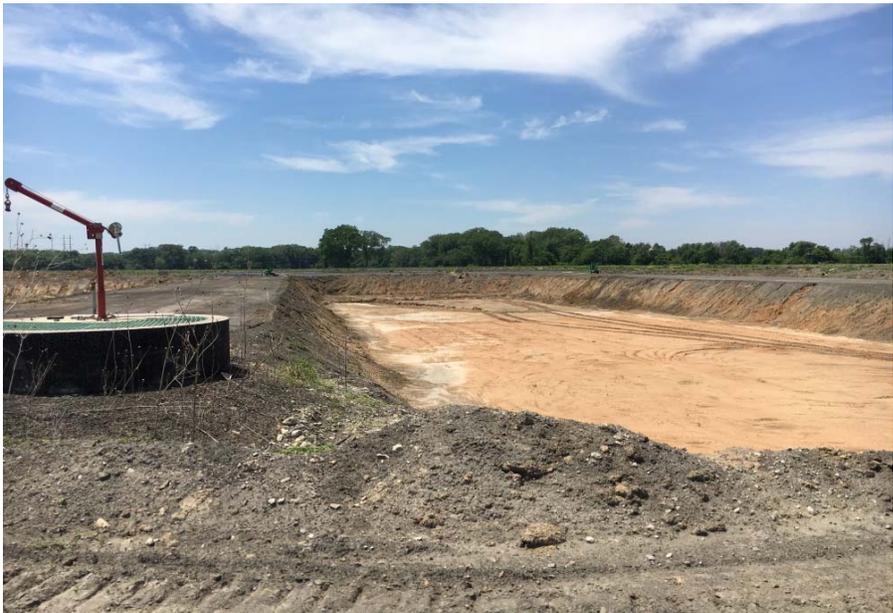
<p><b>Photograph No. 7</b></p> <p><b>Date:</b> May 15, 2017</p> <p><b>Direction:</b> Northwest</p>

<p><b>Description:</b> Pond 503 has been dewatered and will be undergoing clean closure in the future. Knife-gate inlet structure shown.</p>

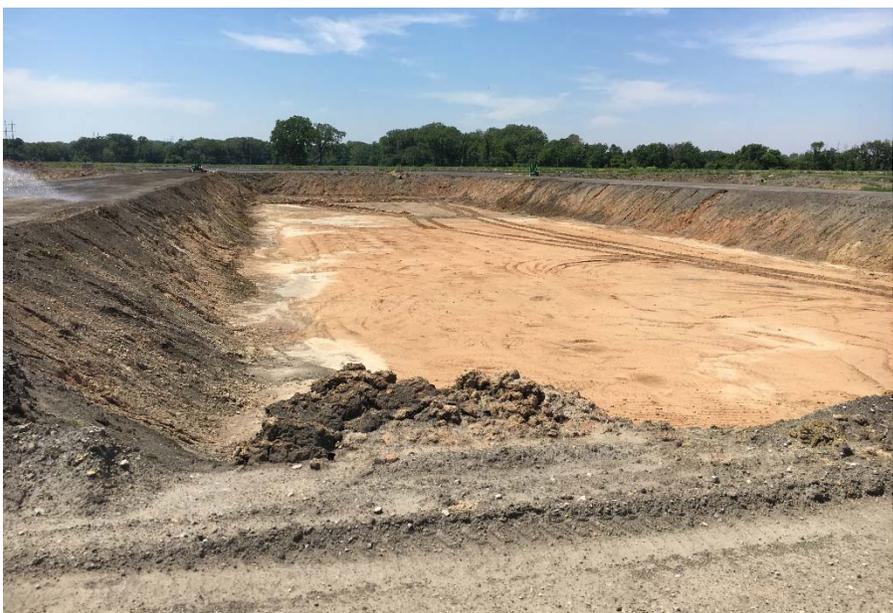
<p><b>Photograph No. 8</b></p> <p><b>Date:</b> May 15, 2017</p> <p><b>Direction:</b> Northwest</p>

<p><b>Description:</b> Dewatered Pond 503. Will begin process of closure in near future.</p>

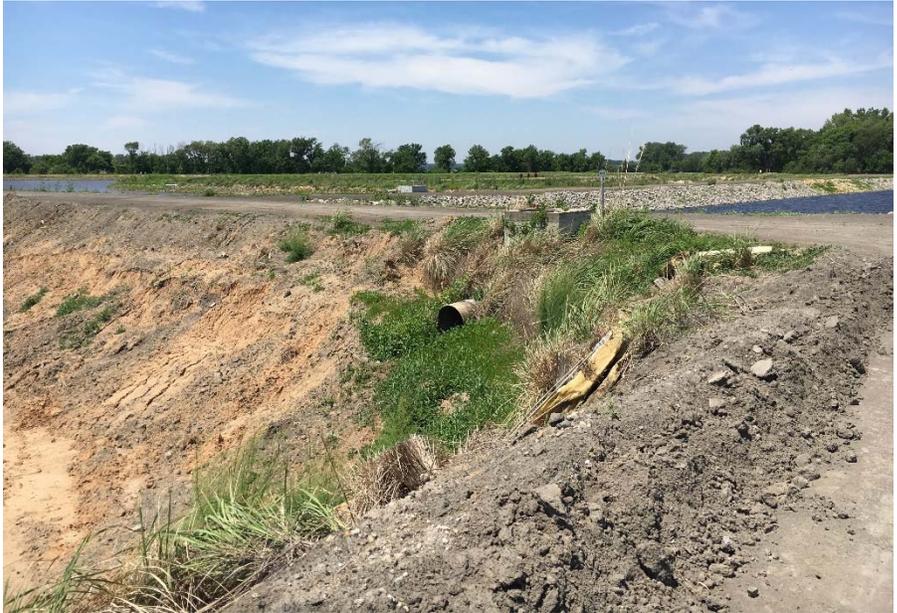
<p><b>Photograph No. 9</b></p> <p><b>Date:</b> May 15, 2017</p> <p><b>Direction:</b> Northwest</p>

<p><b>Description:</b> Culvert connection Pond 503 and Pond 401 that is no longer in use due to closure of Pond 503. Site roads are in stable condition.</p>

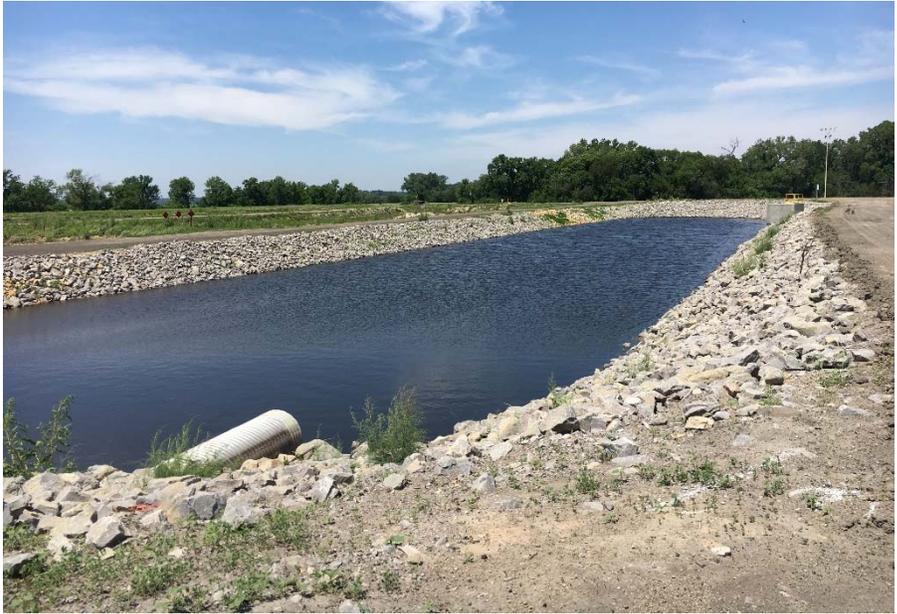
<p><b>Photograph No. 10</b></p> <p><b>Date:</b> May 15, 2017</p> <p><b>Direction:</b> Northwest</p>

<p><b>Description:</b> Observing Pond 401. Side slopes are stabilized with rip-rap. Piping connecting Pond 401 to Pond 503 is shown. Pond 401 underwent clean closure and construction for receipt of process water.</p>

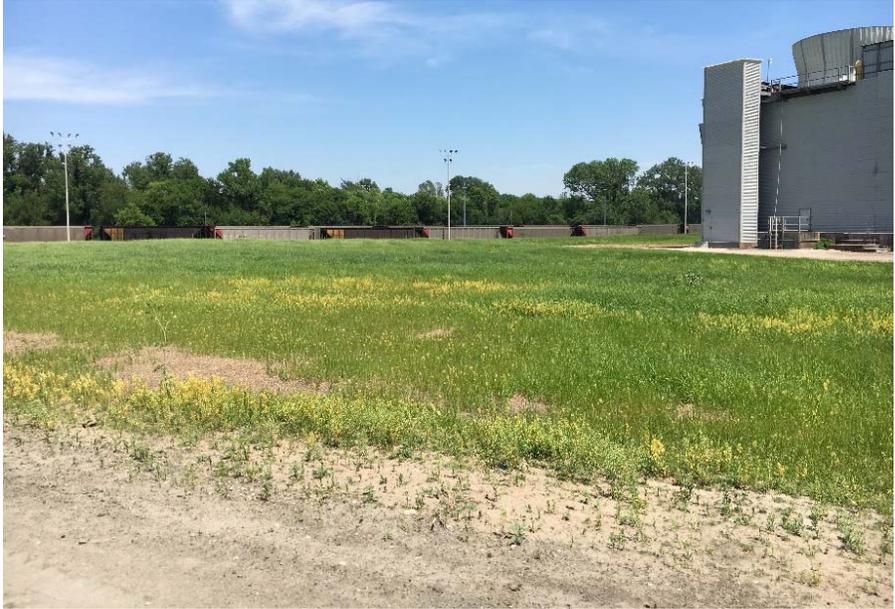
<p><b>Photograph No. 11</b></p> <p><b>Date:</b> May 15, 2017</p> <p><b>Direction:</b> Northeast</p>

<p><b>Description:</b> Closed Scrubber Supply Pond (Area 4 Pond). Appropriate vegetative growth present.</p>

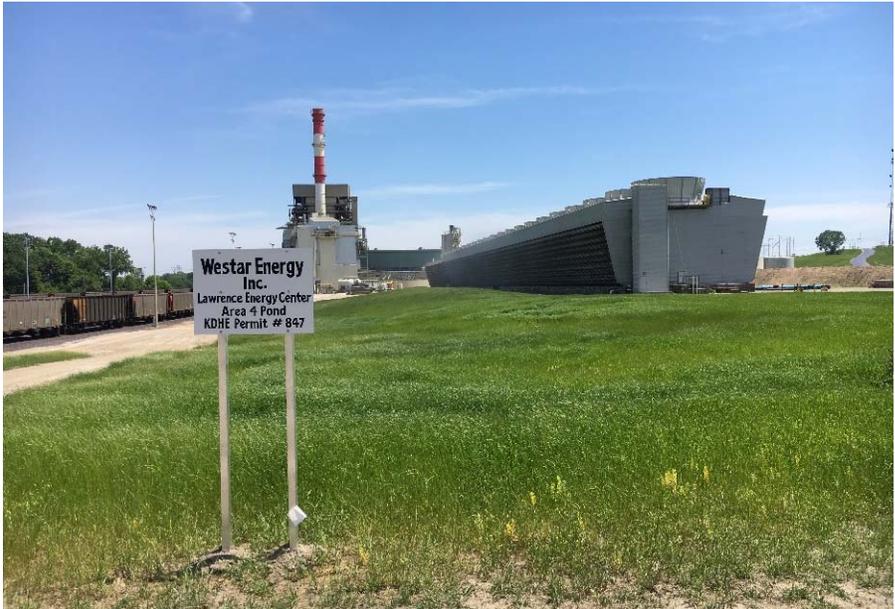
<p><b>Photograph No. 12</b></p> <p><b>Date:</b> May 15, 2017</p> <p><b>Direction:</b> Southeast</p>

<p><b>Description:</b> Former Scrubber Supply Pond (Area 4 Pond) that was cleaned, filled with soil fill, and vegetated.</p>

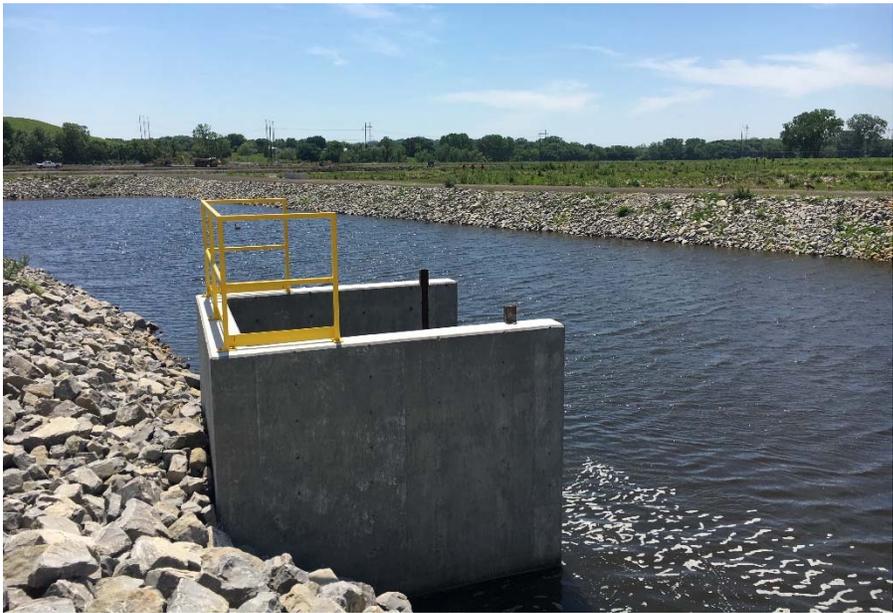
<p><b>Photograph No. 13</b></p> <p><b>Date:</b> May 15, 2017</p> <p><b>Direction:</b> Southwest</p>

<p><b>Description:</b> Pond 401 outlet structure. Rip-rap stabilized side slopes present. Pond 401 underwent clean closure and construction for receipt of process water.</p>

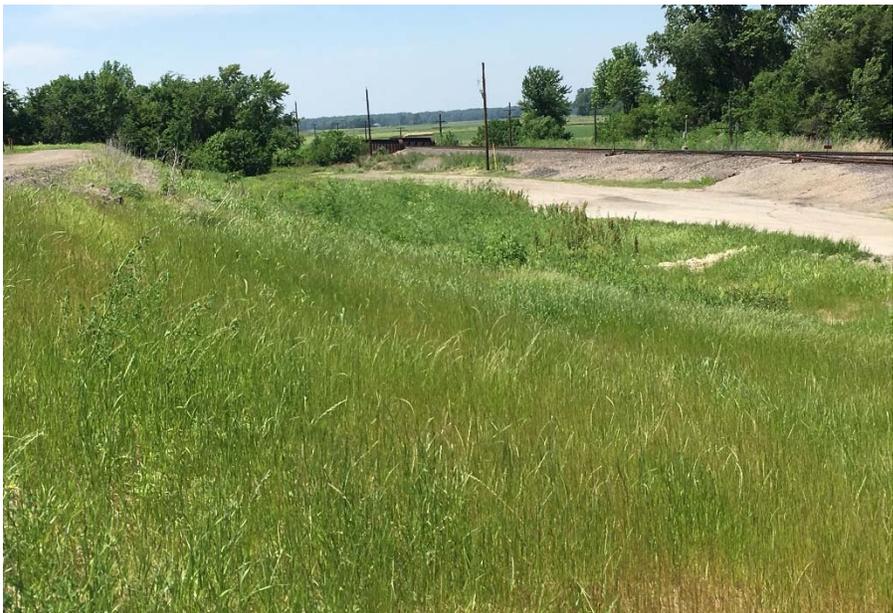
<p><b>Photograph No. 14</b></p> <p><b>Date:</b> May 15, 2017</p> <p><b>Direction:</b> Northwest</p>

<p><b>Description:</b> Impoundment outer northern side slope (north of Pond 401). Very good condition - significant vegetative growth present. No erosion present.</p>

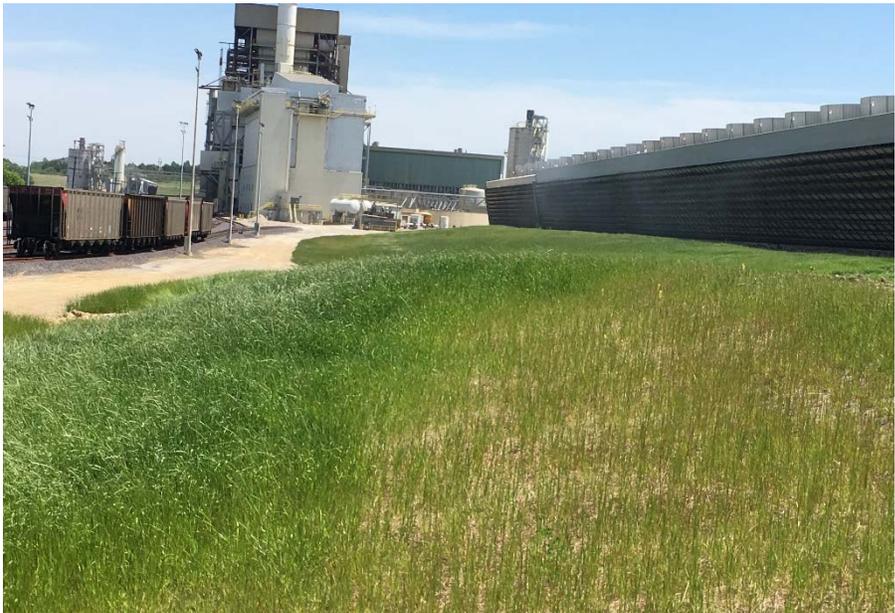
<p><b>Photograph No. 15</b></p> <p><b>Date:</b> May 15, 2017</p> <p><b>Direction:</b> Southeast</p>

<p><b>Description:</b> Impoundment outer northern side slope (north of Pond 401). Very good condition - significant vegetative growth present. No erosion present.</p>

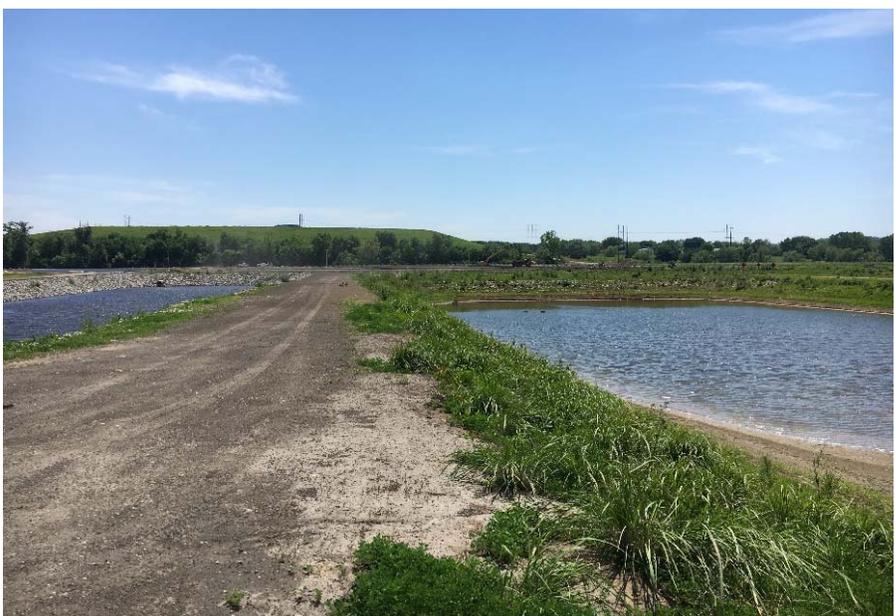
<p><b>Photograph No. 16</b></p> <p><b>Date:</b> May 15, 2017</p> <p><b>Direction:</b> South</p>

<p><b>Description:</b> Berm separating Pond 401 (left) and 402 (right). Mild vegetation present on side slopes of both Ponds. Site road is in stable condition.</p>

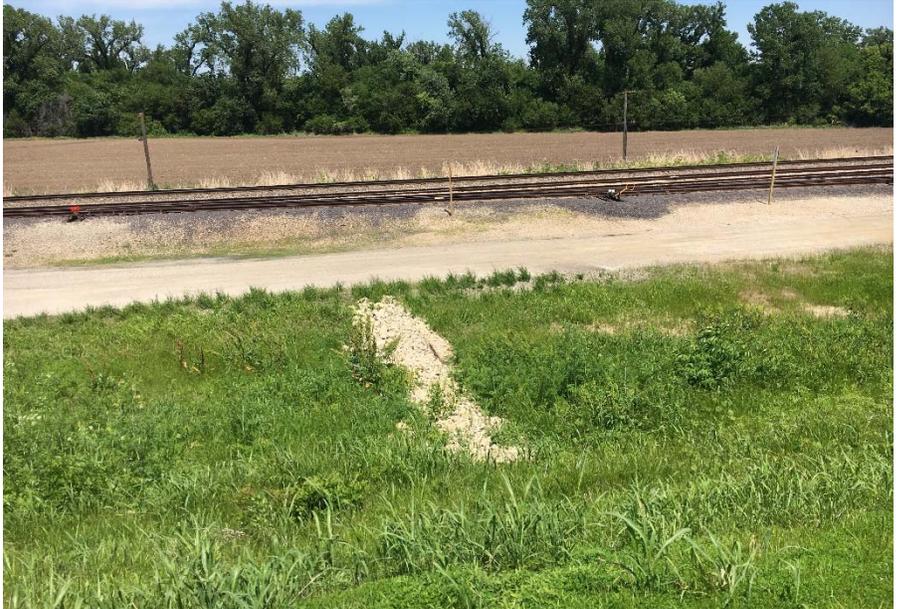
<p><b>Photograph No. 17</b></p> <p><b>Date:</b> May 15, 2017</p> <p><b>Direction:</b> Northeast</p>

<p><b>Description:</b> Stormwater ditch at bottom of impoundment on northern slope a rock check dam as shown. Appropriate vegetative growth and no erosion present. Good condition.</p>

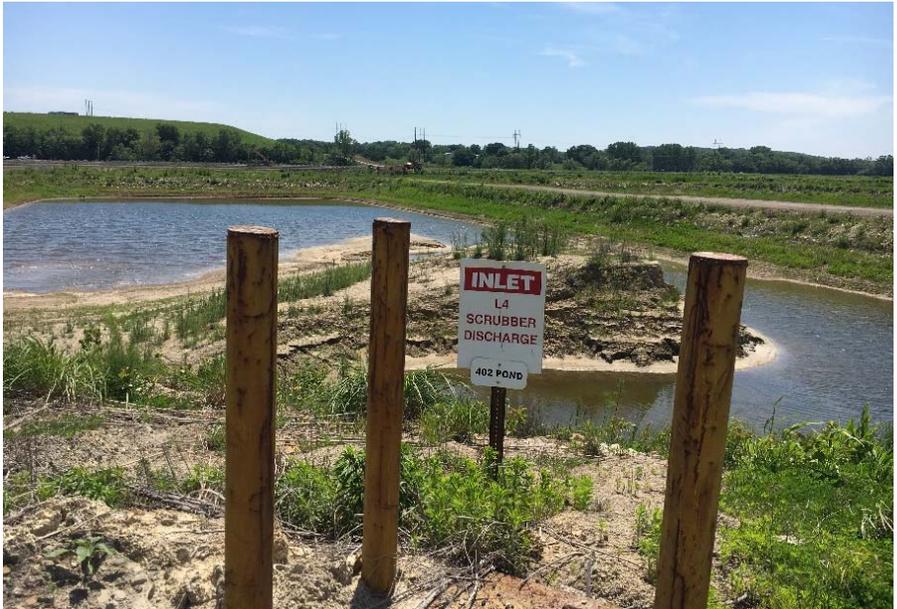
<p><b>Photograph No. 18</b></p> <p><b>Date:</b> May 15, 2017</p> <p><b>Direction:</b> Southwest</p>

<p><b>Description:</b> Pond 402 inlet. Mild to moderate vegetation present on side slopes. Moderate erosion within pond, but does not impact stability of impoundment.</p>

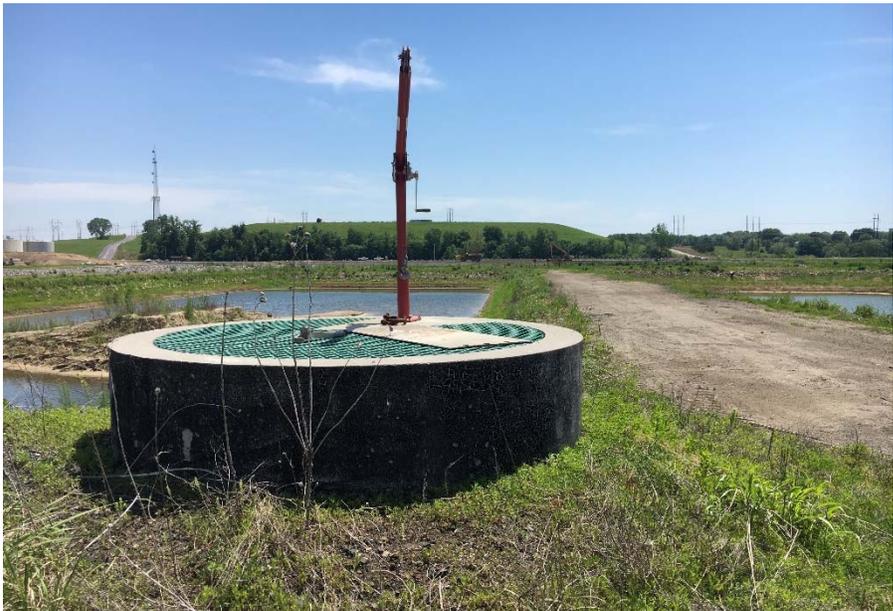
<p><b>Photograph No. 19</b></p> <p><b>Date:</b> May 15, 2017</p> <p><b>Direction:</b> Southwest</p>

<p><b>Description:</b> Pond 402 outlet structure between Pond 402 (left) and Pond 403 (right). Site road is in stable condition.</p>

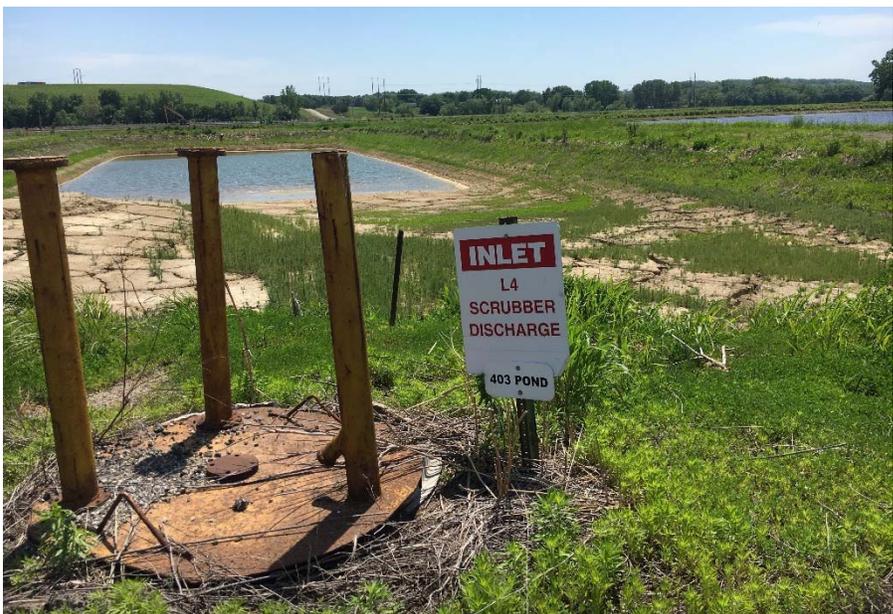
<p><b>Photograph No. 20</b></p> <p><b>Date:</b> May 15, 2017</p> <p><b>Direction:</b> South</p>

<p><b>Description:</b> Pond 403 inlet. Moderate erosion and mud cracking within pond, but does not impact stability of impoundment.</p>

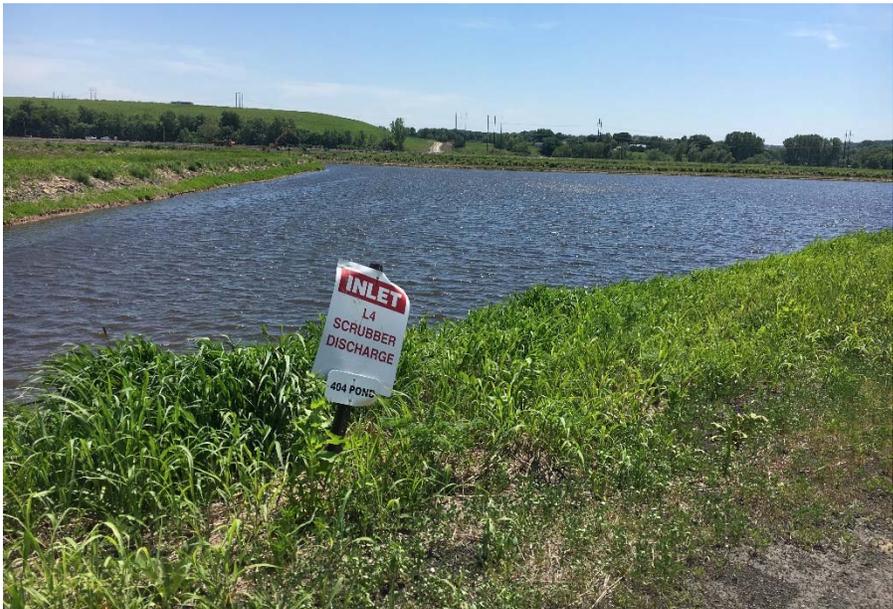
<p><b>Photograph No. 21</b></p> <p><b>Date:</b> May 15, 2017</p> <p><b>Direction:</b> Southeast</p>

<p><b>Description:</b> Pond 404 inlet. Healthy vegetation present on the side slopes.</p>

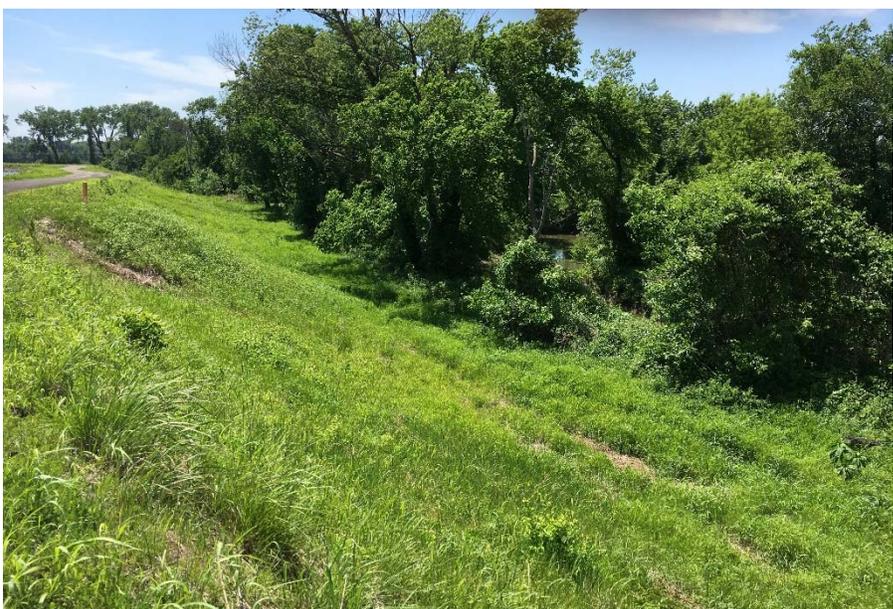
<p><b>Photograph No. 22</b></p> <p><b>Date:</b> May 15, 2017</p> <p><b>Direction:</b> Southwest</p>

<p><b>Description:</b> Outer slope of impoundment (near Pond 404). Well vegetated, no erosion. Good condition.</p>

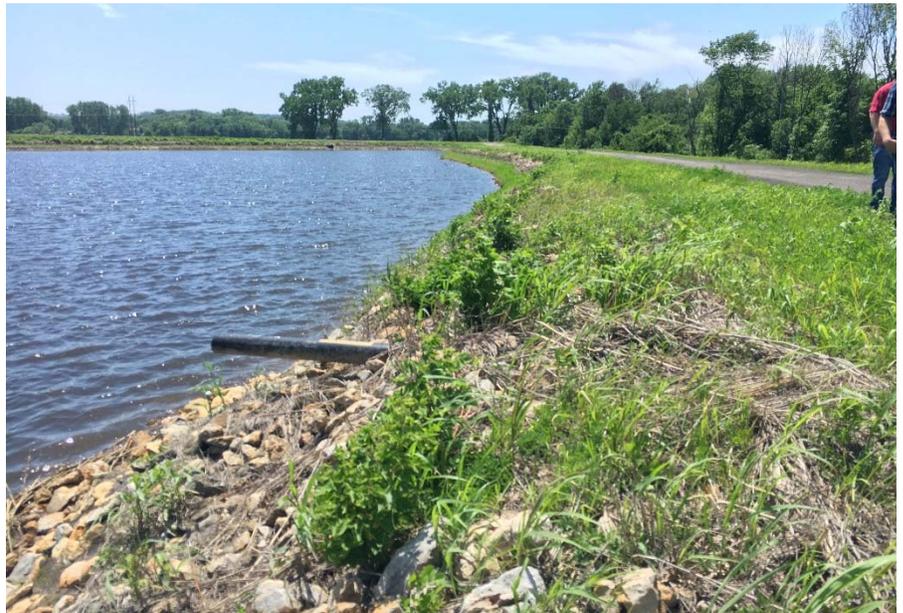
**Photograph No. 23**

Pond 404 side slope and outfall. Rip-rap and mild to moderate vegetation present on side slopes. No significant erosion present.

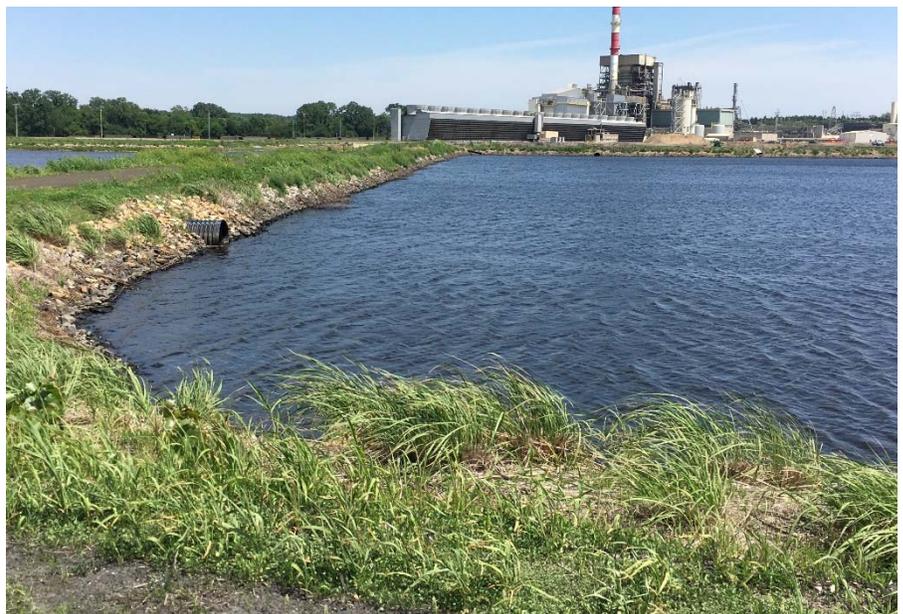
**Photograph No. 24**

West Pond outlet to Pond 404. Rip-rap and mild vegetation present on side slopes. No observed erosion.

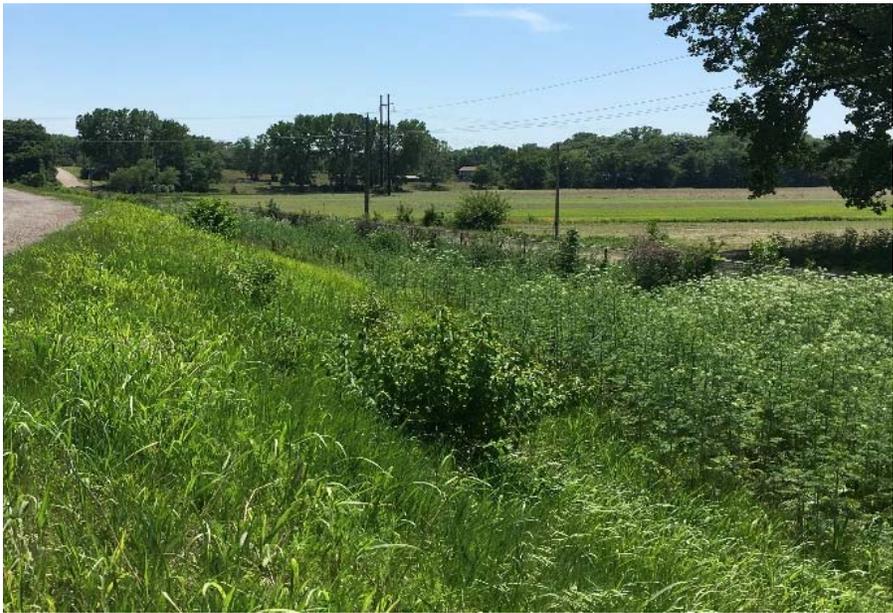
<p><b>Photograph No. 25</b></p> <p><b>Date:</b> May 15, 2017</p> <p><b>Direction:</b> South</p>

<p><b>Description:</b> Outer slope of impoundment (near West Pond). Good condition, well vegetated, no erosion observed.</p>

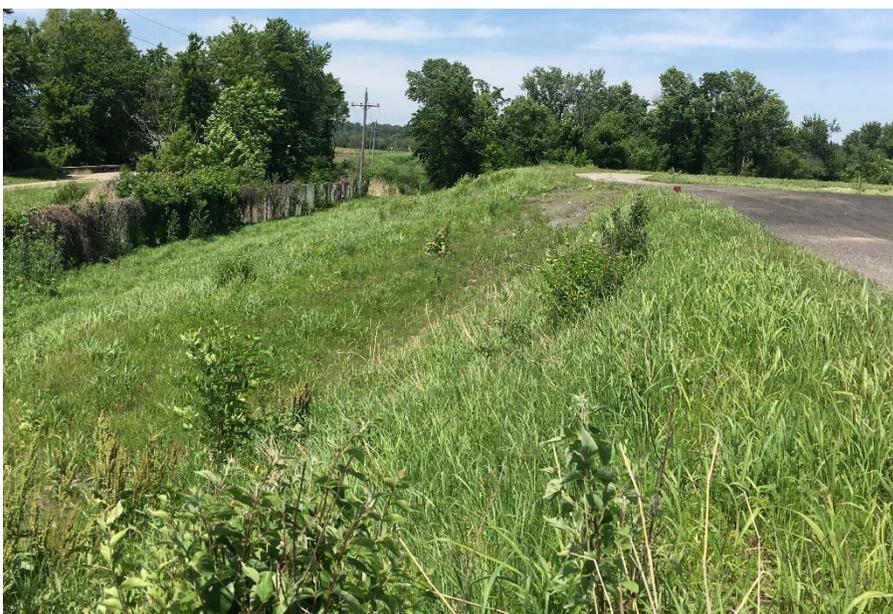
<p><b>Photograph No. 26</b></p> <p><b>Date:</b> May 15, 2017</p> <p><b>Direction:</b> North</p>

<p><b>Description:</b> Outer slope of impoundment (near West Pond). Moderate to significant vegetation present. No significant erosion present.</p>

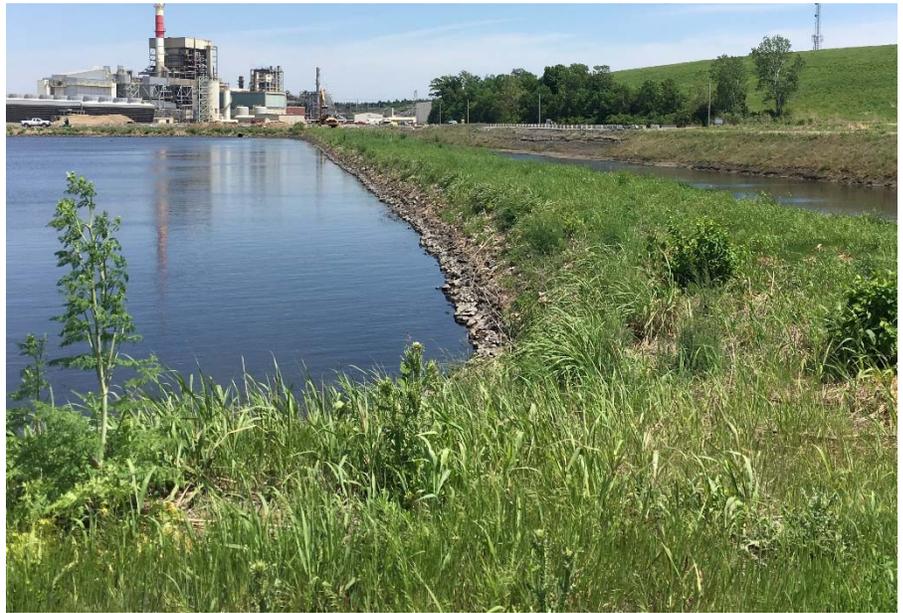
**Photograph No. 27**

Berm separating the West Pond and Laydown Area. West Pond slope is stabilized with rip-rap. Vegetation present.

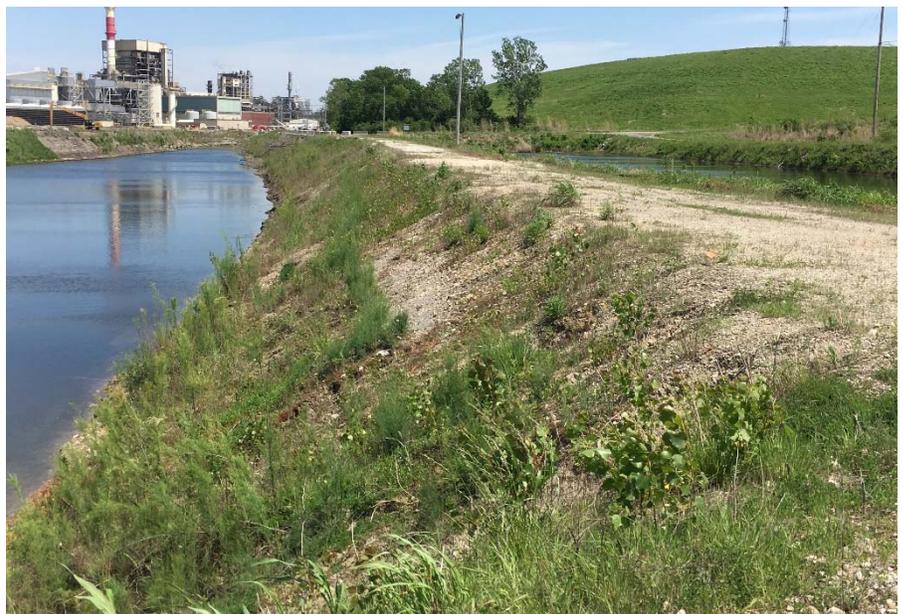
**Photograph No. 28**

Berm separating the Laydown Area and the Storm Water Settling Pond. Mild erosion present on side slope of Laydown Area, which does not impact stability of impoundment.

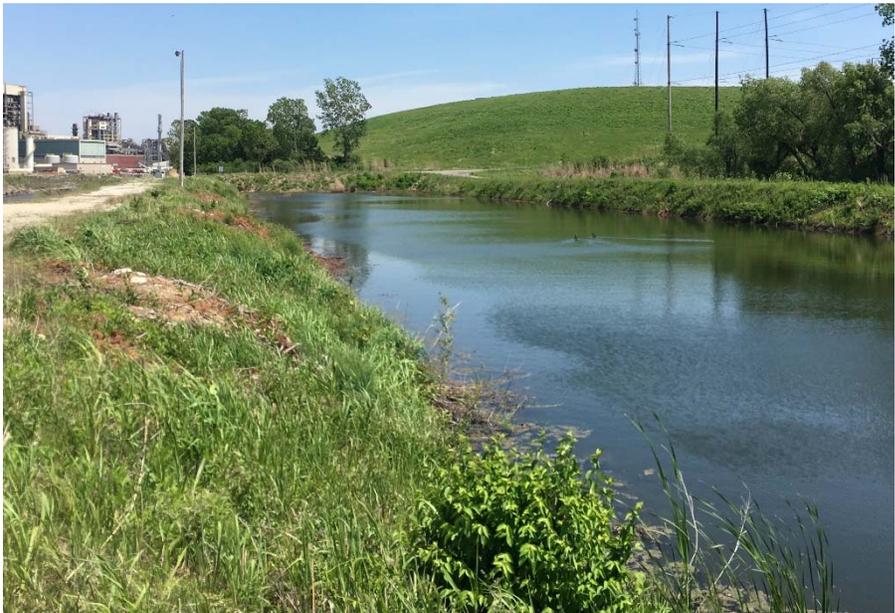
<p><b>Photograph No. 29</b></p> <p><b>Date:</b> May 15, 2017</p> <p><b>Direction:</b> East</p>

<p><b>Description:</b> Berm separating the Laydown Area and the Storm Water Settling Pond.</p>

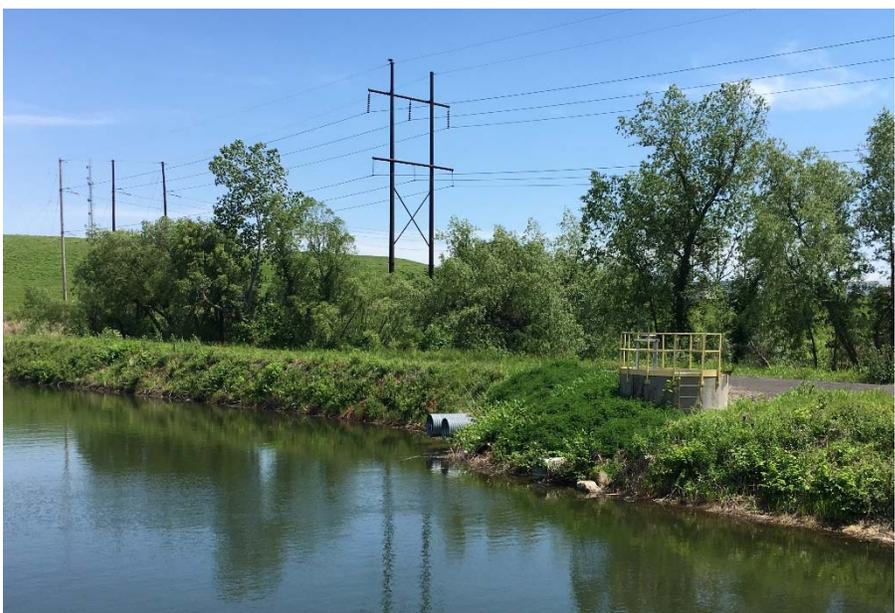
<p><b>Photograph No. 30</b></p> <p><b>Date:</b> May 15, 2017</p> <p><b>Direction:</b> Southeast</p>

<p><b>Description:</b> Outfall of Storm Water Settling Pond. Mild to moderate vegetation present. No significant erosion present.</p>

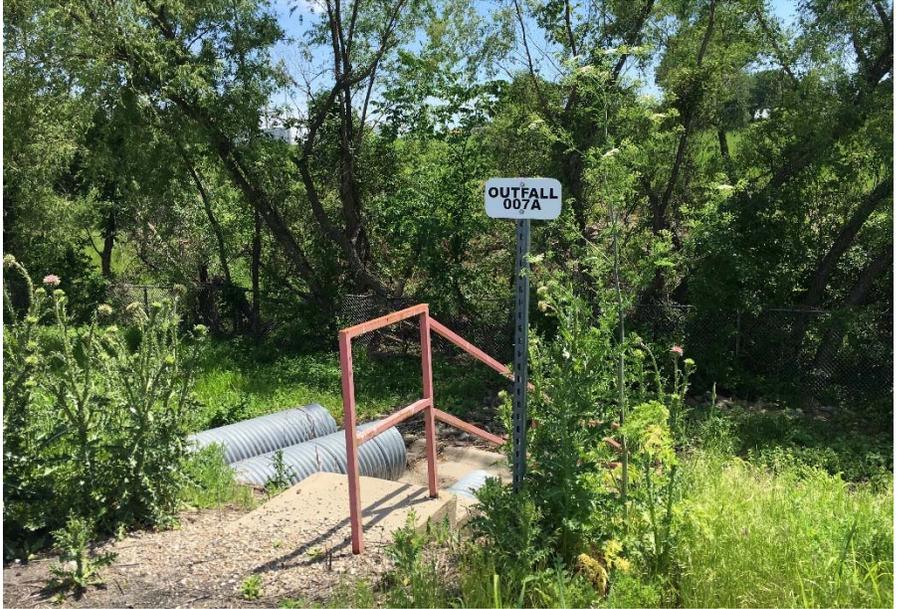
<p><b>Photograph No. 31</b></p> <p><b>Date:</b> May 15, 2017</p> <p><b>Direction:</b> Southeast</p>

<p><b>Description:</b> Outfall 007A on south side of Storm Water Settling Pond. Healthy vegetation present near outfall.</p>

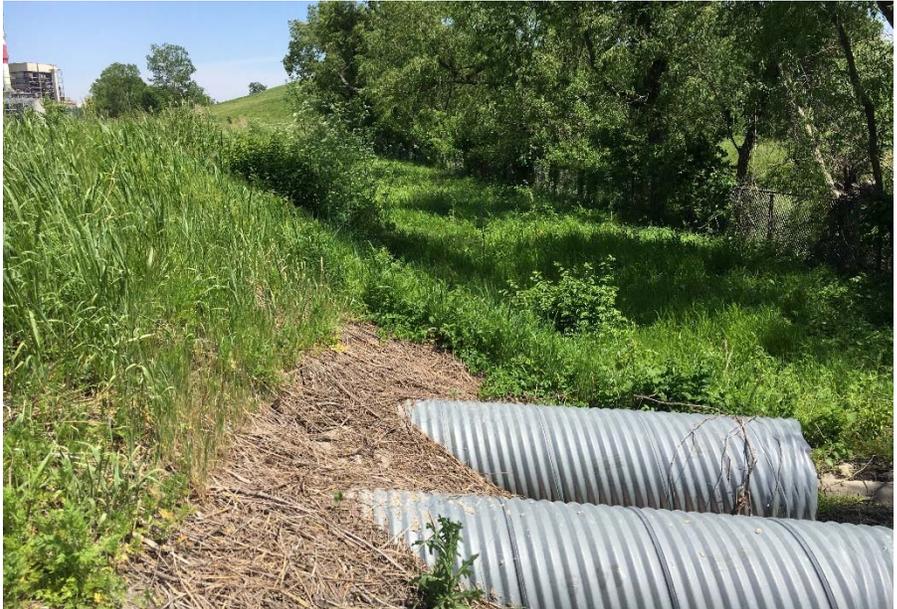
<p><b>Photograph No. 32</b></p> <p><b>Date:</b> May 15, 2017</p> <p><b>Direction:</b> East</p>

<p><b>Description:</b> Outfall 007A on south side of Storm Water Settling Pond. Moderate to significant vegetation present near outfall. Outfall is well maintained.</p>

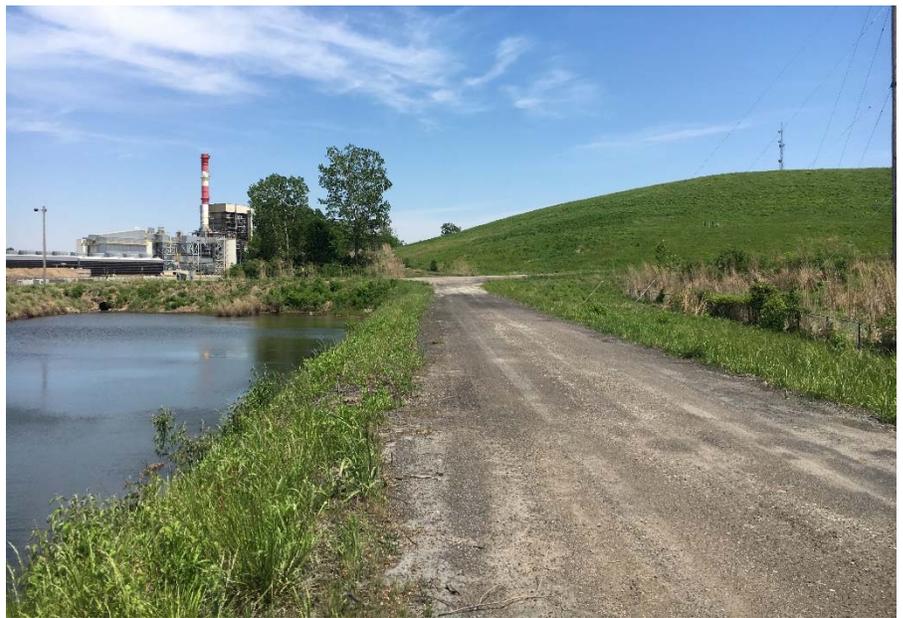
**Photograph No. 33**

**Description:**  
Perimeter dike on south side of Storm Water Settling Pond is in stable condition. Mild to moderate vegetation present on side slope of Pond.

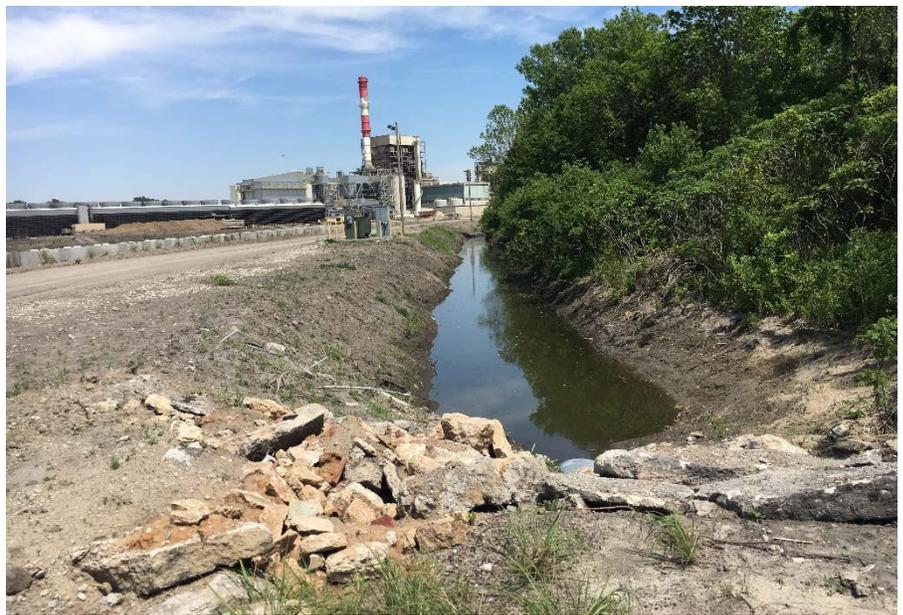
**Photograph No. 34**

**Description:**  
Recently regraded stormwater ditch. Good condition.
