Structural Stability Assessment Lawrence Energy Center

Inactive Units - Ash Pond Area 2, Ash Pond Area 3,
and Ash Pond 4

Westar Energy

April 2018

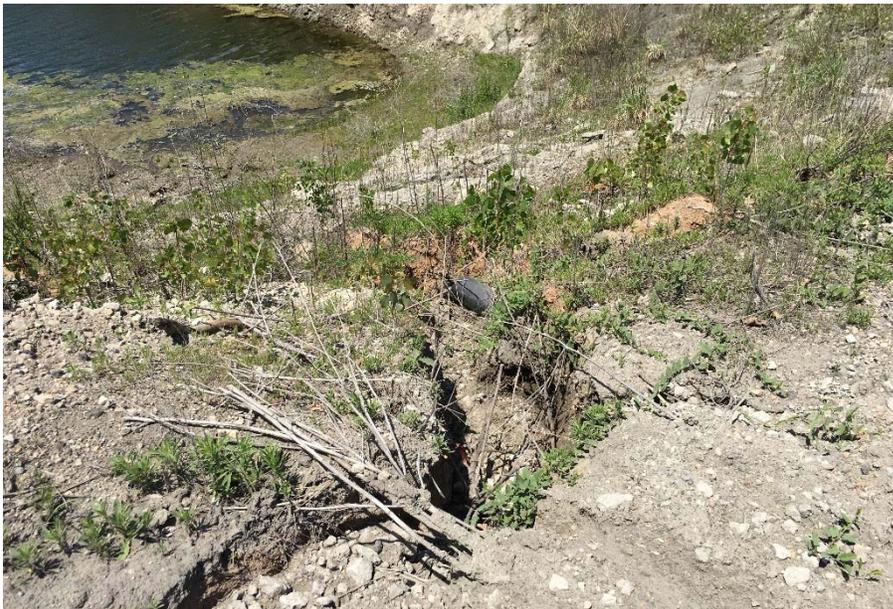
<p>Photograph No. 2</p> <p>Date: May 15, 2017</p> <p>Direction: Northwest</p>

<p>Description: Observing Pond 501. Erosion is present within pond, but does not impact stability of impoundment.</p>

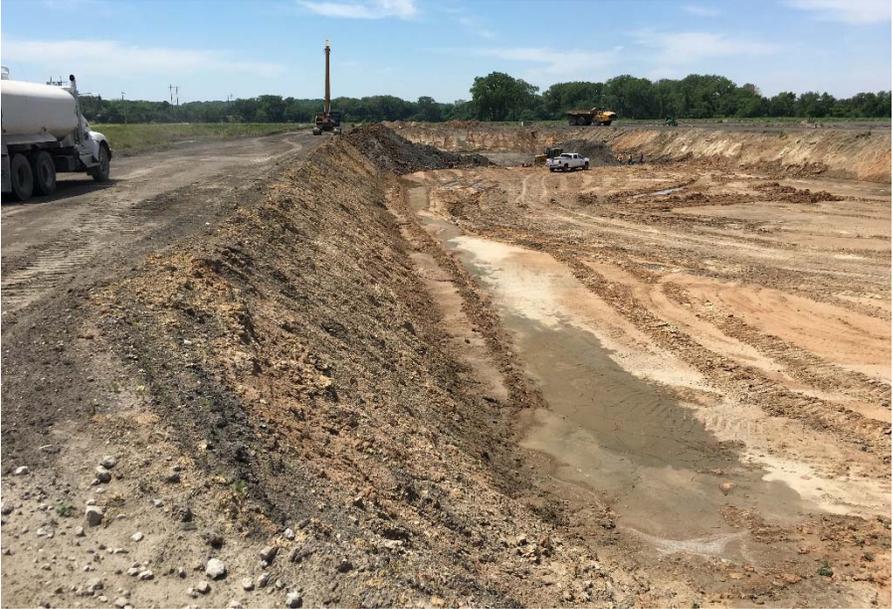
<p>Photograph No. 5</p> <p>Date: May 15, 2017</p> <p>Direction: West</p>

<p>Description: Clean closure activities ongoing in Pond 502. Side slopes appear stable. Site road is in good condition.</p>

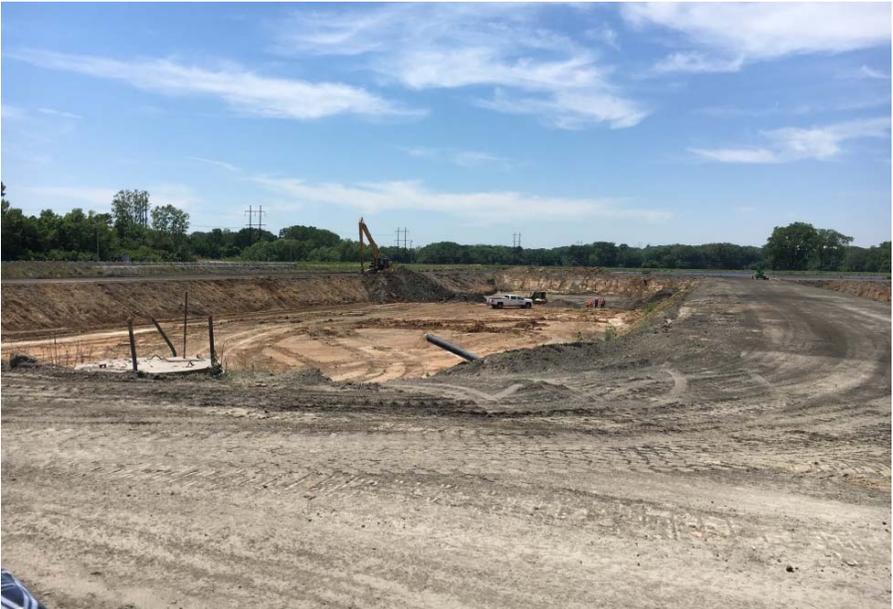
<p>Photograph No. 6</p> <p>Date: May 15, 2017</p> <p>Direction: Southwest</p>

<p>Description: Clean closure activities ongoing in Pond 502. Site roads surrounding Pond 502 are in stable condition.</p>

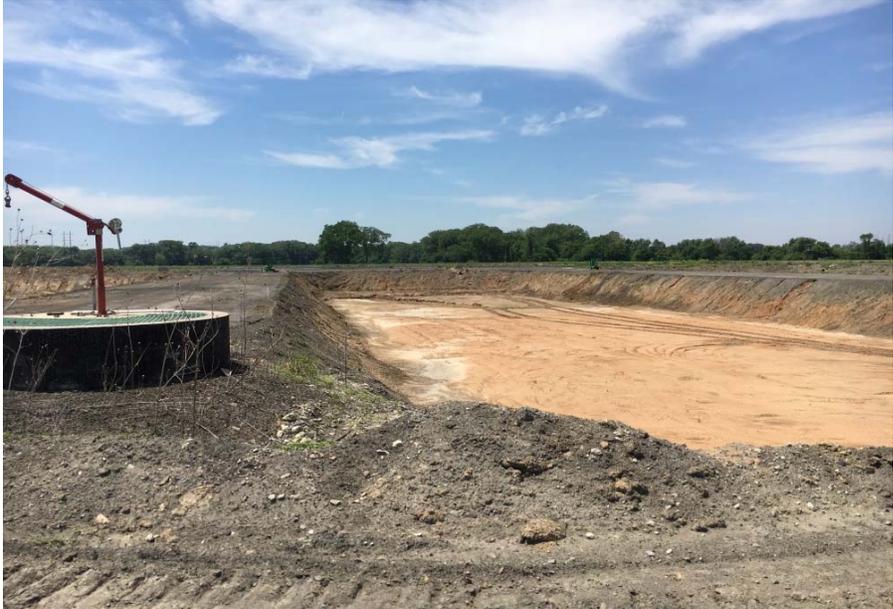
<p>Photograph No. 7</p> <p>Date: May 15, 2017</p> <p>Direction: Northwest</p>

<p>Description: Pond 503 has been dewatered and will be undergoing clean closure in the future. Knife-gate inlet structure shown.</p>

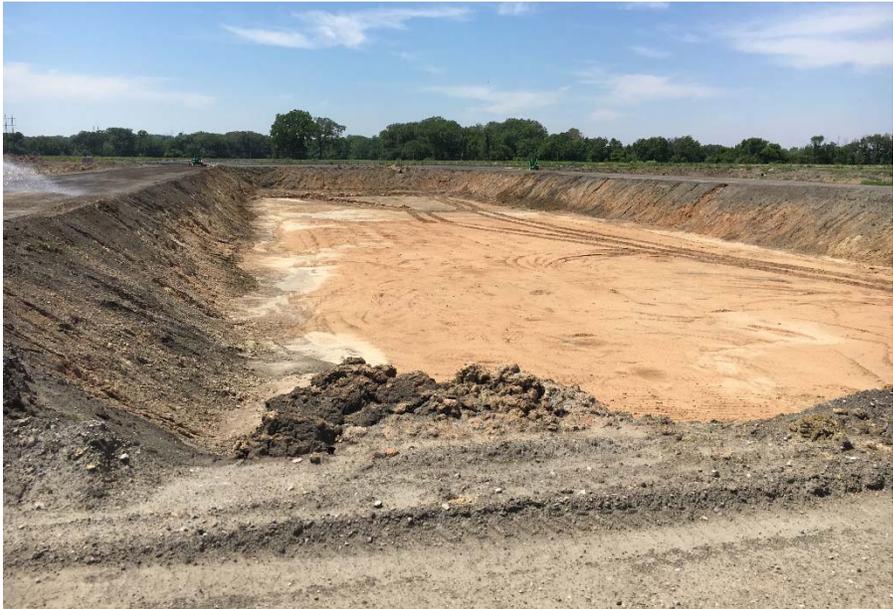
<p>Photograph No. 8</p> <p>Date: May 15, 2017</p> <p>Direction: Northwest</p>

<p>Description: Dewatered Pond 503. Will begin process of closure in near future.</p>

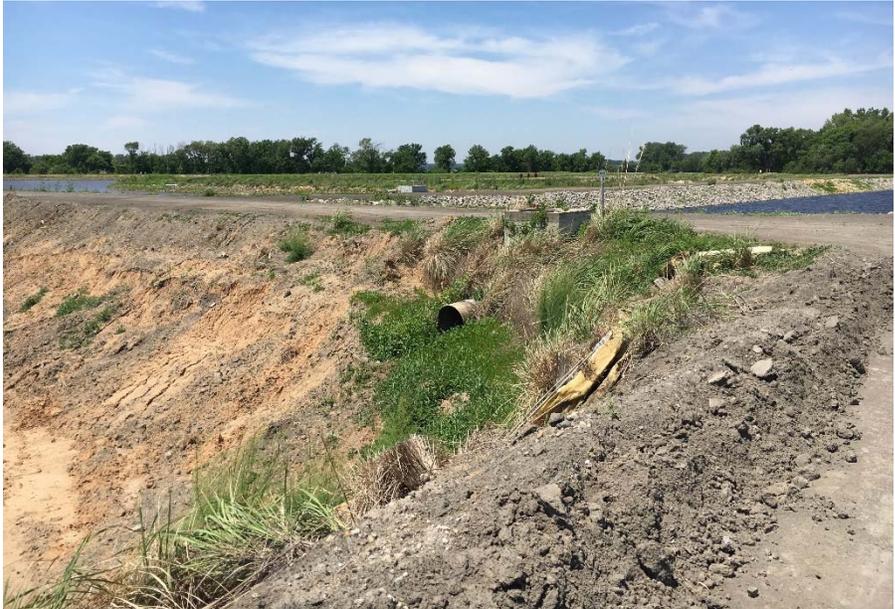
<p>Photograph No. 9</p> <p>Date: May 15, 2017</p> <p>Direction: Northwest</p>

<p>Description: Culvert connection Pond 503 and Pond 401 that is no longer in use due to closure of Pond 503. Site roads are in stable condition.</p>

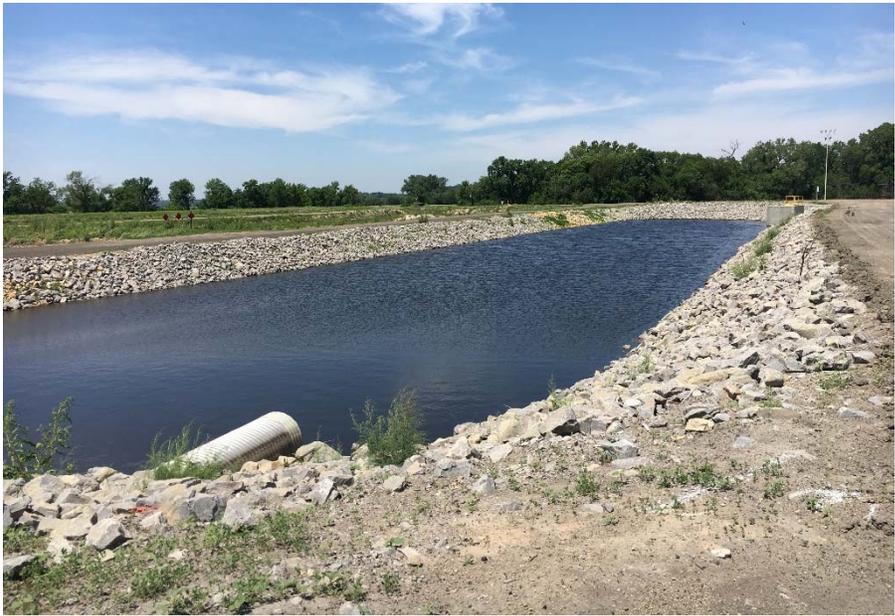
<p>Photograph No. 10</p> <p>Date: May 15, 2017</p> <p>Direction: Northwest</p>

<p>Description: Observing Pond 401. Side slopes are stabilized with rip-rap. Piping connecting Pond 401 to Pond 503 is shown. Pond 401 underwent clean closure and construction for receipt of process water.</p>

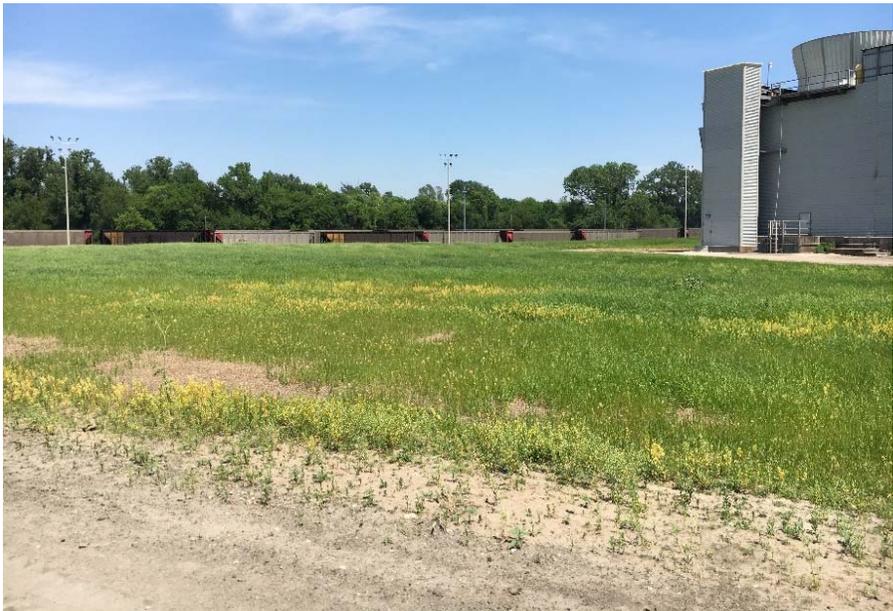
<p>Photograph No. 11</p> <p>Date: May 15, 2017</p> <p>Direction: Northeast</p>

<p>Description: Closed Scrubber Supply Pond (Area 4 Pond). Appropriate vegetative growth present.</p>

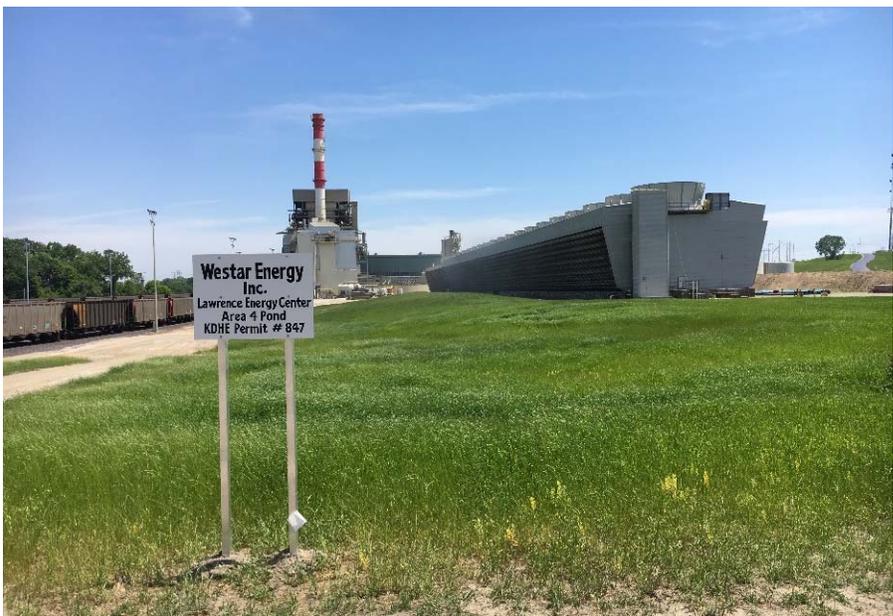
<p>Photograph No. 12</p> <p>Date: May 15, 2017</p> <p>Direction: Southeast</p>

<p>Description: Former Scrubber Supply Pond (Area 4 Pond) that was cleaned, filled with soil fill, and vegetated.</p>

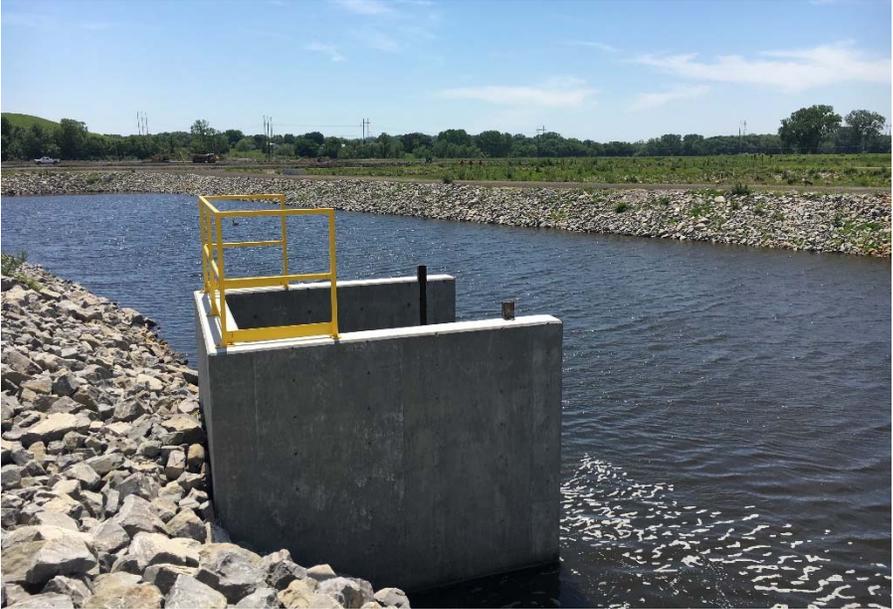
<p>Photograph No. 13</p> <p>Date: May 15, 2017</p> <p>Direction: Southwest</p>

<p>Description: Pond 401 outlet structure. Rip-rap stabilized side slopes present. Pond 401 underwent clean closure and construction for receipt of process water.</p>

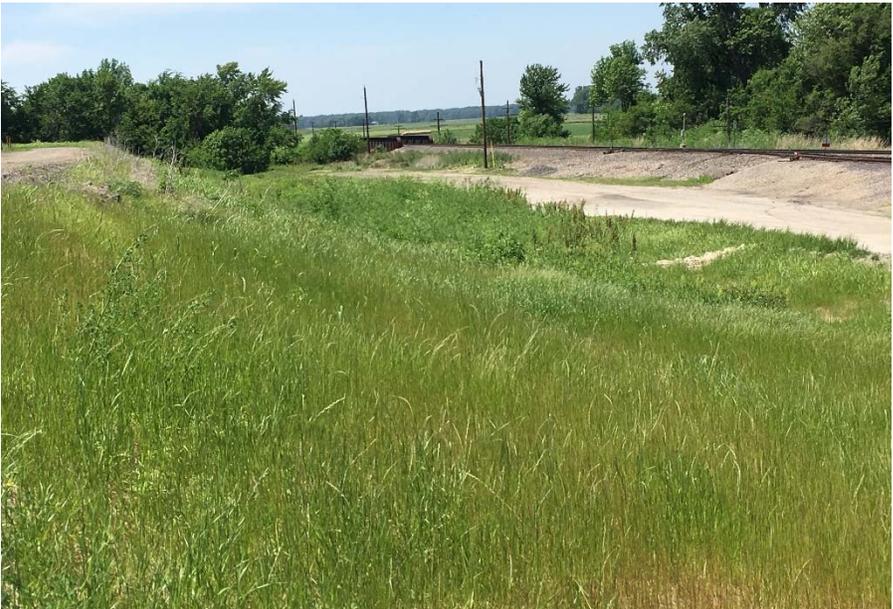
<p>Photograph No. 14</p> <p>Date: May 15, 2017</p> <p>Direction: Northwest</p>

<p>Description: Impoundment outer northern side slope (north of Pond 401). Very good condition - significant vegetative growth present. No erosion present.</p>

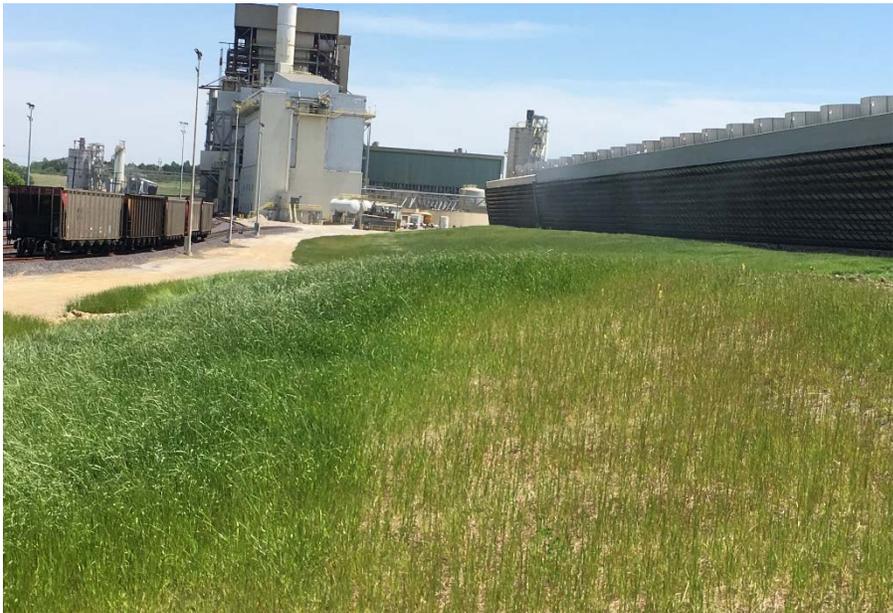
<p>Photograph No. 15</p> <p>Date: May 15, 2017</p> <p>Direction: Southeast</p>

<p>Description: Impoundment outer northern side slope (north of Pond 401). Very good condition - significant vegetative growth present. No erosion present.</p>

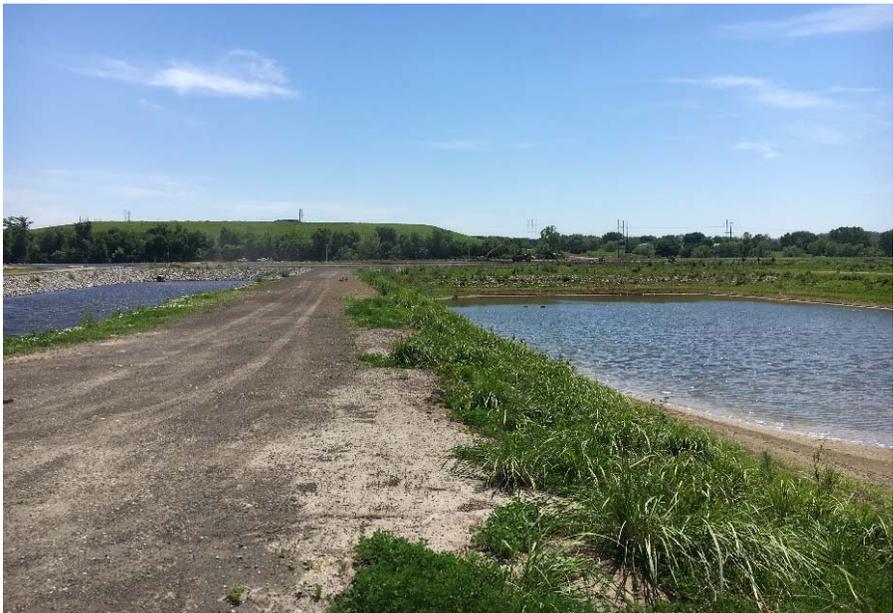
<p>Photograph No. 16</p> <p>Date: May 15, 2017</p> <p>Direction: South</p>

<p>Description: Berm separating Pond 401 (left) and 402 (right). Mild vegetation present on side slopes of both Ponds. Site road is in stable condition.</p>

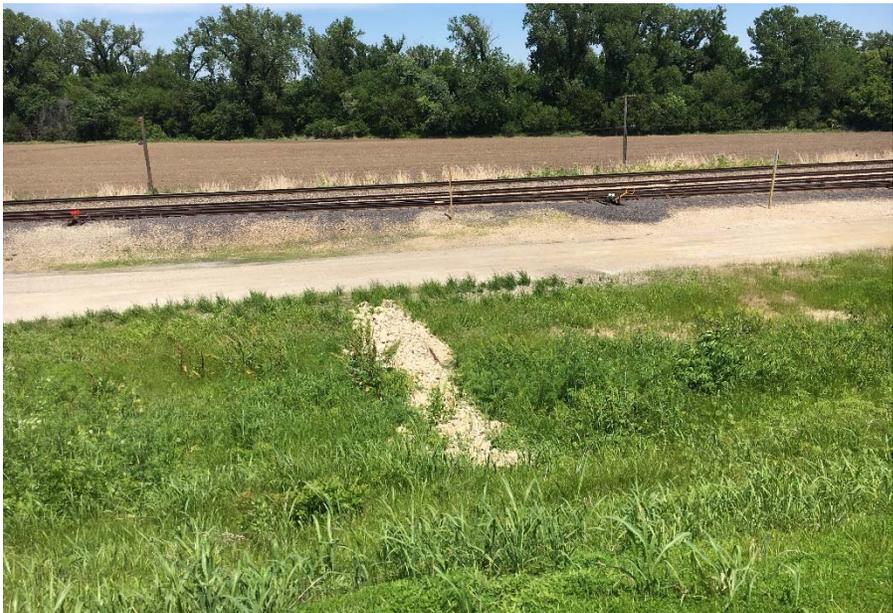
<p>Photograph No. 17</p> <p>Date: May 15, 2017</p> <p>Direction: Northeast</p>

<p>Description: Stormwater ditch at bottom of impoundment on northern slope a rock check dam as shown. Appropriate vegetative growth and no erosion present. Good condition.</p>

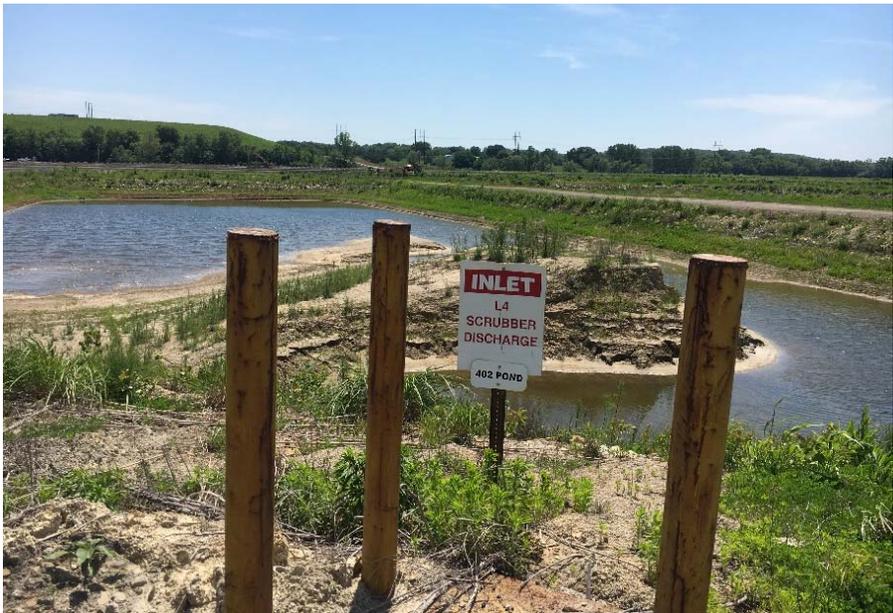
<p>Photograph No. 18</p> <p>Date: May 15, 2017</p> <p>Direction: Southwest</p>

<p>Description: Pond 402 inlet. Mild to moderate vegetation present on side slopes. Moderate erosion within pond, but does not impact stability of impoundment.</p>

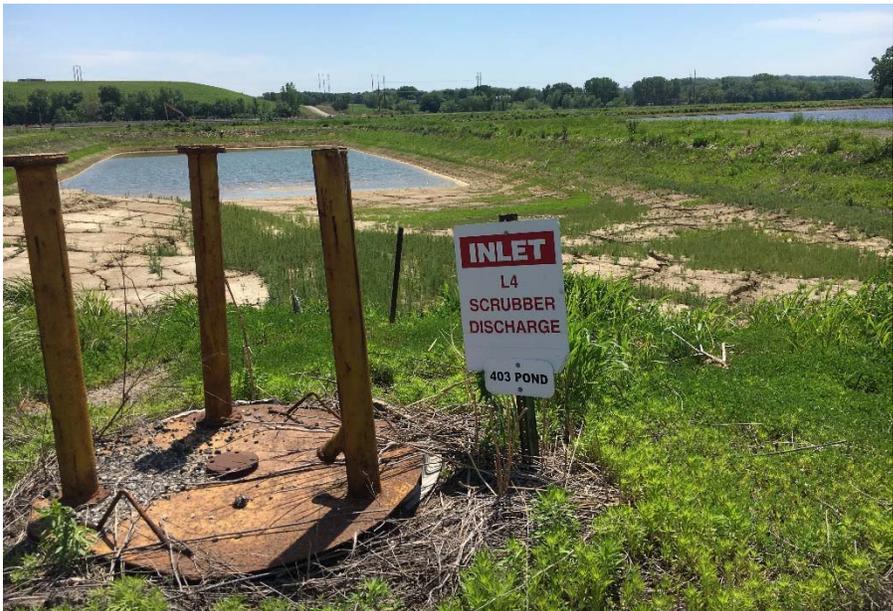
<p>Photograph No. 20</p> <p>Date: May 15, 2017</p> <p>Direction: South</p>

<p>Description: Pond 403 inlet. Moderate erosion and mud cracking within pond, but does not impact stability of impoundment.</p>

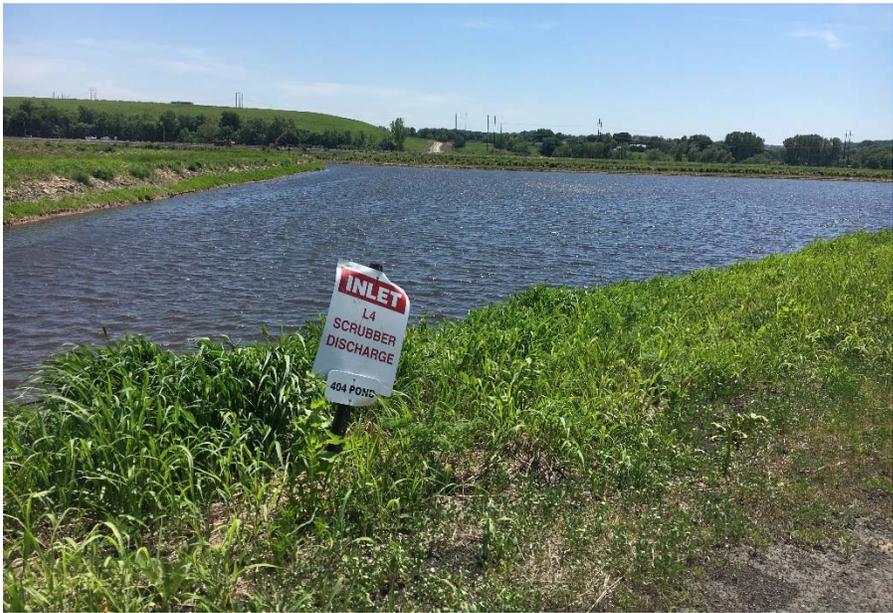
<p>Photograph No. 21</p> <p>Date: May 15, 2017</p> <p>Direction: Southeast</p>

<p>Description: Pond 404 inlet. Healthy vegetation present on the side slopes.</p>

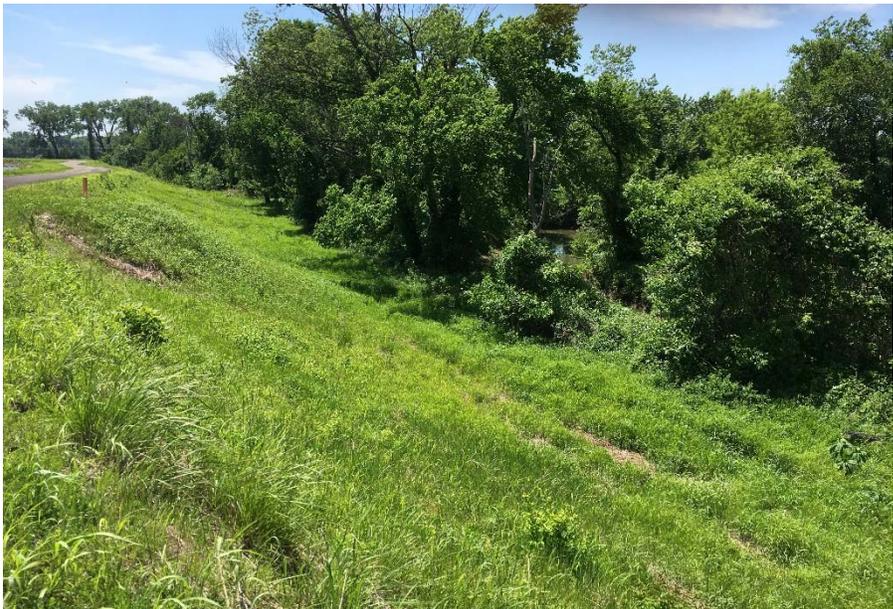
<p>Photograph No. 22</p> <p>Date: May 15, 2017</p> <p>Direction: Southwest</p>

<p>Description: Outer slope of impoundment (near Pond 404). Well vegetated, no erosion. Good condition.</p>

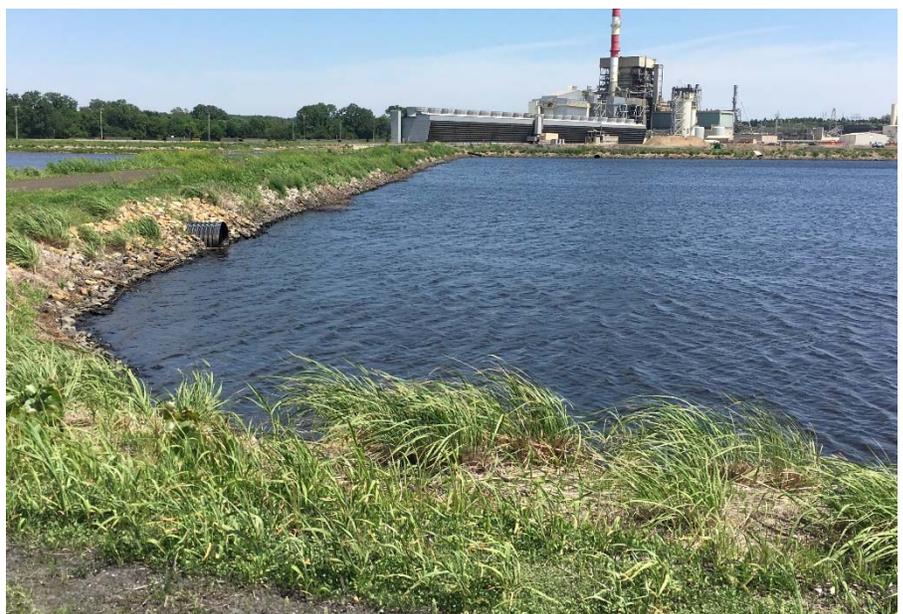
Photograph No. 24

Description:
West Pond outlet to Pond 404. Rip-rap and mild vegetation present on side slopes. No observed erosion.

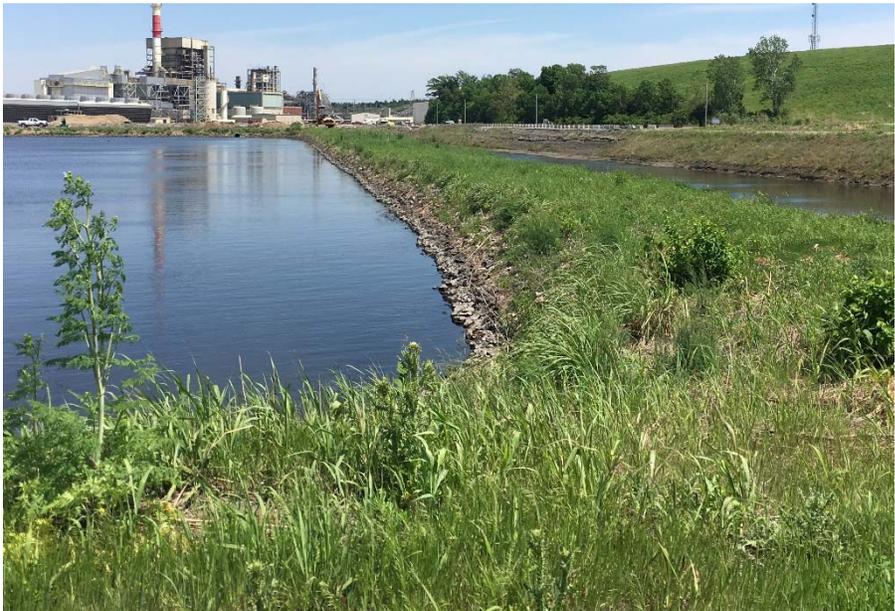
<p>Photograph No. 27</p> <p>Date: May 15, 2017</p> <p>Direction: East</p>

<p>Description: Berm separating the West Pond and Laydown Area. West Pond slope is stabilized with rip-rap. Vegetation present.</p>

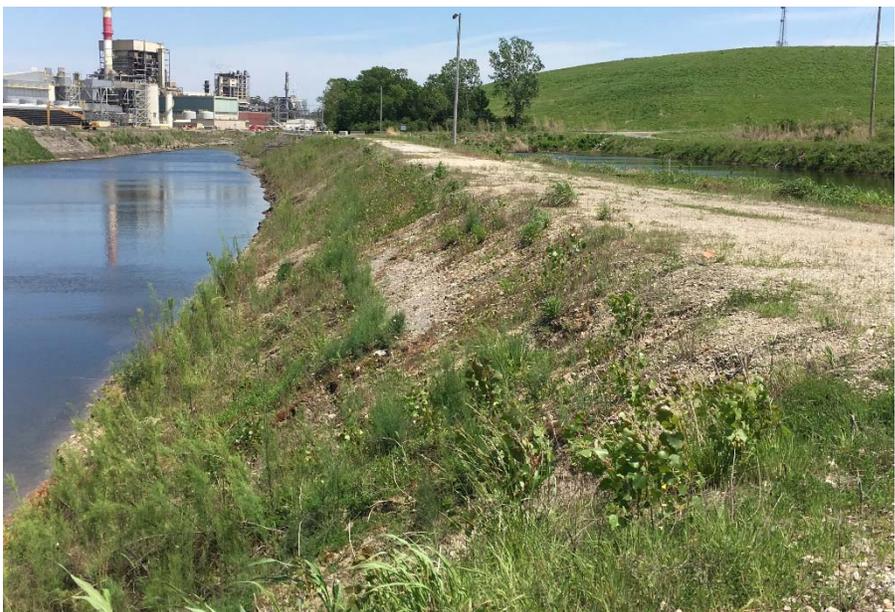
<p>Photograph No. 28</p> <p>Date: May 15, 2017</p> <p>Direction: East</p>

<p>Description: Berm separating the Laydown Area and the Storm Water Settling Pond. Mild erosion present on side slope of Laydown Area, which does not impact stability of impoundment.</p>

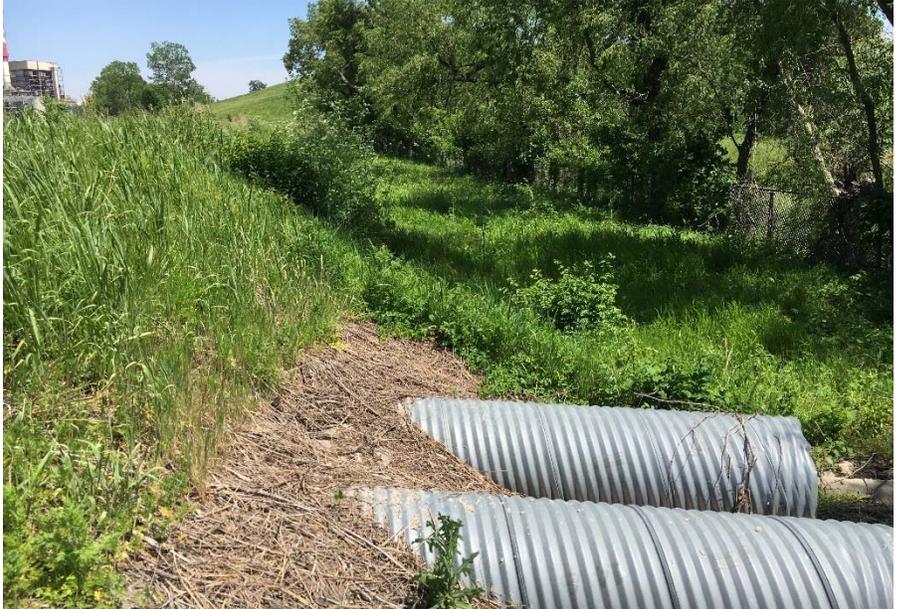
<p>Photograph No. 32</p> <p>Date: May 15, 2017</p> <p>Direction: East</p>

<p>Description: Outfall 007A on south side of Storm Water Settling Pond. Moderate to significant vegetation present near outfall. Outfall is well maintained.</p>
