Annual Inspection Report  
Lawrence Energy Center  
Inactive Units - Ash Pond Area 2, Ash Pond Area 3,  
and Ash Pond 4

Prepared for:  
Westar Energy  
Lawrence Energy Center  
Lawrence, Kansas

Prepared by:  
CB&I Environmental & Infrastructure, Inc.

June 2017

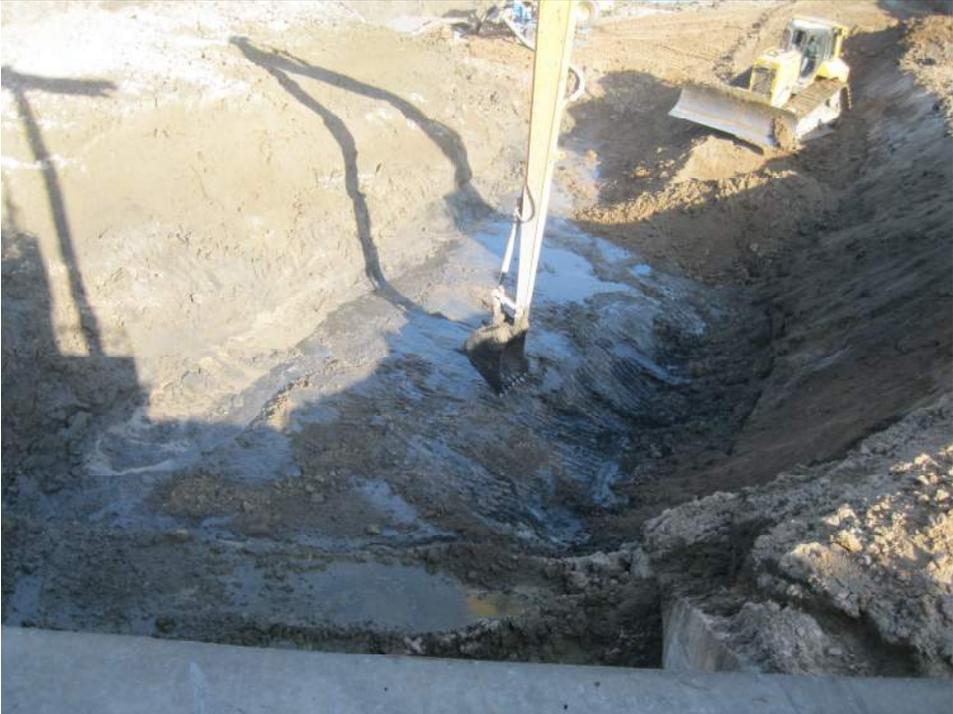
Pond 4 Clean Closure	LEC – Bottom Ash Pond 4	Photo No: 20160810 - 1
DESCRIPTION: Excavating bottom ash at northeast corner of impoundment.

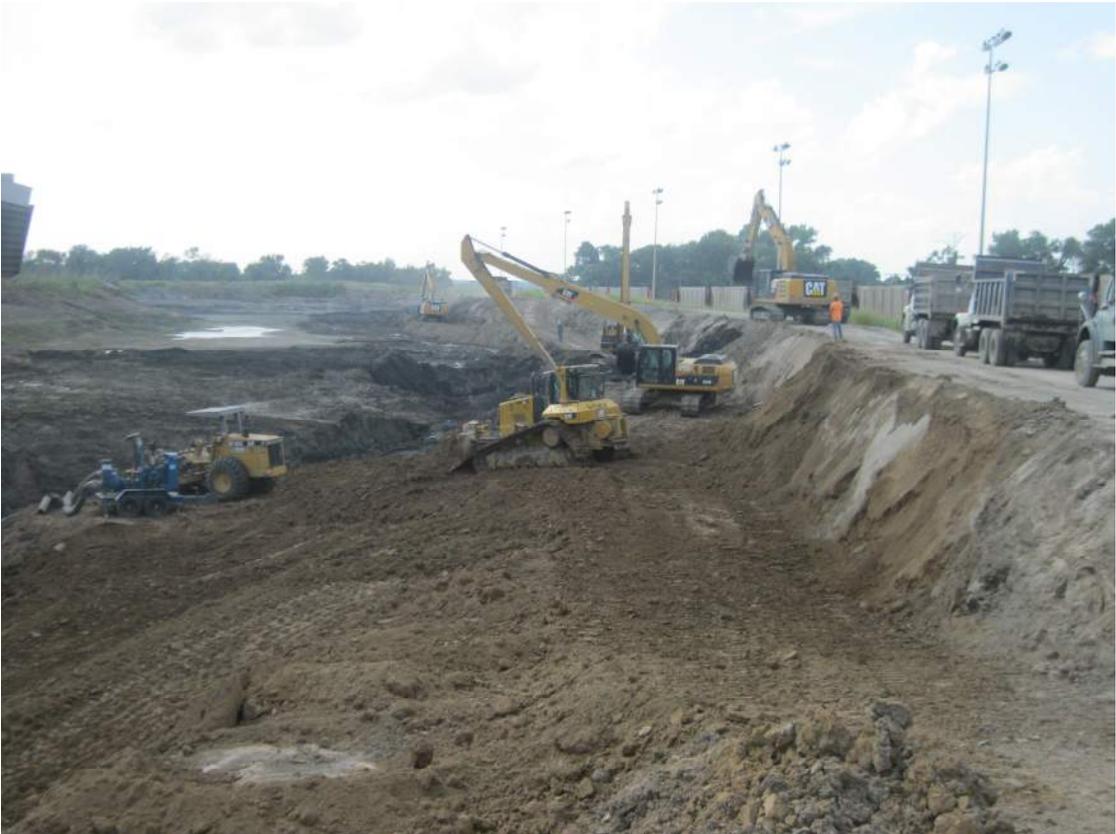
10 August 2016		
Pond 4 Clean Closure	LEC – Bottom Ash Pond 4	Photo No: 20160810 - 2
DESCRIPTION: New fill at Northeast Corner.

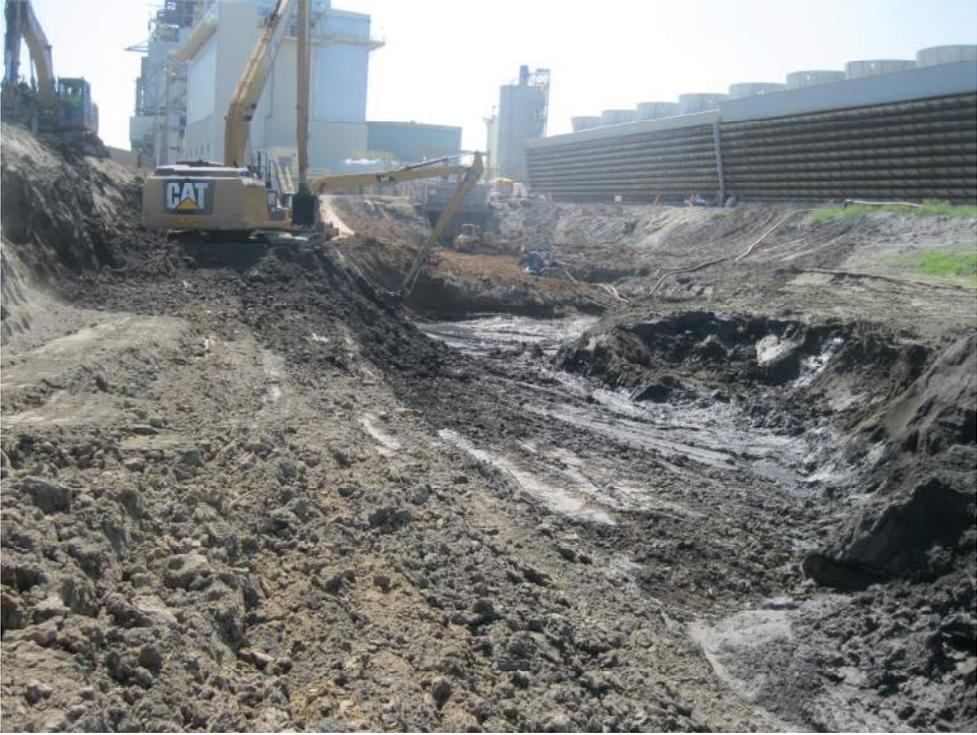
Pond 4 Clean Closure	LEC – Bottom Ash Pond 4	Photo No: 20160811 - 1
<b>DESCRIPTION:</b> Two backhoes west of pump.

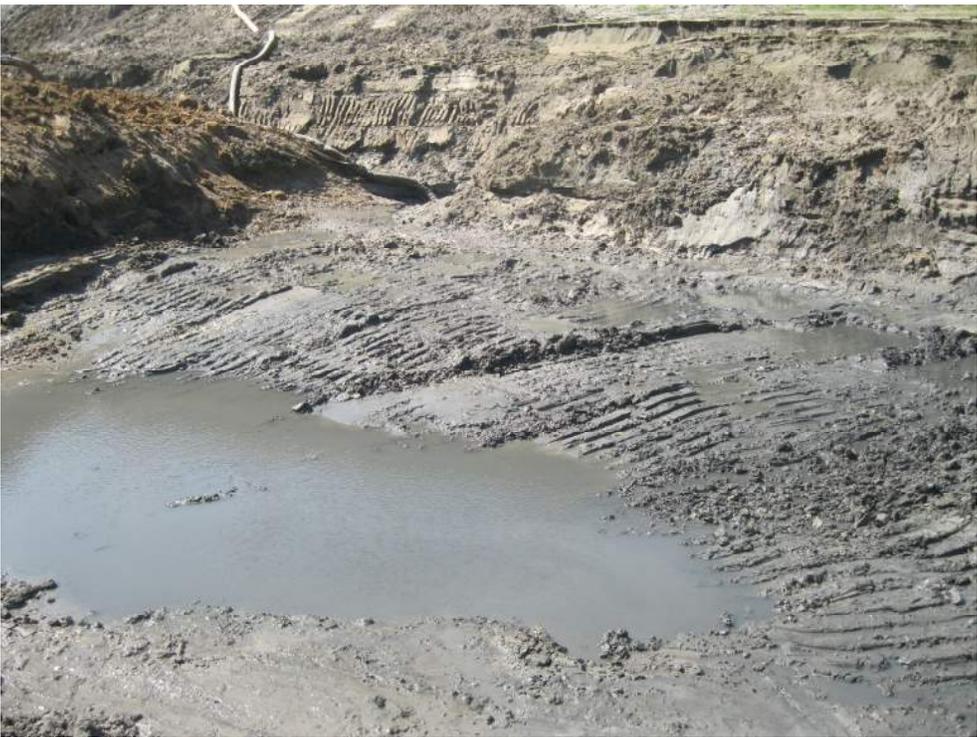
11 August 2016		
Pond 4 Clean Closure	LEC – Bottom Ash Pond 4	Photo No: 20160811 - 2
<b>DESCRIPTION:</b> Cleaned Subgrade

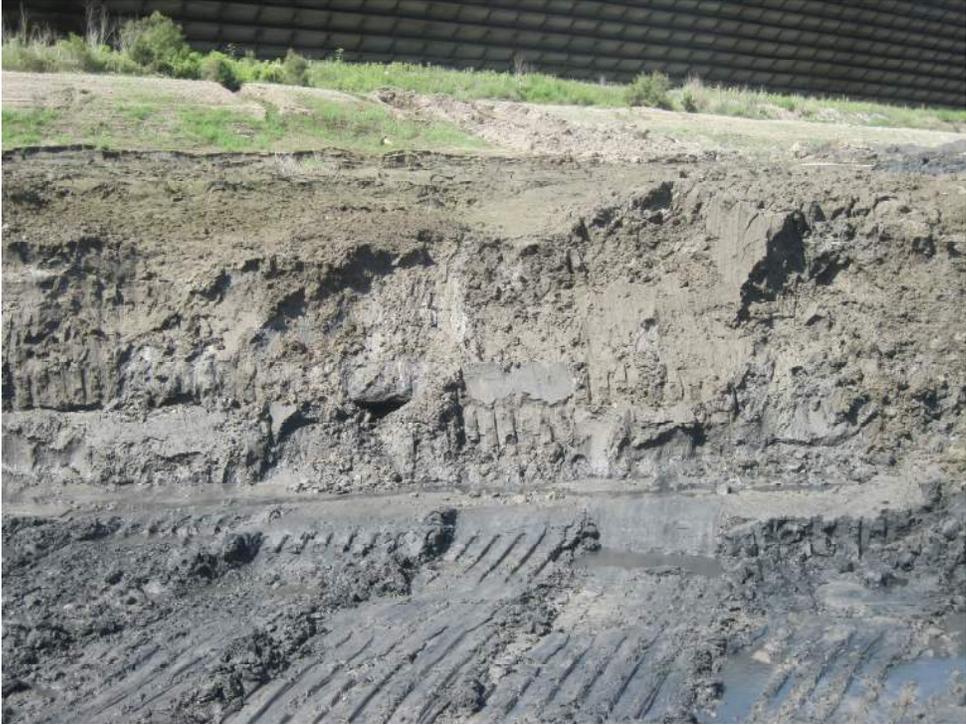
The photos show the similar colors between the bottom ash and native soils in some locations. Also the photos show the work that has been continuing in the west area of the impoundment.

Pond 4 Clean Closure	LEC – Bottom Ash Pond 4	Photo No: 20160811 - 3
<p>DESCRIPTION: Similar colors of bottom ash and subgrade</p>

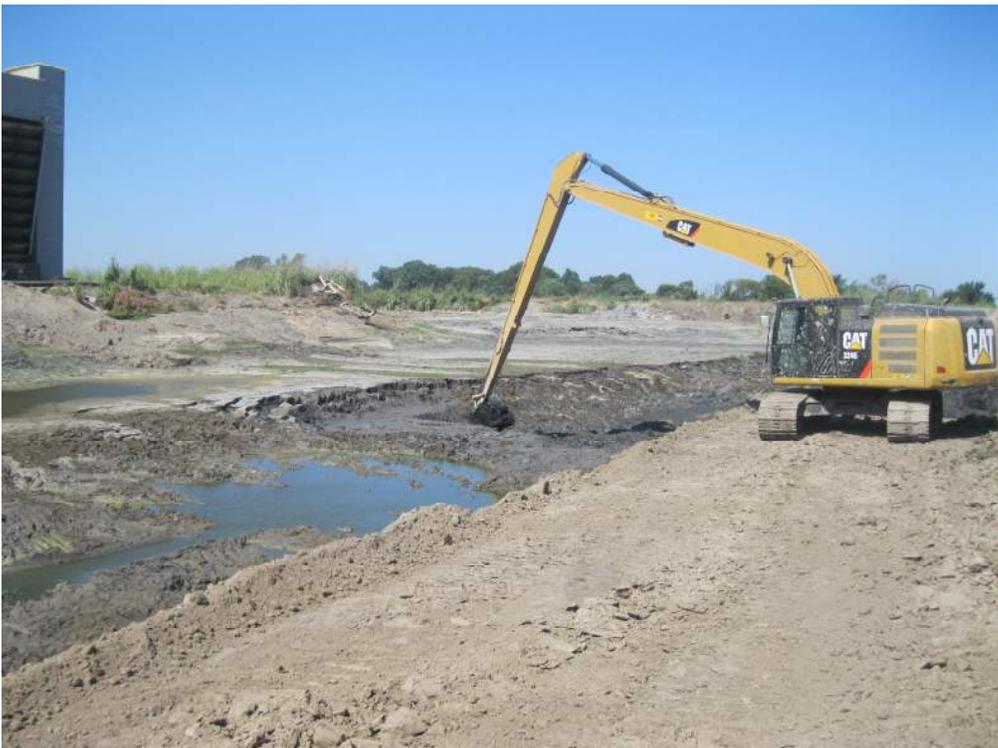
11 August 2016		
Pond 4 Clean Closure	LEC – Bottom Ash Pond 4	Photo No: 20160811 - 4
<p>DESCRIPTION: Excavating bottom ash at far west side of impoundment</p>

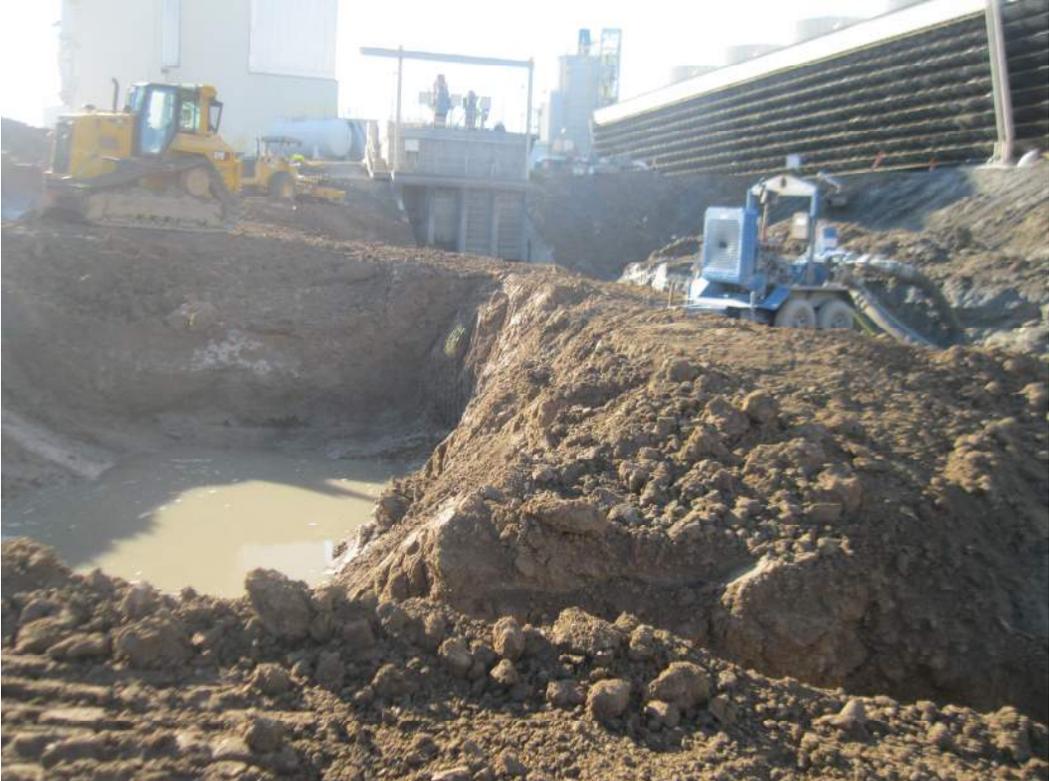
Pond 4 Clean Closure	LEC – Bottom Ash Pond 4	Photo No: 20160813 - 1
DESCRIPTION: Excavated area of the work area constructed before August 9

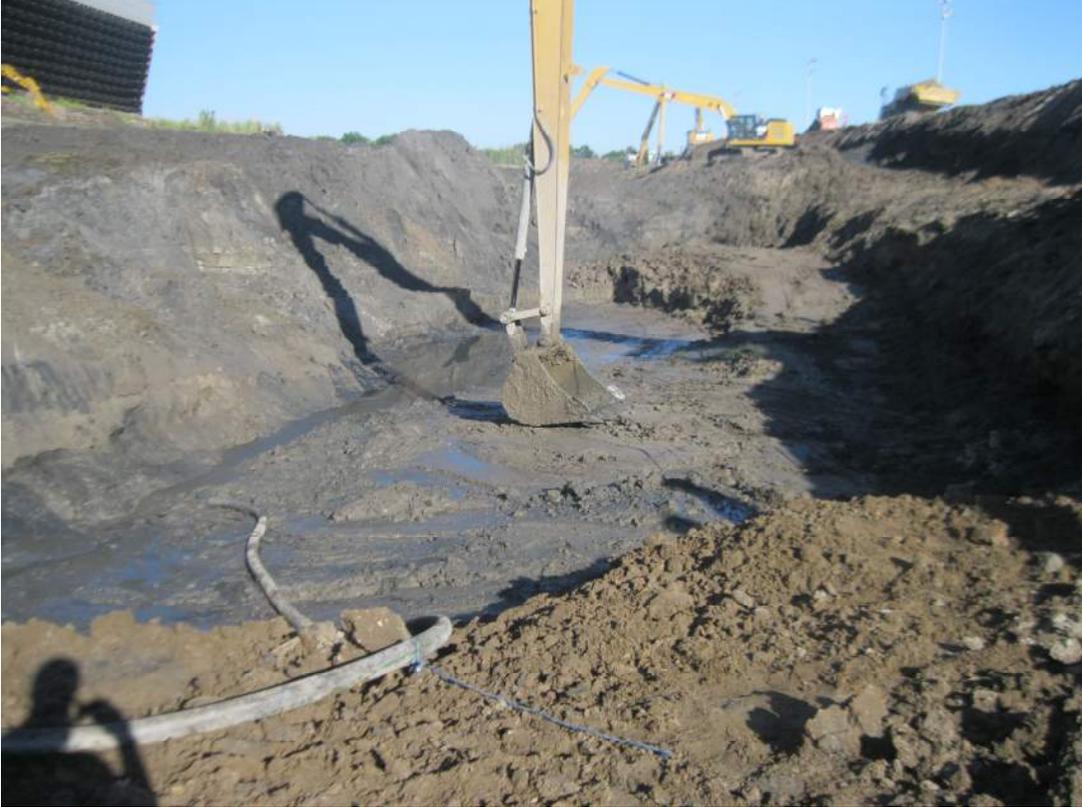
13 August 2016		
Pond 4 Clean Closure	LEC – Bottom Ash Pond 4	Photo No: 20160813 - 2
DESCRIPTION: Clean base located west of August 11 area.

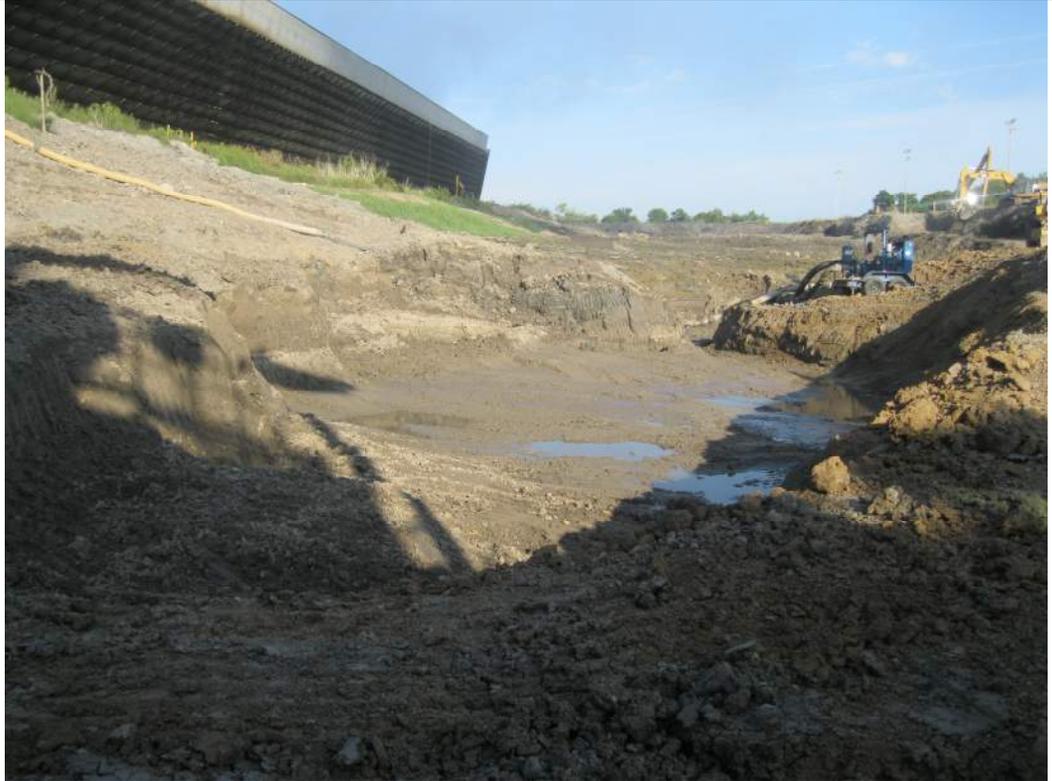
<p>Pond 4 Clean Closure</p>	<p>LEC – Bottom Ash Pond 4</p>	<p>Photo No: 20160818 - 1</p>
<p>DESCRIPTION: Excavated work Area adjacent to intake at southeast corner of pond.</p>

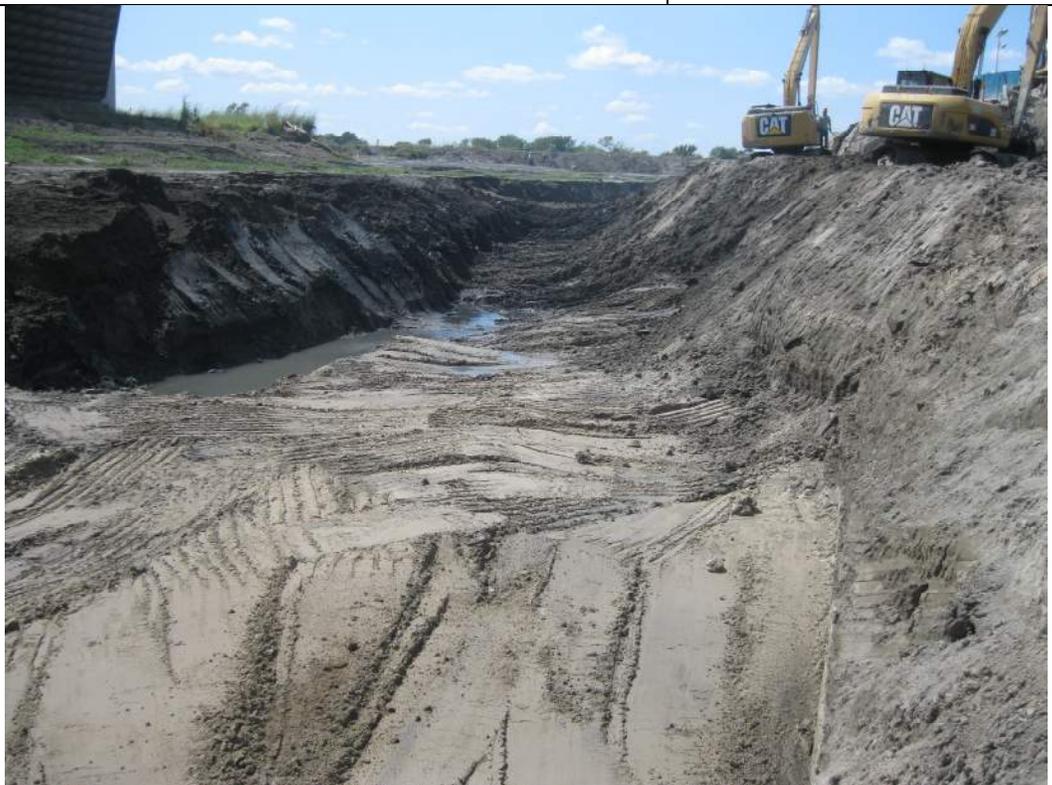
<p>18 August 2016</p>		
<p>Pond 4 Clean Closure</p>	<p>LEC – Bottom Ash Pond 4</p>	<p>Photo No: 20160818 -</p>
<p>DESCRIPTION: Clean base located west of August 11 area.</p>

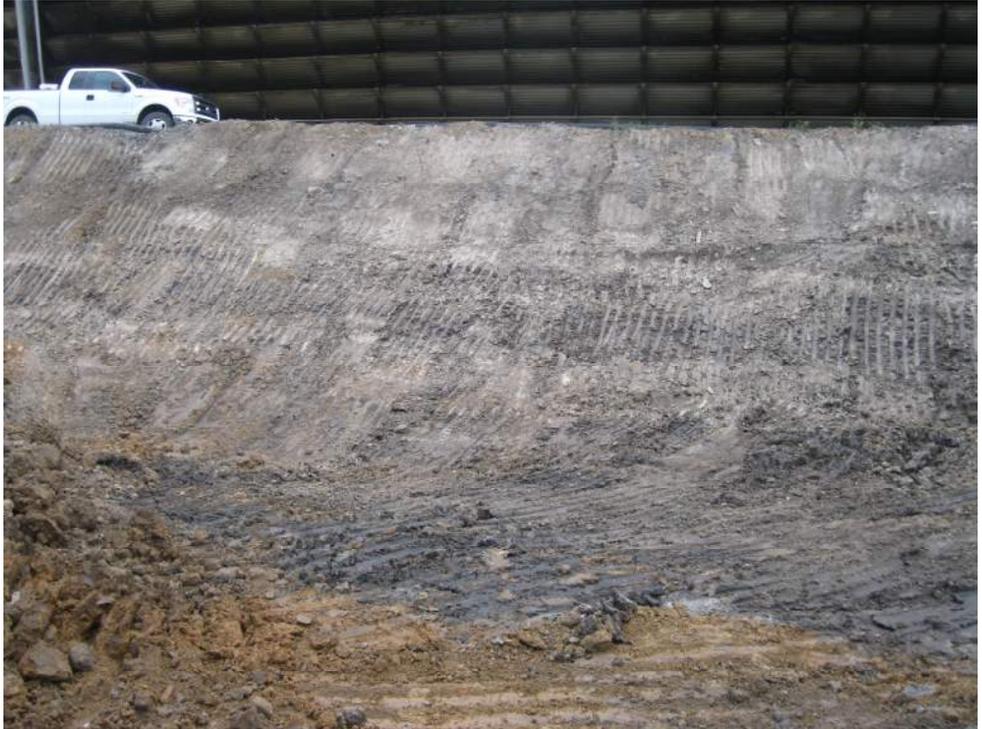
Pond 4 Clean Closure	LEC – Bottom Ash Pond 4	Photo No: 20160823 - 1
<p>DESCRIPTION: SE Corner – Bottom ash removed to clay. Slope is clean.</p>

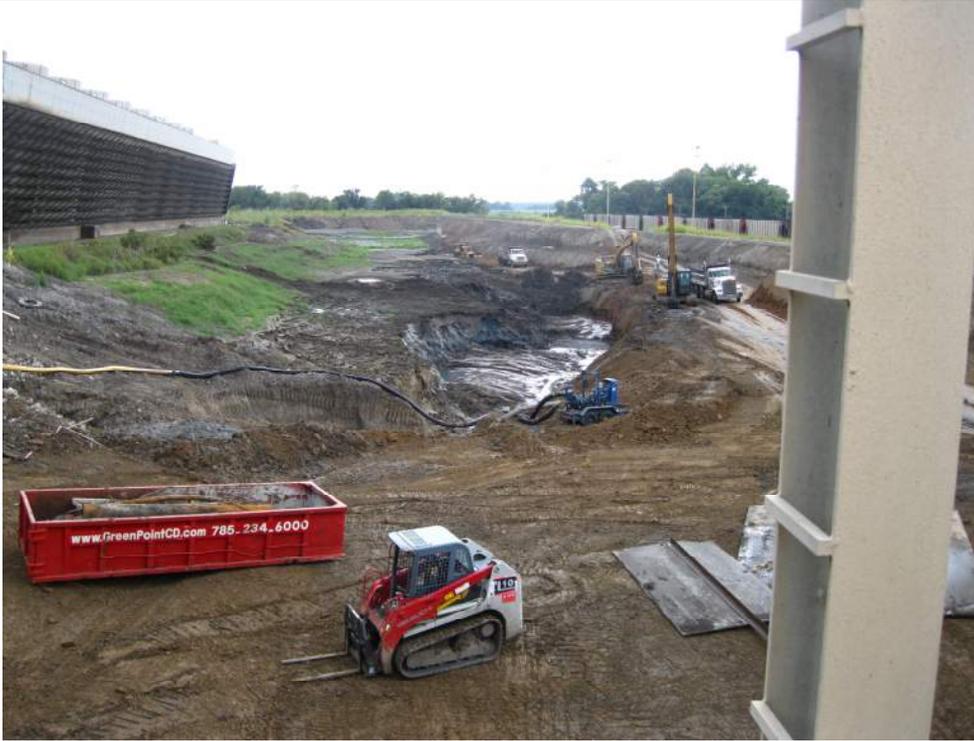
24 August 2016		
Pond 4 Clean Closure	LEC – Bottom Ash Pond 4	Photo No: 20160824 - 2
DESCRIPTION: Clean fill in Foreground

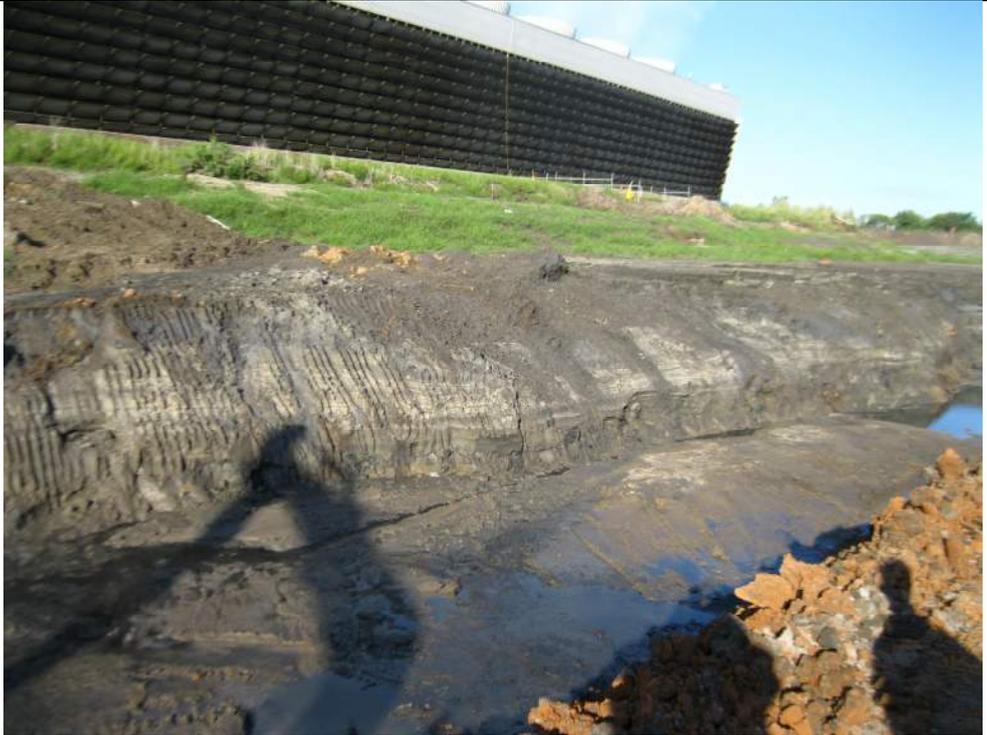
Pond 4 Clean Closure	LEC – Bottom Ash Pond 4	Photo No: 20160902 - 1
<p>DESCRIPTION: Encountered silty sand at base of bottom ash</p>

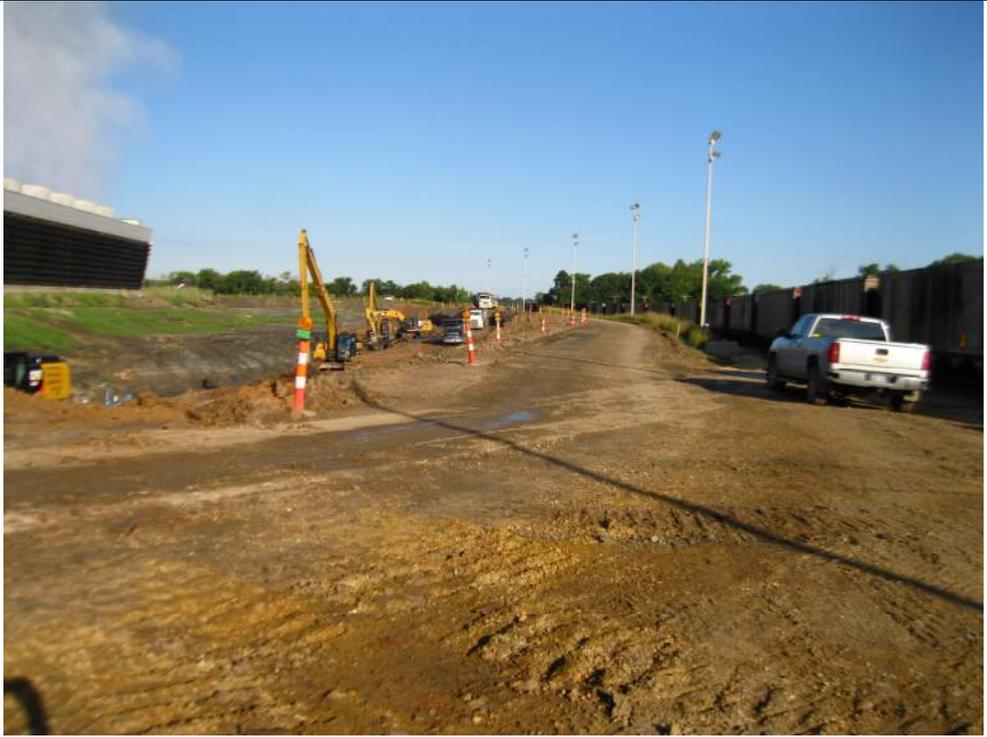
02 September 2016		
Pond 4 Clean Closure	LEC – Bottom Ash Pond 4	Photo No: 20160902 - 2
<p>DESCRIPTION: Location of planned rail spur</p>

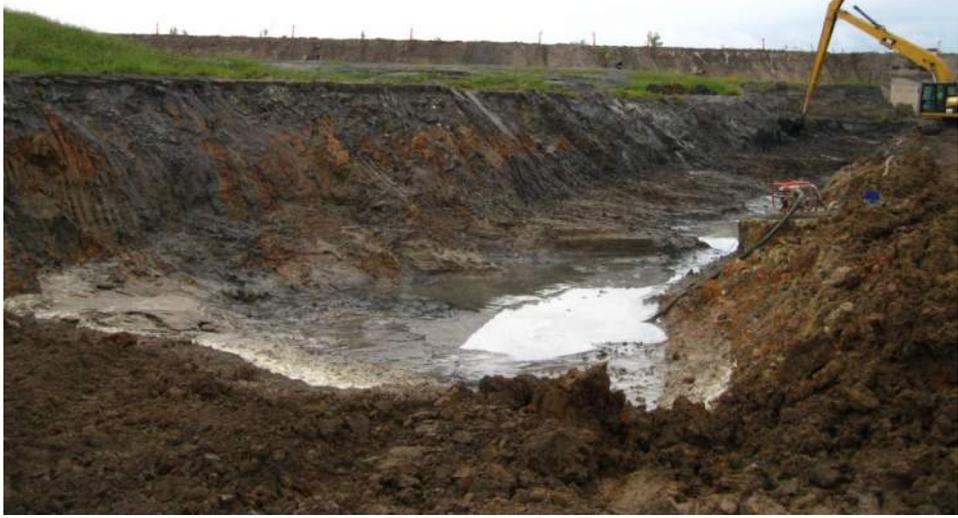
Pond 4 Clean Closure	LEC – Bottom Ash Pond 4	Photo No: 20160913 - 1
<p>DESCRIPTION: Excavated area with excess water being pumped</p>

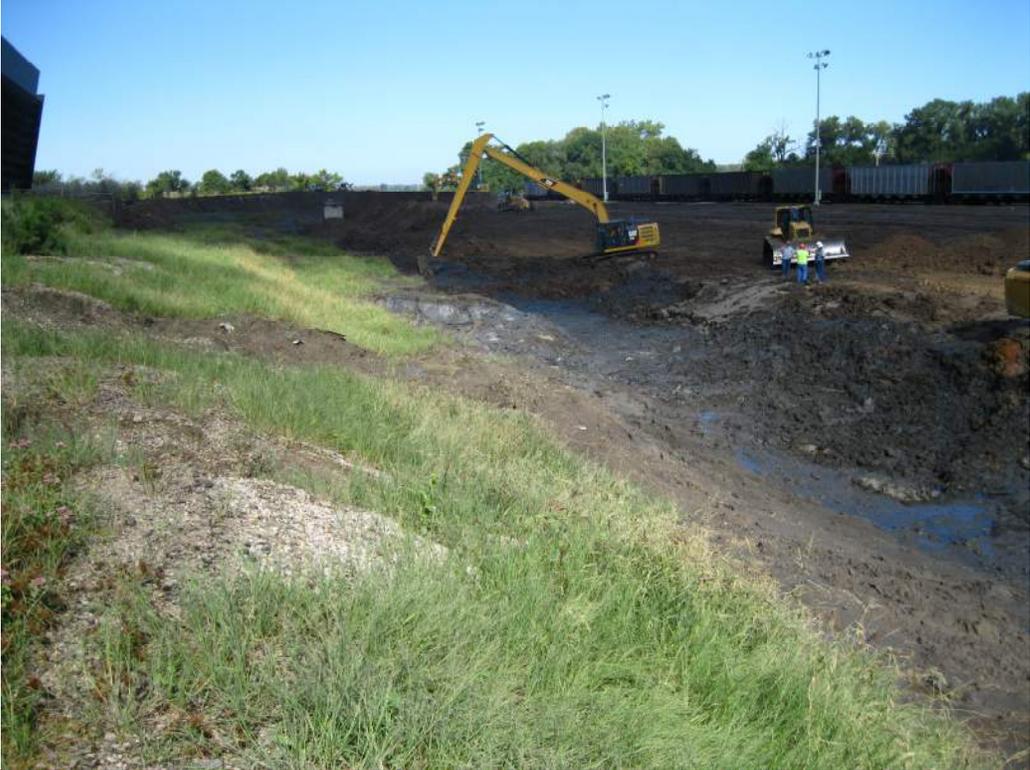
Pond 4 Clean Closure	LEC – Bottom Ash Pond 4	Photo No: 20160917 - 1
DESCRIPTION: Sloped cleared to native soil

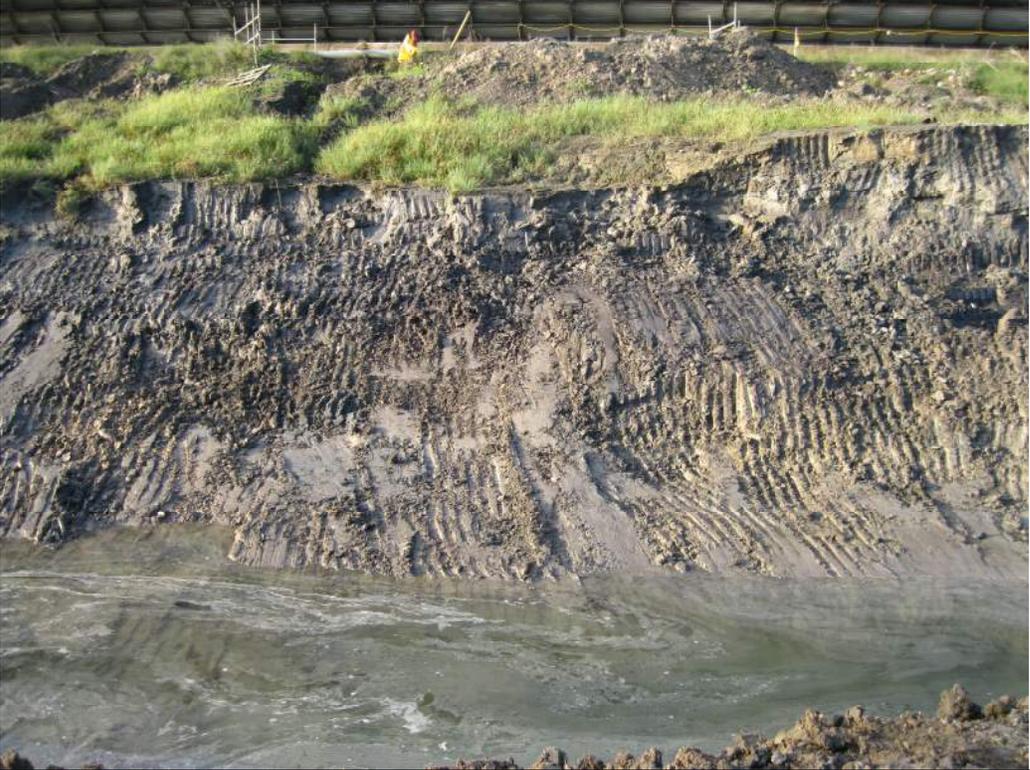
Pond 4 Clean Closure	LEC – Bottom Ash Pond 4	Photo No: 20160920 - 1
DESCRIPTION: Sloped cleared to native soil

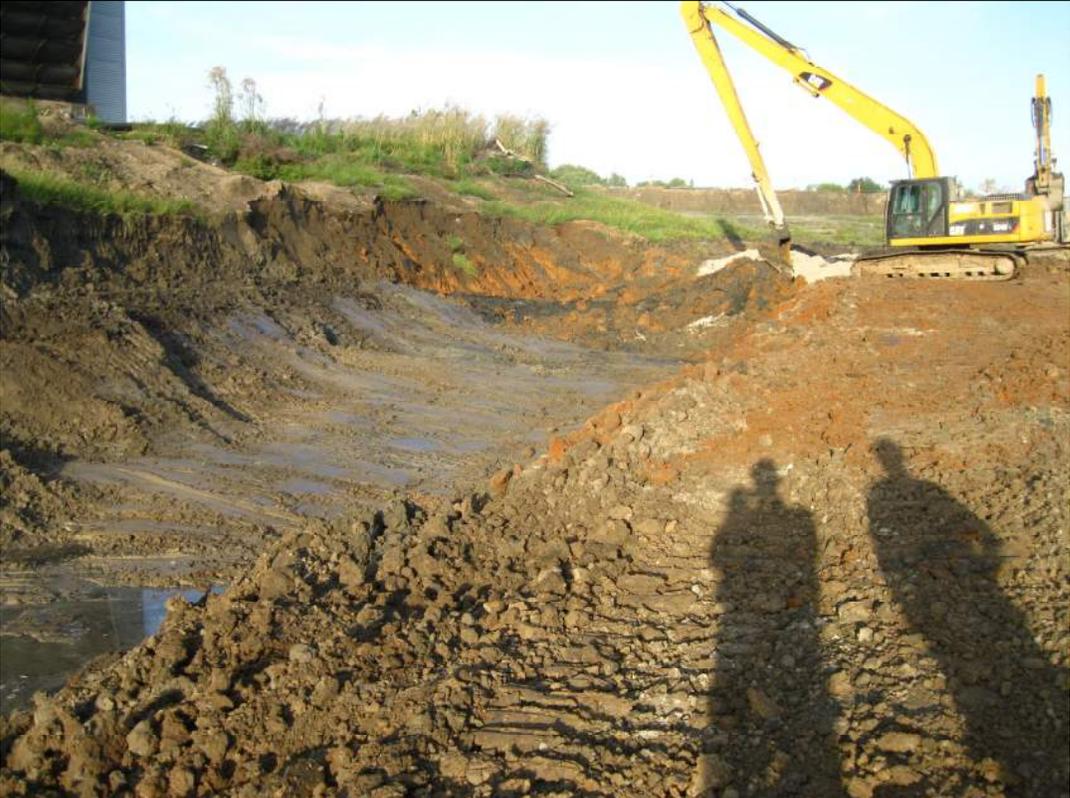
20 September 2016		
Pond 4 Clean Closure	LEC – Bottom Ash Pond 4	Photo No: 20160920 - 2
DESCRIPTION: Length of slope within reach of long-arm backhoe.

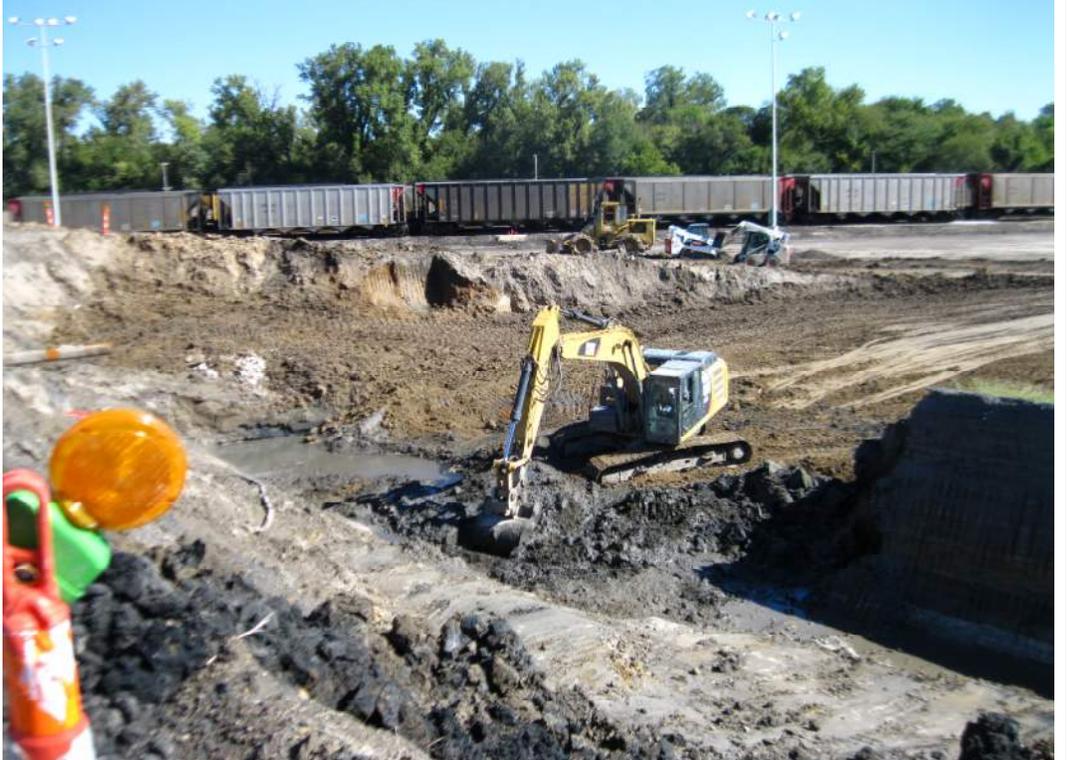
27 September 2016		
Pond 4 Clean Closure	LEC – Bottom Ash Pond 4	Photo No: 20160927 - 2
<p>DESCRIPTION: Excavating bottom ash</p>

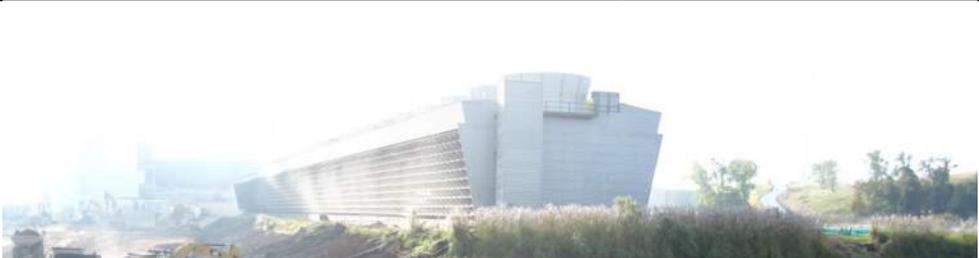
Pond 4 Clean Closure	LEC – Bottom Ash Pond 4	Photo No: 20161001 - 1
DESCRIPTION: Excavation at end of cleaned area

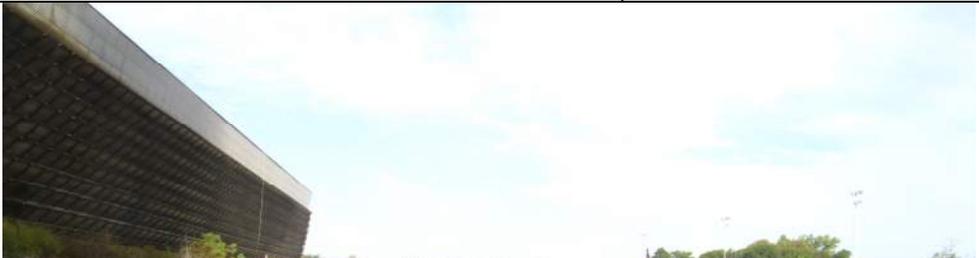
01 October 2016		
Pond 4 Clean Closure	LEC – Bottom Ash Pond 4	Photo No: 20161001 - 2
Excavated area looking west

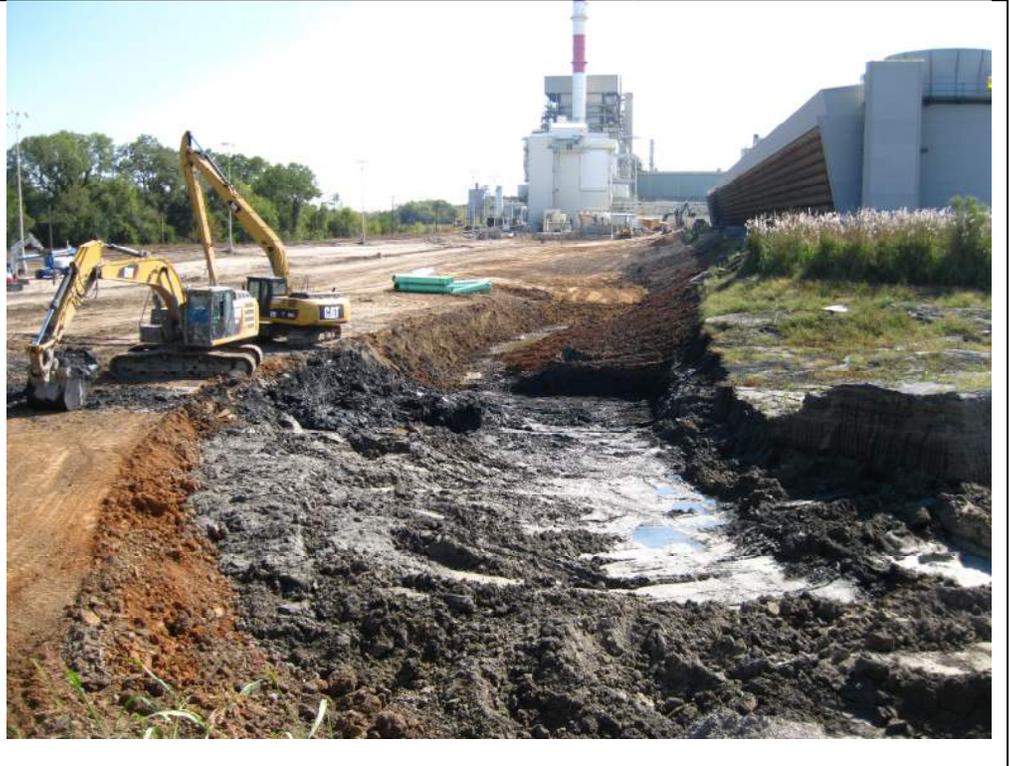
Pond 4 Clean Closure	LEC – Bottom Ash Pond 4	Photo No: 20161003 - 1
DESCRIPTION: Excavation past end of south slope.

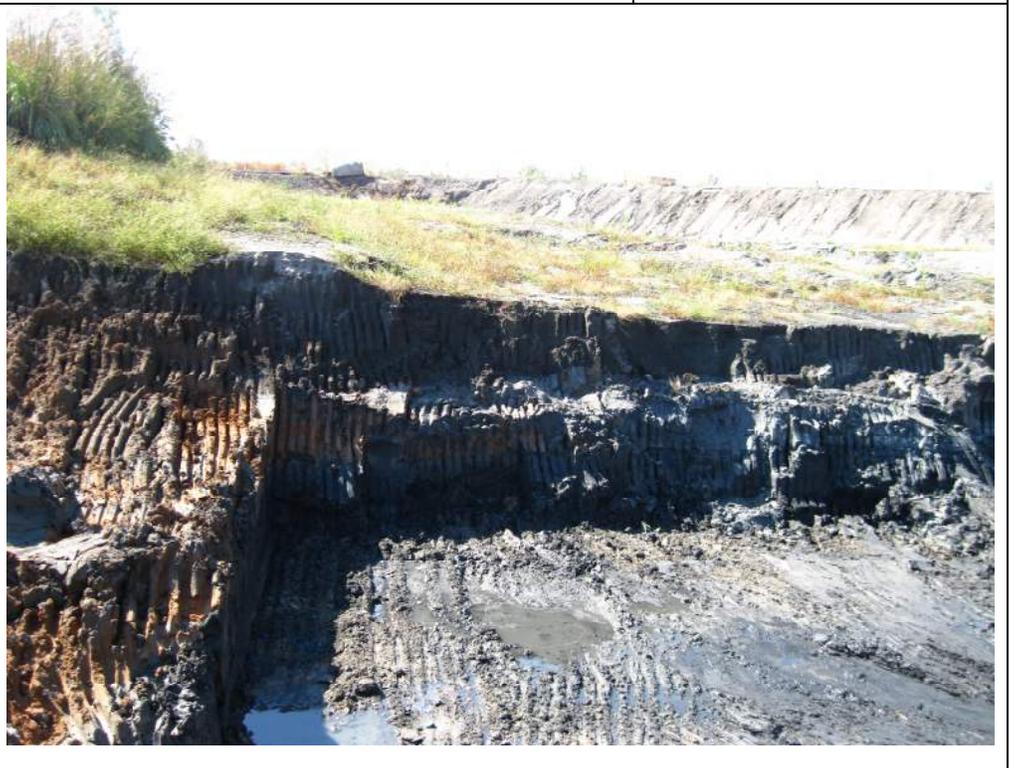
03 October 2016		
Pond 4 Clean Closure	LEC – Bottom Ash Pond 4	Photo No: 20161003 - 2
Excavation past the south slope

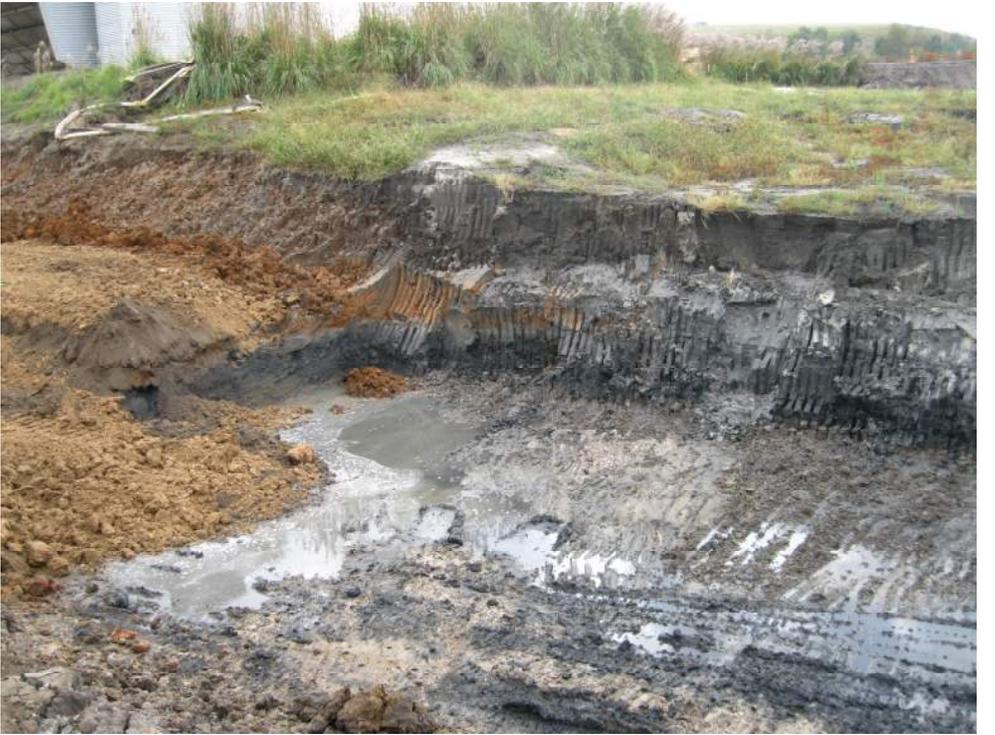
Pond 4 Clean Closure	LEC – Bottom Ash Pond 4	Photo No: 20161004 - 1
<p>DESCRIPTION: Excavation to gray sand below dark bottom ash</p>

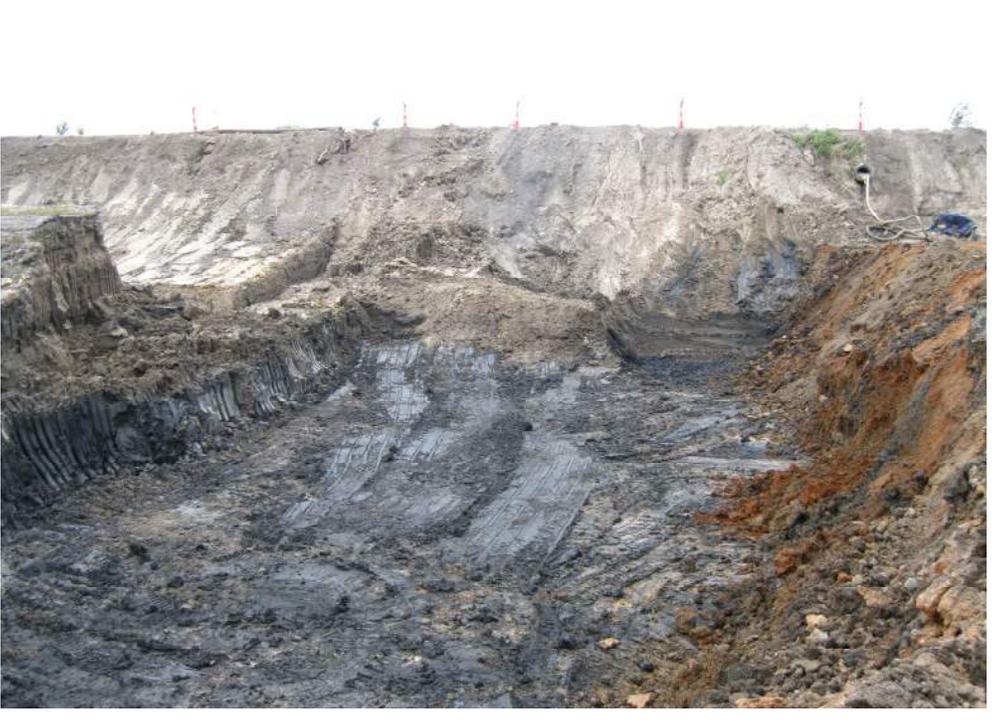
04 October 2016		
Pond 4 Clean Closure	LEC – Bottom Ash Pond 4	Photo No: 20161004 - 2
<p>Gray sand</p>

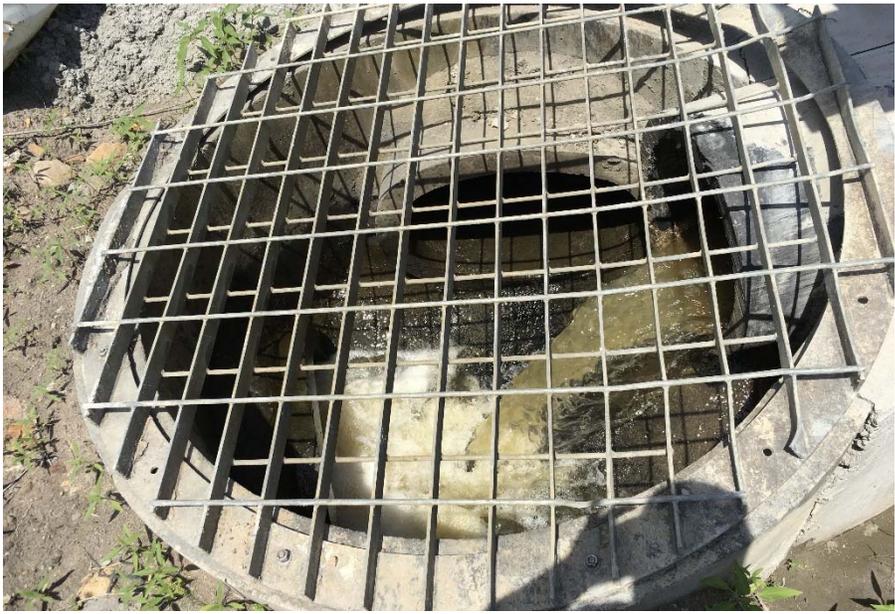
<p><b>Photograph No. 4</b></p> <p><b>Date:</b> May 15, 2017</p> <p><b>Direction:</b> South of the Pond 501</p>

<p><b>Description:</b> Manhole inlet where process water enters impounded pond network.</p>

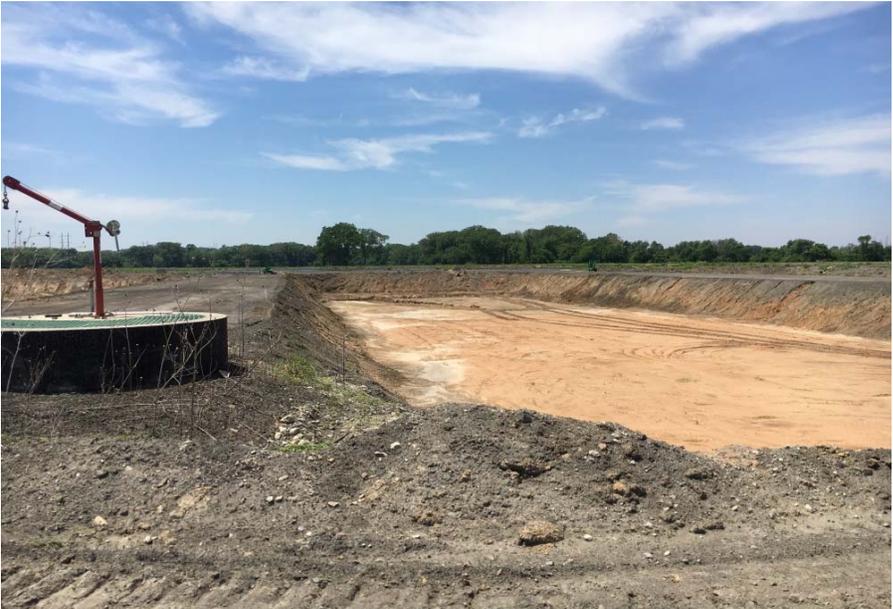
<p><b>Photograph No. 7</b></p> <p><b>Date:</b> May 15, 2017</p> <p><b>Direction:</b> Northwest</p>

<p><b>Description:</b> Pond 503 has been dewatered and will be undergoing clean closure in the future. Knife-gate inlet structure shown.</p>

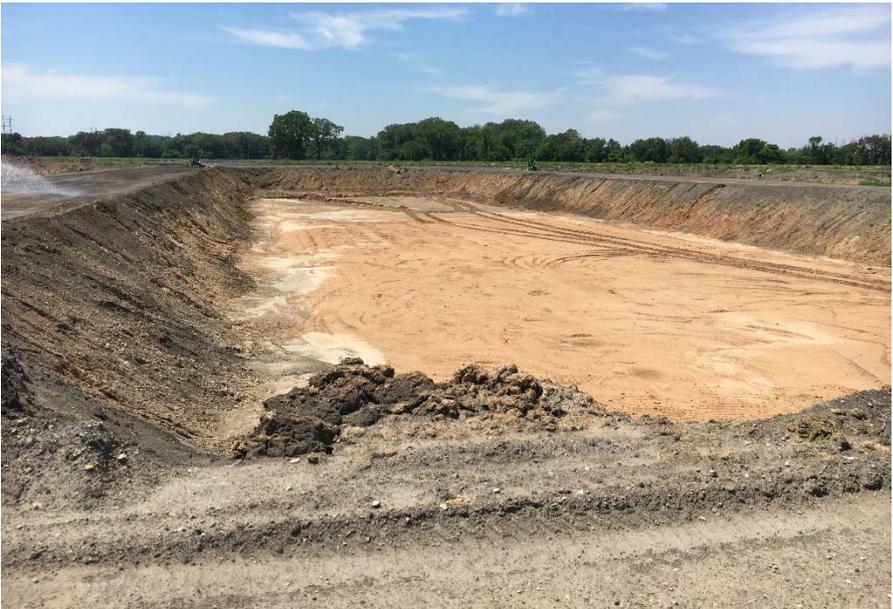
<p><b>Photograph No. 8</b></p> <p><b>Date:</b> May 15, 2017</p> <p><b>Direction:</b> Northwest</p>

<p><b>Description:</b> Dewatered Pond 503. Will begin process of closure in near future.</p>

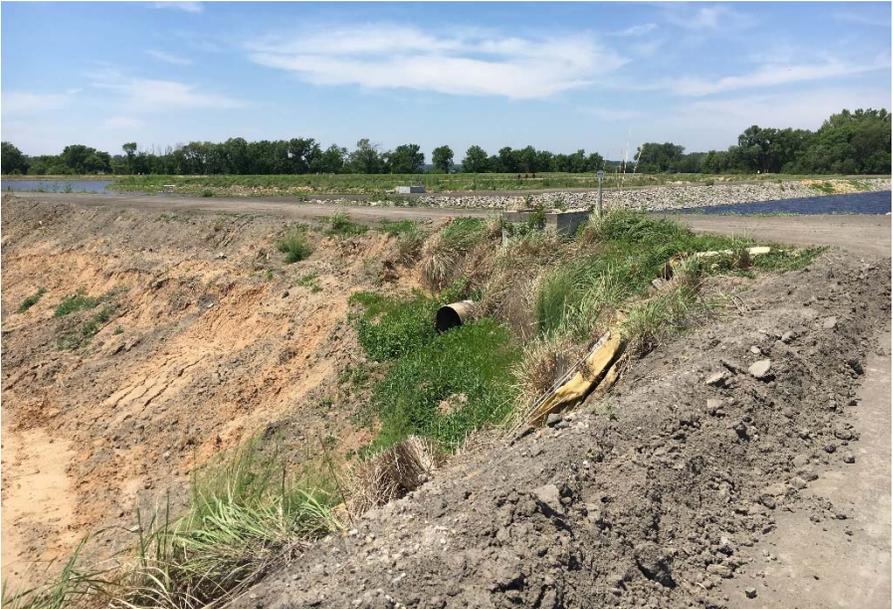
<p><b>Photograph No. 9</b></p> <p><b>Date:</b> May 15, 2017</p> <p><b>Direction:</b> Northwest</p>

<p><b>Description:</b> Culvert connection Pond 503 and Pond 401 that is no longer in use due to closure of Pond 503. Site roads are in stable condition.</p>

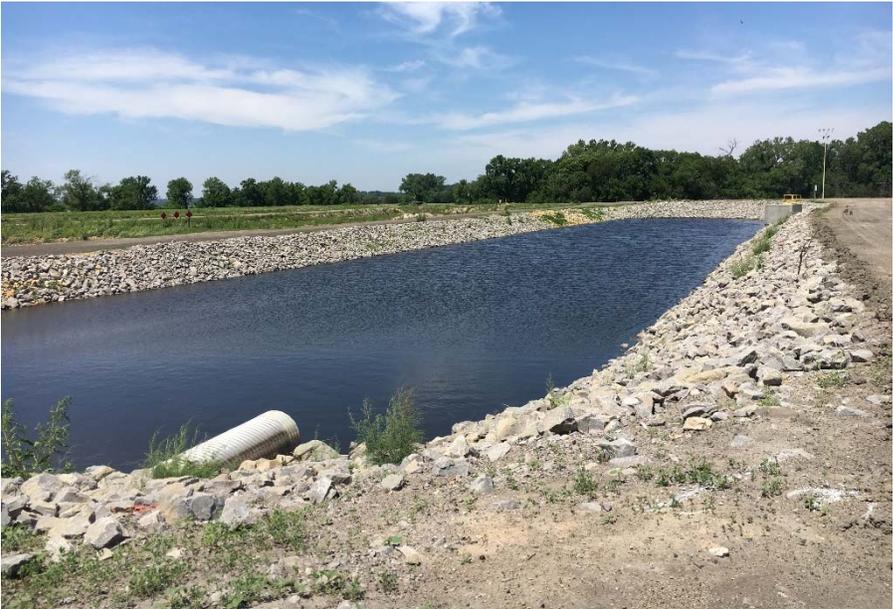
<p><b>Photograph No. 10</b></p> <p><b>Date:</b> May 15, 2017</p> <p><b>Direction:</b> Northwest</p>

<p><b>Description:</b> Observing Pond 401. Side slopes are stabilized with rip-rap. Piping connecting Pond 401 to Pond 503 is shown. Pond 401 underwent clean closure and construction for receipt of process water.</p>

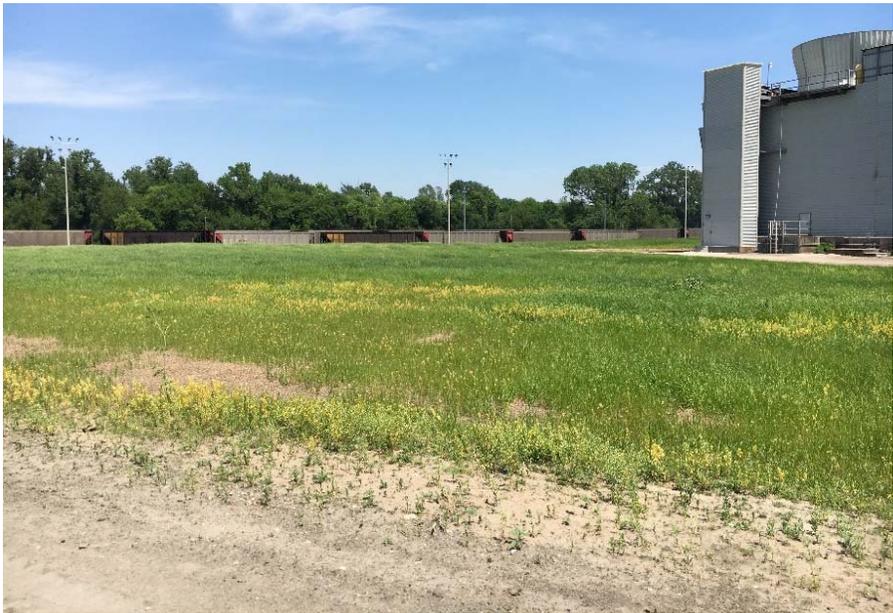
<p><b>Photograph No. 11</b></p> <p><b>Date:</b> May 15, 2017</p> <p><b>Direction:</b> Northeast</p>

<p><b>Description:</b> Closed Scrubber Supply Pond (Area 4 Pond). Appropriate vegetative growth present.</p>

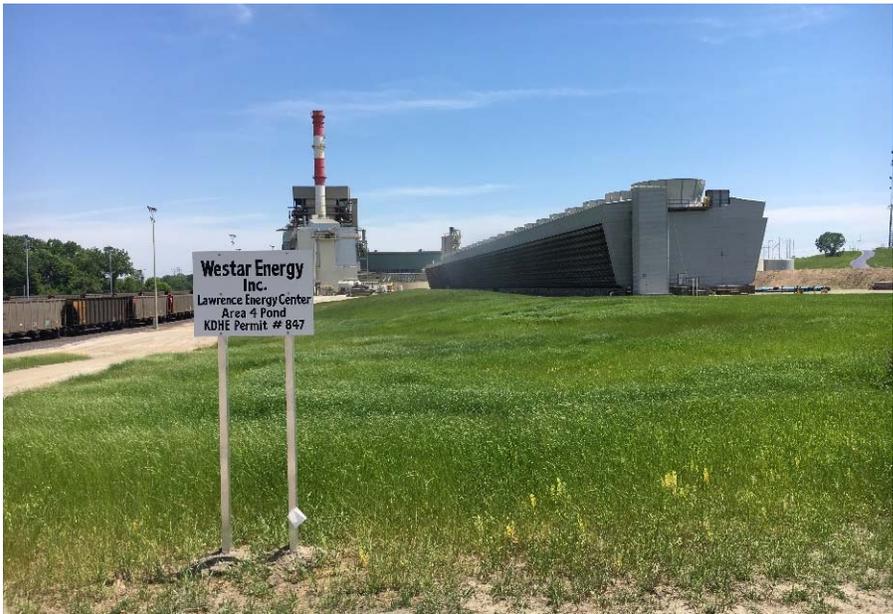
<p><b>Photograph No. 12</b></p> <p><b>Date:</b> May 15, 2017</p> <p><b>Direction:</b> Southeast</p>

<p><b>Description:</b> Former Scrubber Supply Pond (Area 4 Pond) that was cleaned, filled with soil fill, and vegetated.</p>
