Annual Inspection Report  
Lawrence Energy Center  
Inactive Units - Ash Pond Area 2, Ash Pond Area 3,  
and Ash Pond 4

Prepared for:  
Westar Energy  
Lawrence Energy Center  
Lawrence, Kansas

Prepared by:  
CB&I Environmental & Infrastructure, Inc.

June 2017

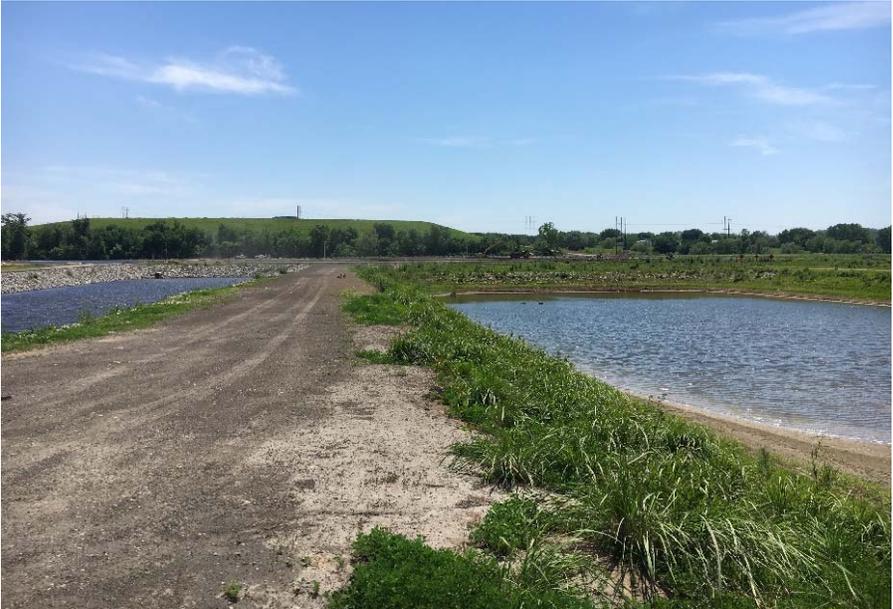
<p><b>Photograph No. 16</b></p> <p><b>Date:</b> May 15, 2017</p> <p><b>Direction:</b> South</p>

<p><b>Description:</b> Berm separating Pond 401 (left) and 402 (right). Mild vegetation present on side slopes of both Ponds. Site road is in stable condition.</p>

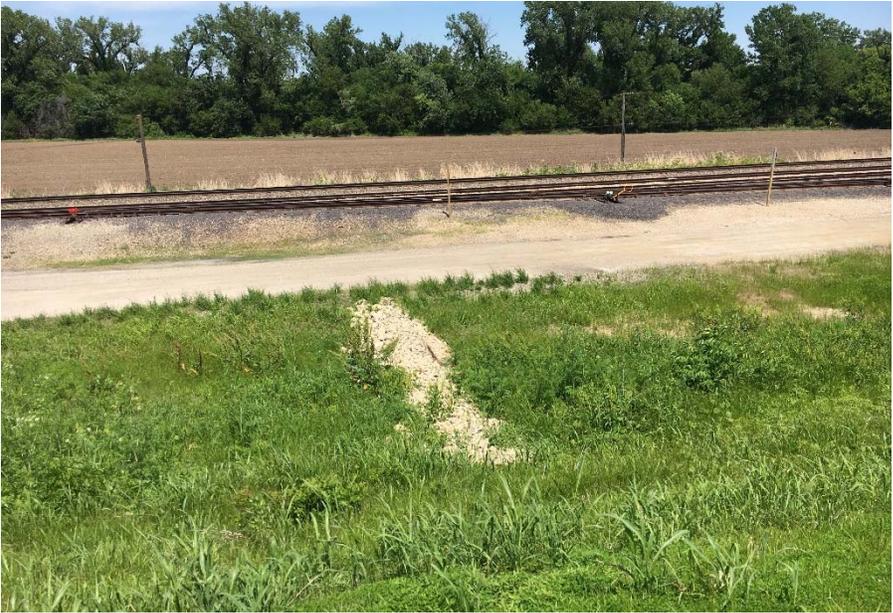
<p><b>Photograph No. 17</b></p> <p><b>Date:</b> May 15, 2017</p> <p><b>Direction:</b> Northeast</p>

<p><b>Description:</b> Stormwater ditch at bottom of impoundment on northern slope a rock check dam as shown. Appropriate vegetative growth and no erosion present. Good condition.</p>

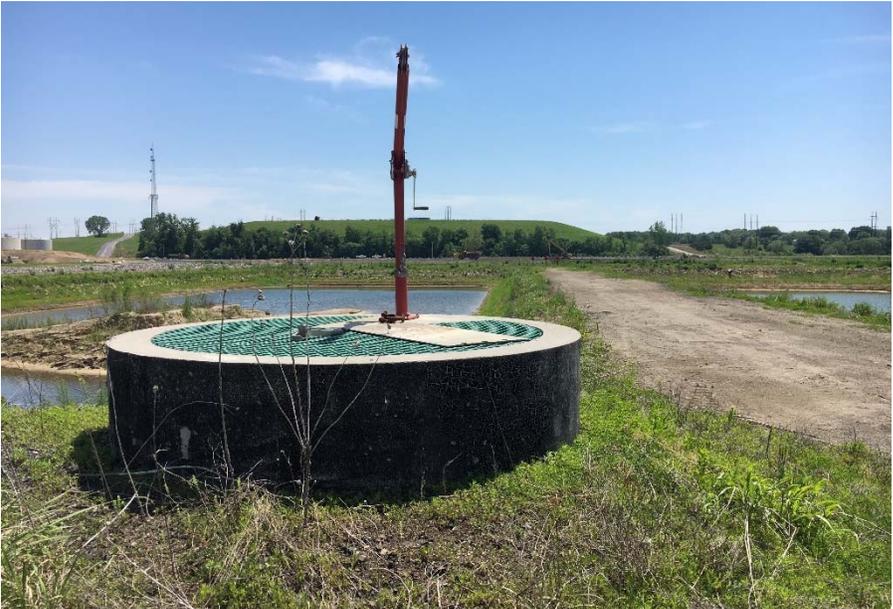
<p><b>Photograph No. 19</b></p> <p><b>Date:</b> May 15, 2017</p> <p><b>Direction:</b> Southwest</p>

<p><b>Description:</b> Pond 402 outlet structure between Pond 402 (left) and Pond 403 (right). Site road is in stable condition.</p>

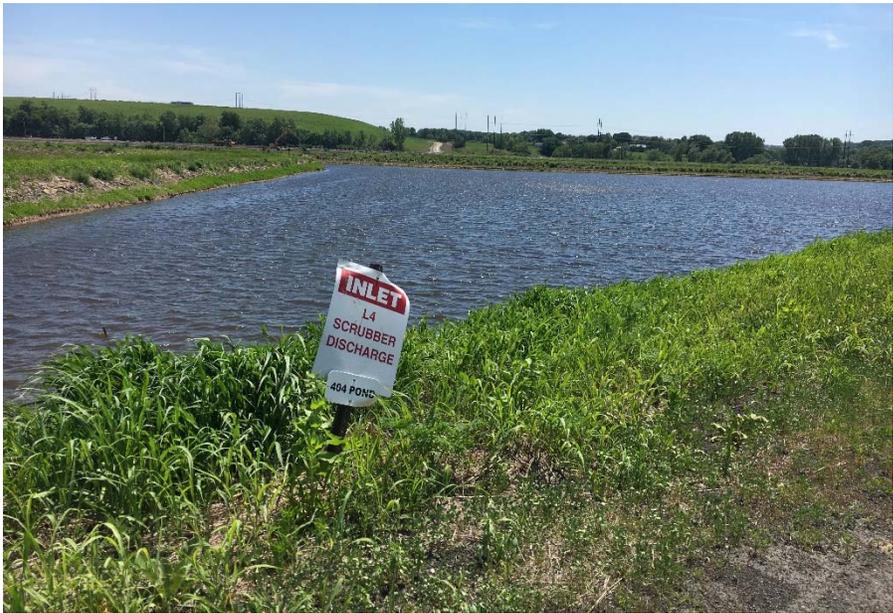
<p><b>Photograph No. 21</b></p> <p><b>Date:</b> May 15, 2017</p> <p><b>Direction:</b> Southeast</p>

<p><b>Description:</b> Pond 404 inlet. Healthy vegetation present on the side slopes.</p>

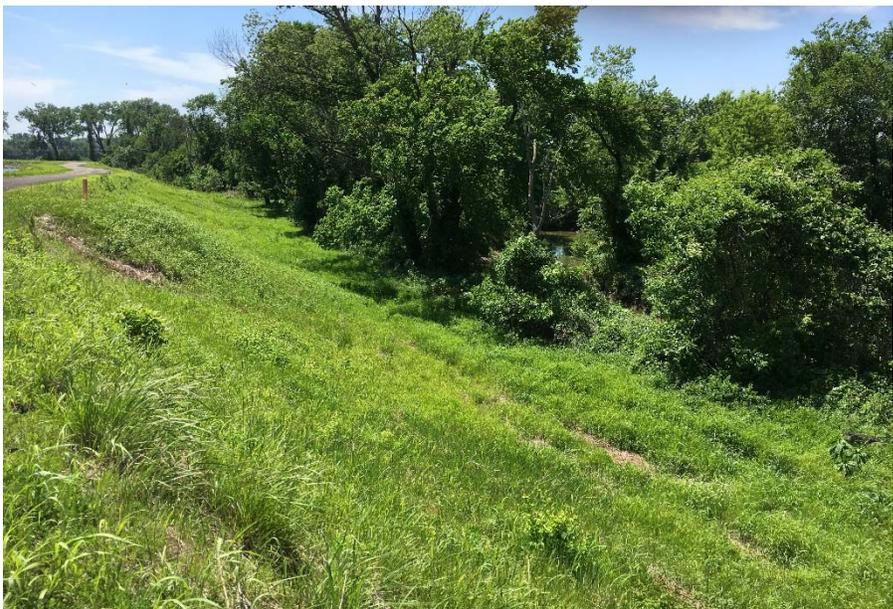
<p><b>Photograph No. 22</b></p> <p><b>Date:</b> May 15, 2017</p> <p><b>Direction:</b> Southwest</p>

<p><b>Description:</b> Outer slope of impoundment (near Pond 404). Well vegetated, no erosion. Good condition.</p>

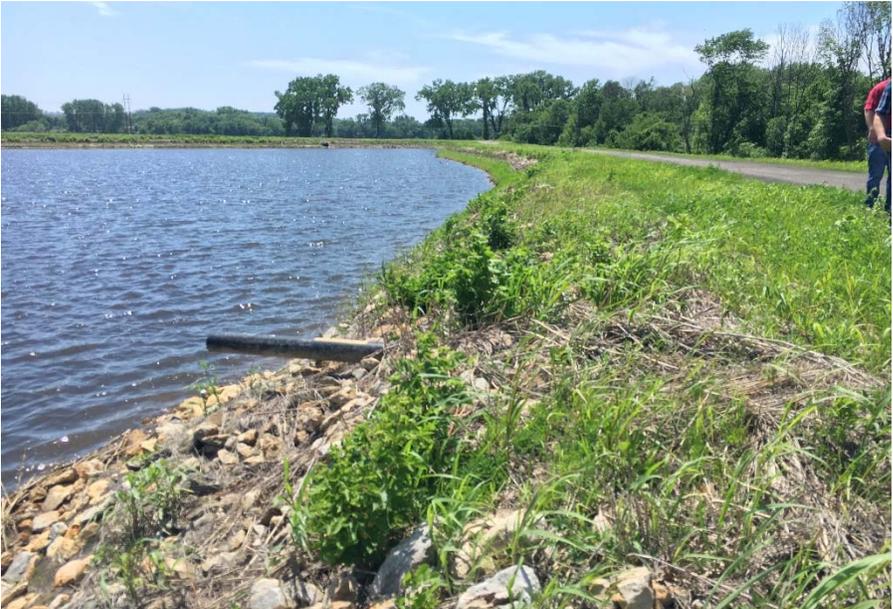
<p><b>Photograph No. 23</b></p> <p><b>Date:</b> May 15, 2017</p> <p><b>Direction:</b> Southwest</p>

<p><b>Description:</b> Pond 404 side slope and outfall. Rip-rap and mild to moderate vegetation present on side slopes. No significant erosion present.</p>

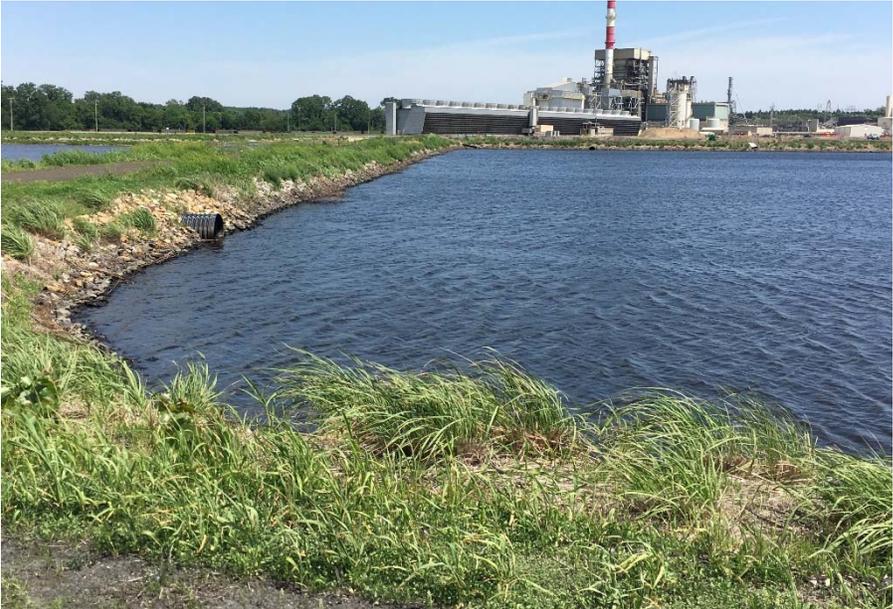
<p><b>Photograph No. 24</b></p> <p><b>Date:</b> May 15, 2017</p> <p><b>Direction:</b> East</p>

<p><b>Description:</b> West Pond outlet to Pond 404. Rip-rap and mild vegetation present on side slopes. No observed erosion.</p>

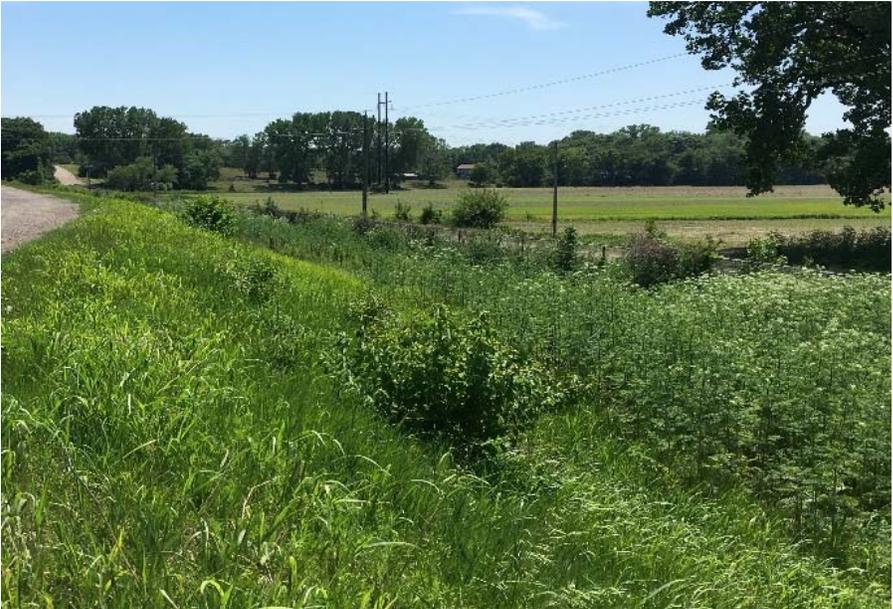
<p><b>Photograph No. 25</b></p> <p><b>Date:</b> May 15, 2017</p> <p><b>Direction:</b> South</p>

<p><b>Description:</b> Outer slope of impoundment (near West Pond). Good condition, well vegetated, no erosion observed.</p>

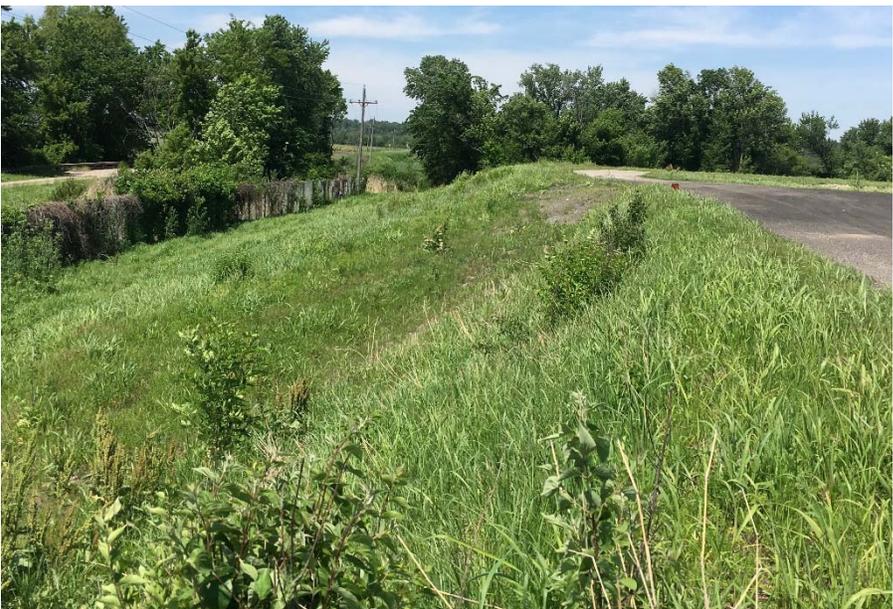
<p><b>Photograph No. 26</b></p> <p><b>Date:</b> May 15, 2017</p> <p><b>Direction:</b> North</p>

<p><b>Description:</b> Outer slope of impoundment (near West Pond). Moderate to significant vegetation present. No significant erosion present.</p>

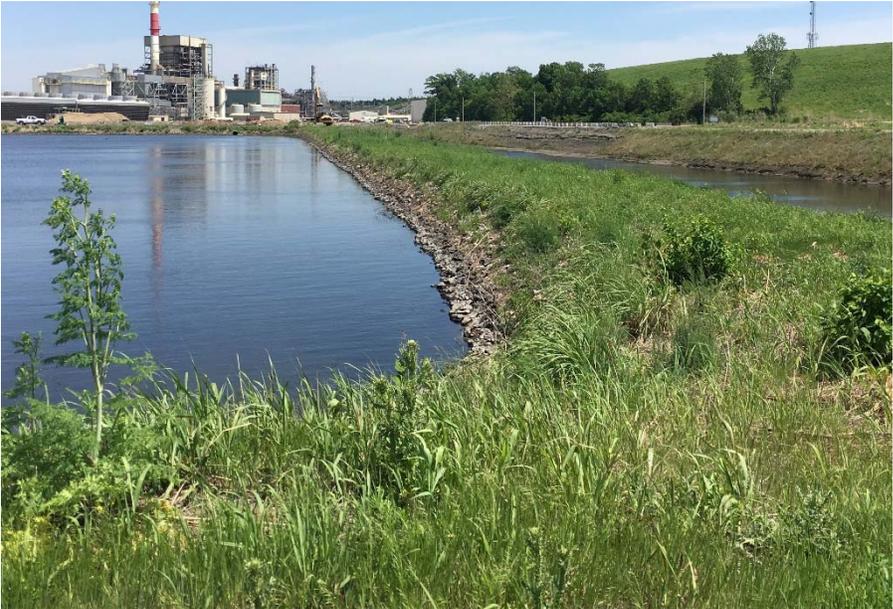
<p><b>Photograph No. 27</b></p> <p><b>Date:</b> May 15, 2017</p> <p><b>Direction:</b> East</p>

<p><b>Description:</b> Berm separating the West Pond and Laydown Area. West Pond slope is stabilized with rip-rap. Vegetation present.</p>

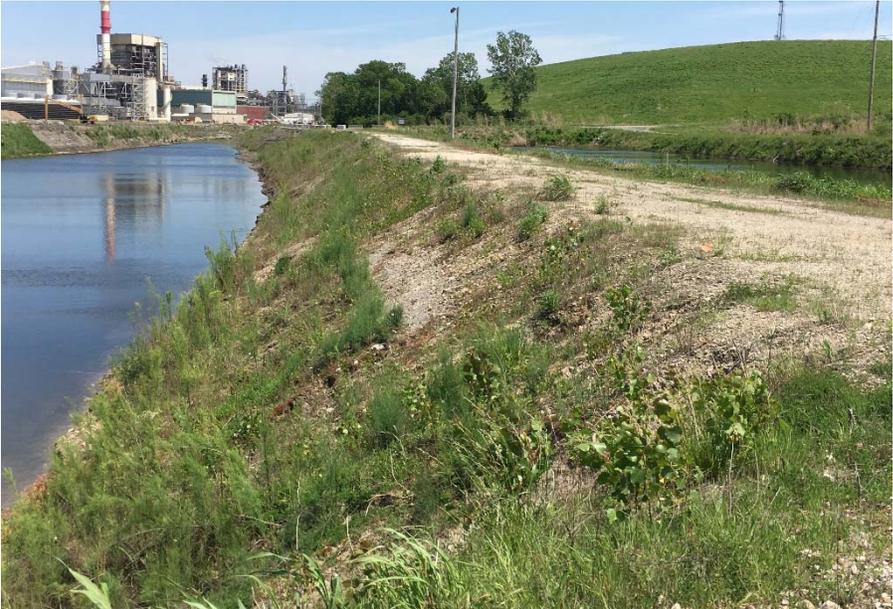
<p><b>Photograph No. 28</b></p> <p><b>Date:</b> May 15, 2017</p> <p><b>Direction:</b> East</p>

<p><b>Description:</b> Berm separating the Laydown Area and the Storm Water Settling Pond. Mild erosion present on side slope of Laydown Area, which does not impact stability of impoundment.</p>

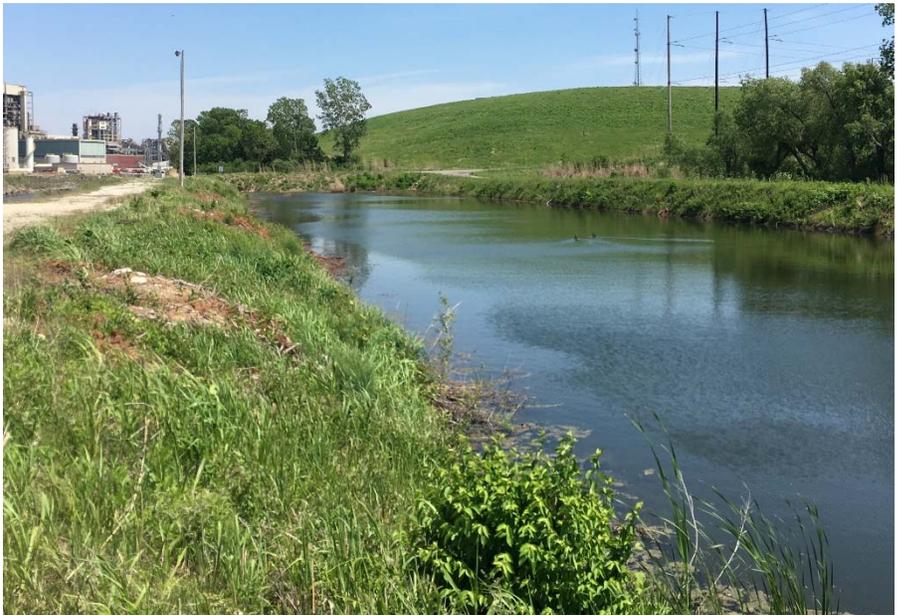
<p><b>Photograph No. 29</b></p> <p><b>Date:</b> May 15, 2017</p> <p><b>Direction:</b> East</p>

<p><b>Description:</b> Berm separating the Laydown Area and the Storm Water Settling Pond.</p>

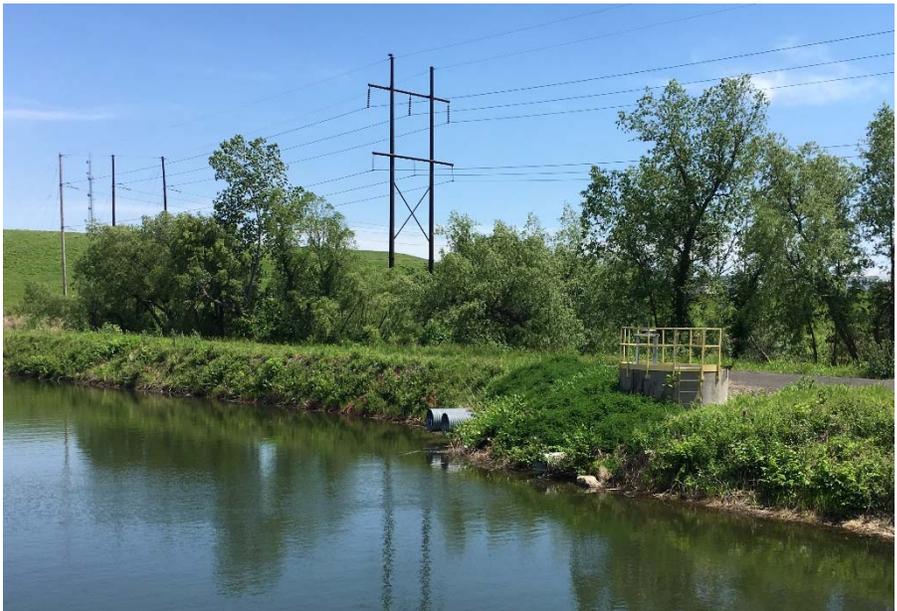
<p><b>Photograph No. 30</b></p> <p><b>Date:</b> May 15, 2017</p> <p><b>Direction:</b> Southeast</p>

<p><b>Description:</b> Outfall of Storm Water Settling Pond. Mild to moderate vegetation present. No significant erosion present.</p>

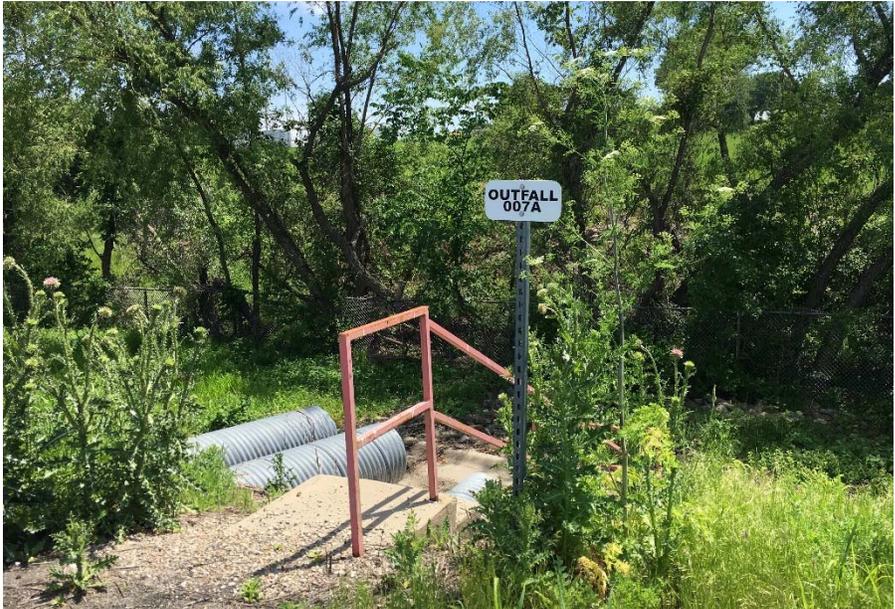
<p><b>Photograph No. 31</b></p> <p><b>Date:</b> May 15, 2017</p> <p><b>Direction:</b> Southeast</p>

<p>A photograph showing an outfall structure with a sign that reads "OUTFALL 007A". The structure is made of metal and is surrounded by dense green vegetation and trees. A corrugated metal pipe is visible in the background.</p>
<p><b>Description:</b> Outfall 007A on south side of Storm Water Settling Pond. Healthy vegetation present near outfall.</p>

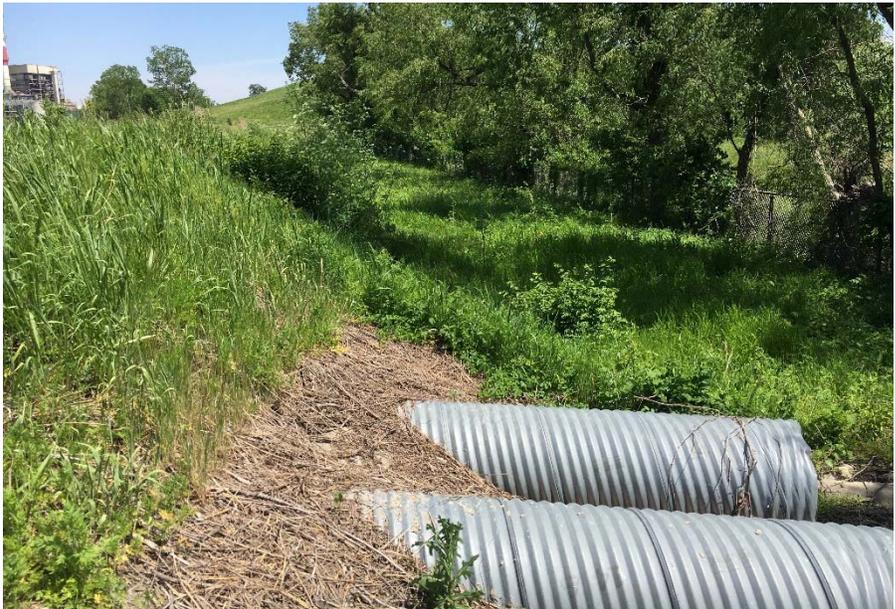
<p><b>Photograph No. 32</b></p> <p><b>Date:</b> May 15, 2017</p> <p><b>Direction:</b> East</p>

<p>A photograph showing a view of the outfall area with a large amount of tall grass and other vegetation. A corrugated metal pipe is visible in the foreground. The outfall structure is partially obscured by the vegetation.</p>
<p><b>Description:</b> Outfall 007A on south side of Storm Water Settling Pond. Moderate to significant vegetation present near outfall. Outfall is well maintained.</p>

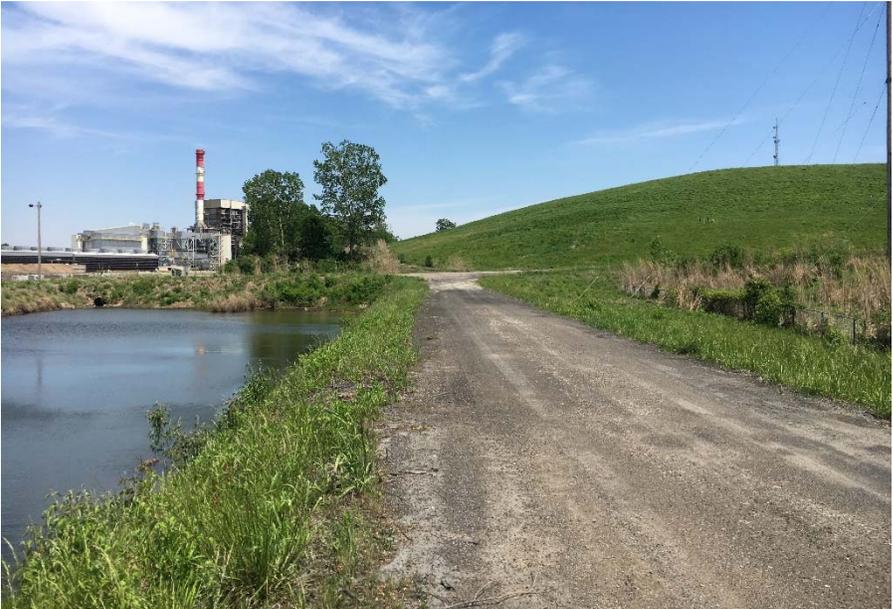
<p><b>Photograph No. 33</b></p> <p><b>Date:</b> May 15, 2017</p> <p><b>Direction:</b> East</p>

<p><b>Description:</b> Perimeter dike on south side of Storm Water Settling Pond is in stable condition. Mild to moderate vegetation present on side slope of Pond.</p>

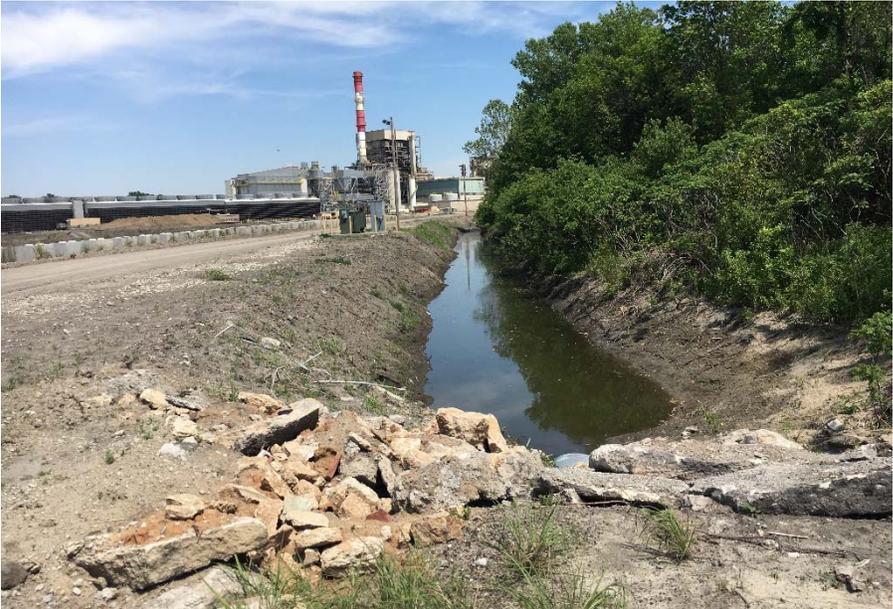
<p><b>Photograph No. 34</b></p> <p><b>Date:</b> May 15, 2017</p> <p><b>Direction:</b> East</p>

<p><b>Description:</b> Recently regraded stormwater ditch. Good condition.</p>
