## Initial Safety Factor Assessment Lawrence Energy Center

Inactive Units - Ash Pond Area 2, Ash Pond Area 3,  
and Ash Pond 4

Westar Energy

April 2018

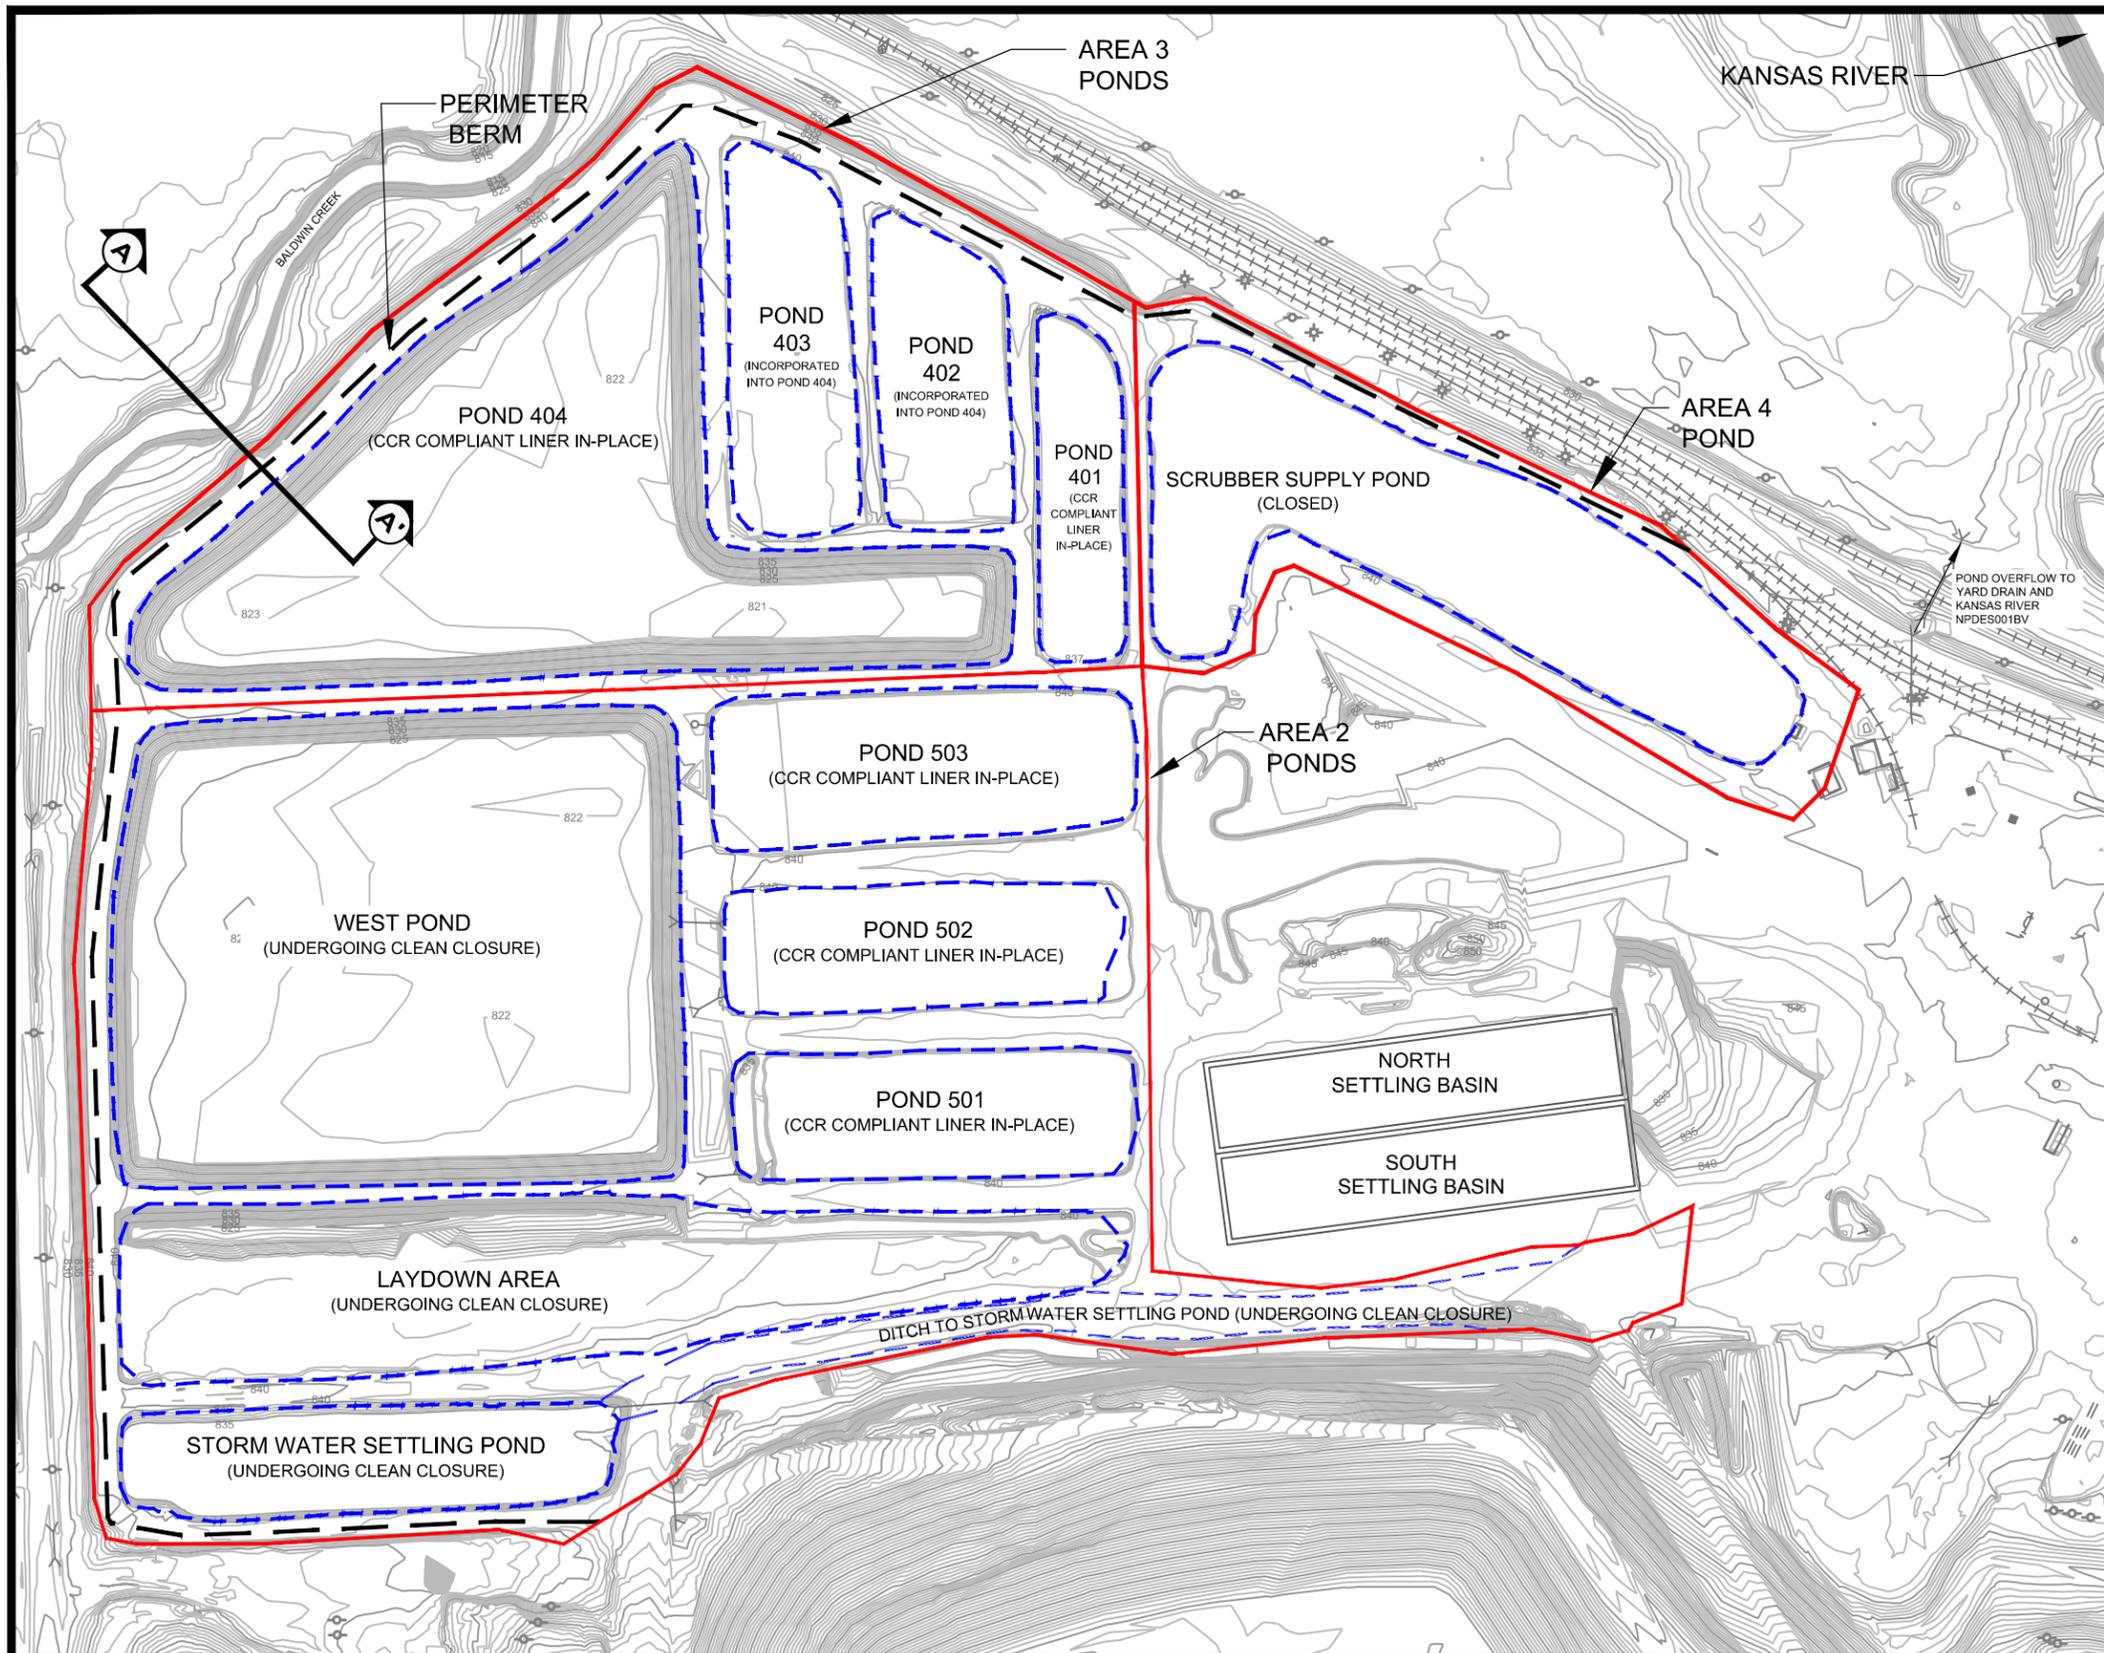
**FIGURE 4  
INACTIVE UNITS - ASH POND AREA 2, ASH POND AREA 3, ASH POND 4  
APPROXIMATE CROSS-SECTION LOCATION**

Cross section A-A' is a schematic, critical cross-section which incorporates the section of the perimeter dike most susceptible to structural failure, as required by §257.73(e)(1). It conservatively captures the area with the highest potential for failure based on the embankment geometry, water levels, and subsurface soil conditions. The cross-section is based on the cross-sections used in the 2009 stability assessment, 2009 boring data, elevations and conditions from the 2016 survey, and the proposed reconfiguration design created by Black & Veatch. The cross-section is characterized by the following features:

The phreatic surface was conservatively modeled to be a linear connection between the upstream water surface elevation and the downstream water surface elevation. See **Figure 4** for an approximate cross-section location.

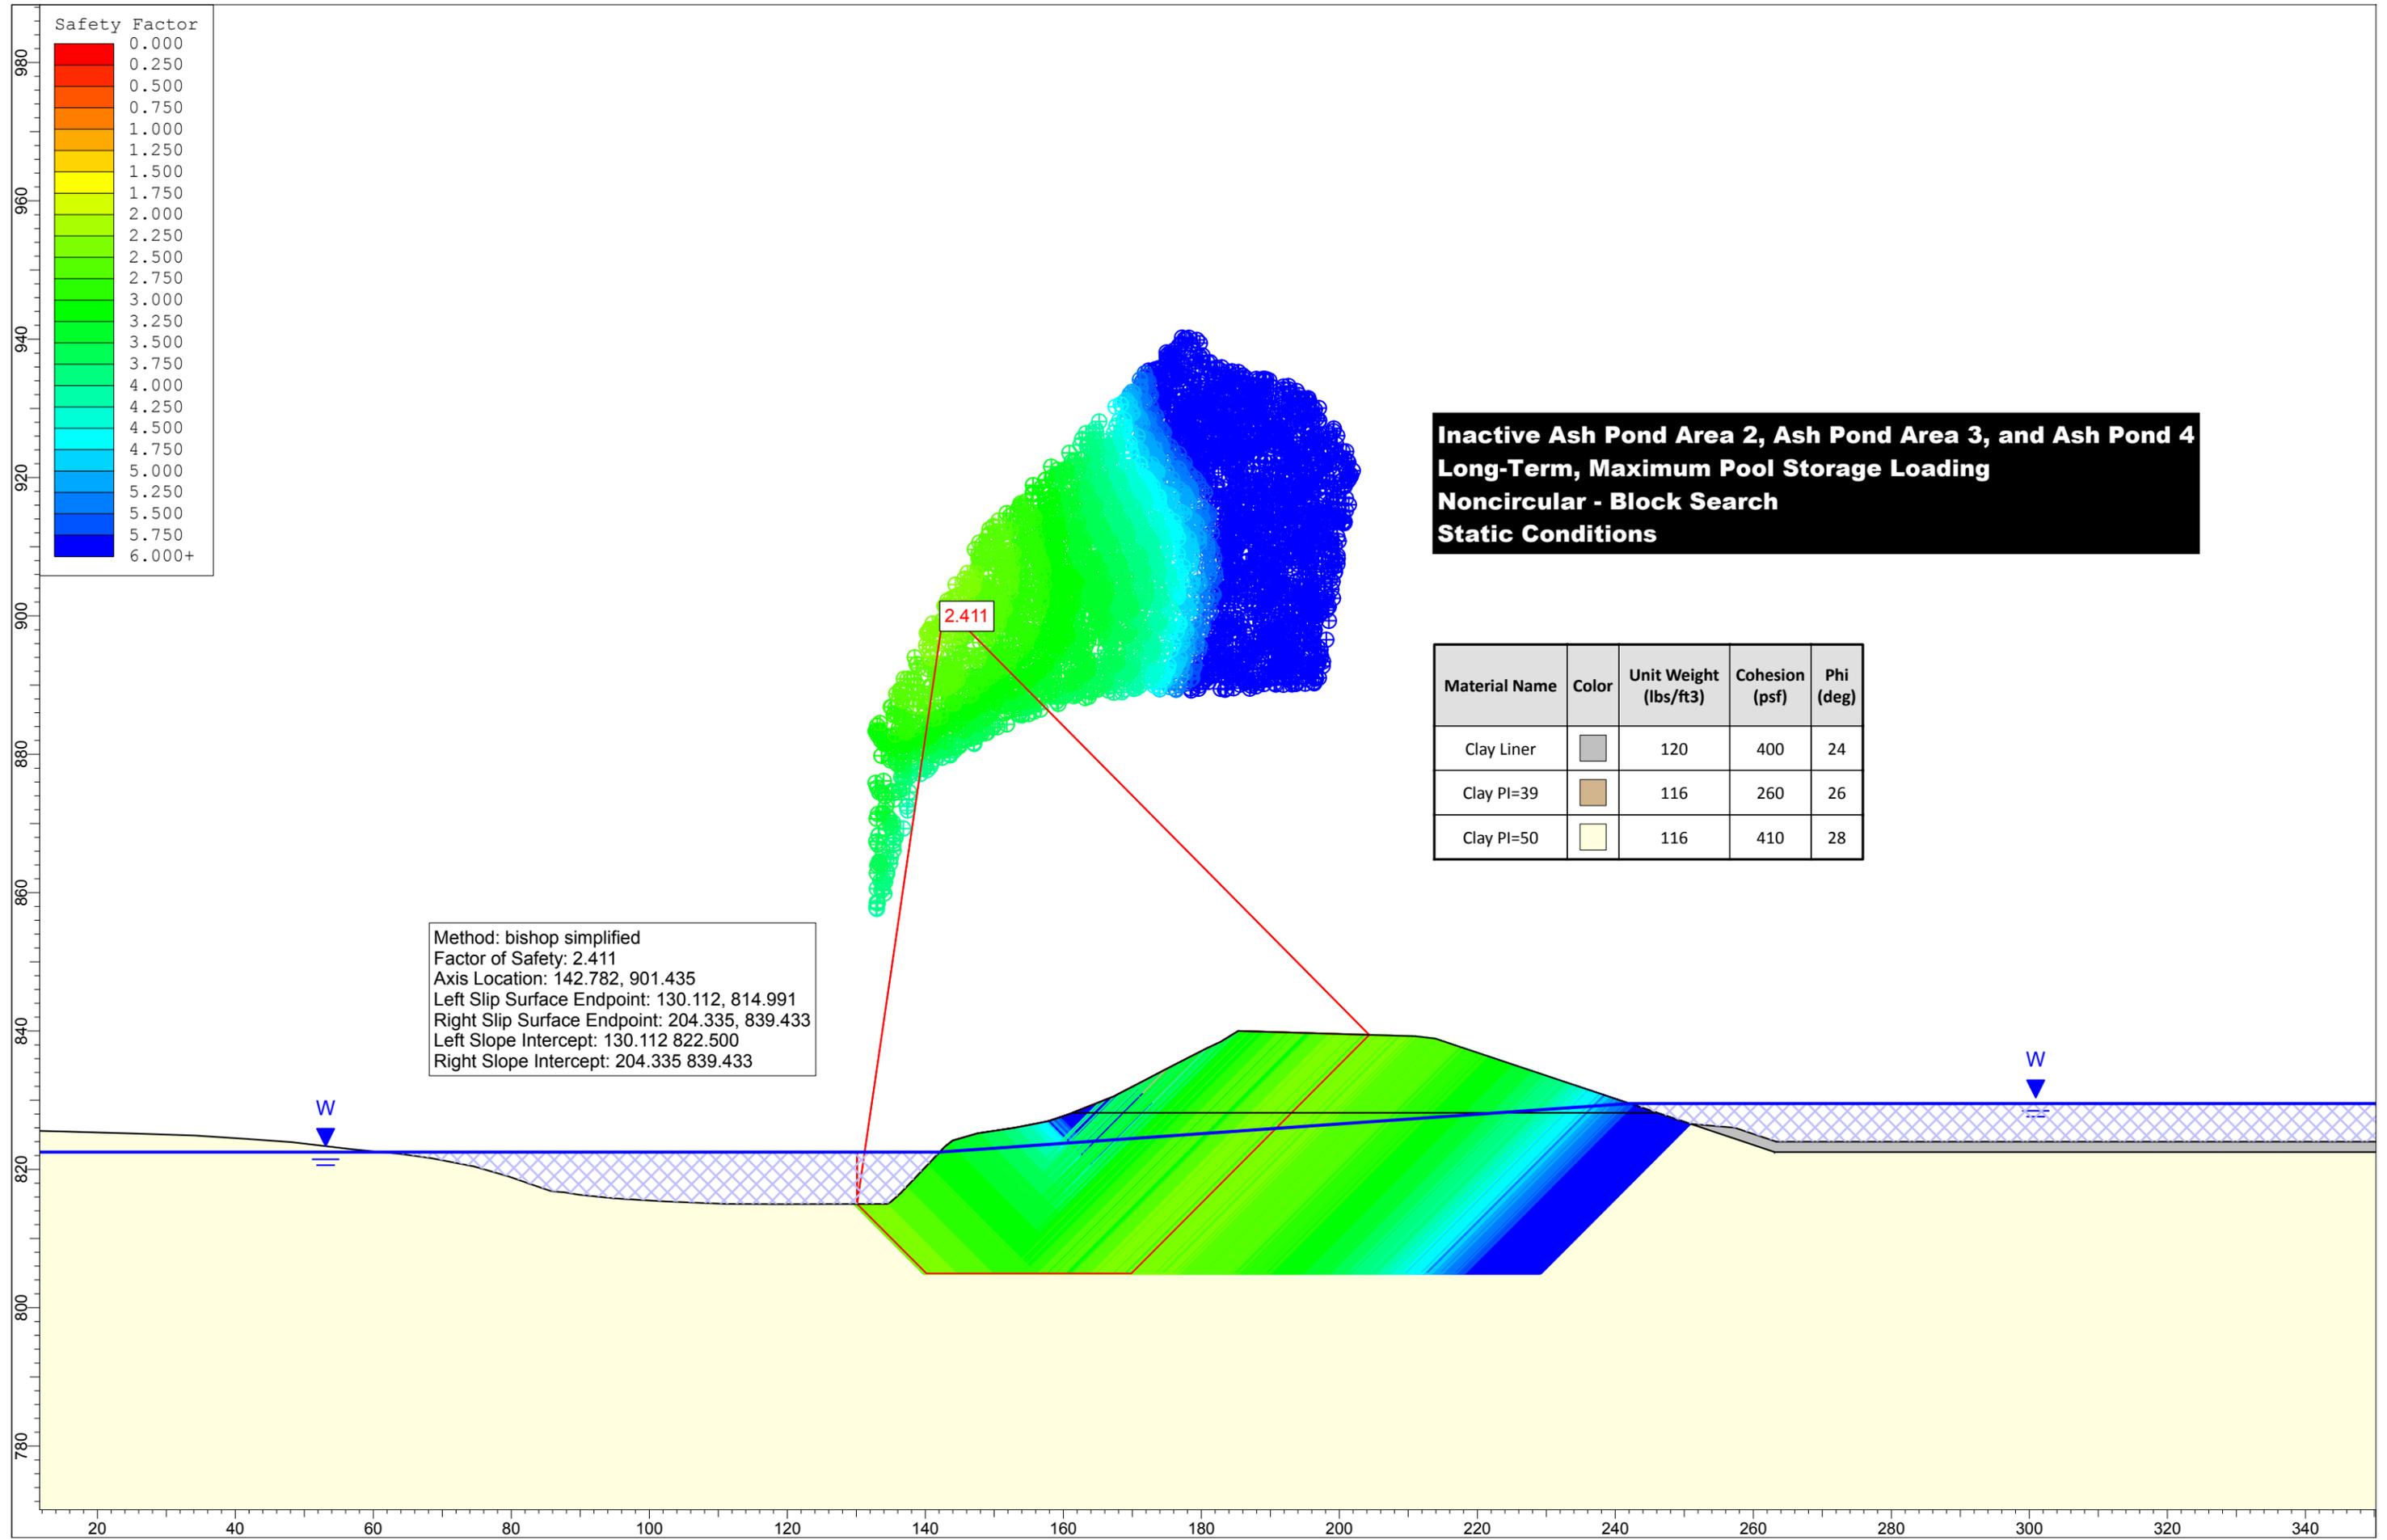
**Inactive Ash Pond Area 2, Ash Pond Area 3, and Ash Pond 4  
Long-Term, Maximum Pool Storage Loading  
Noncircular - Block Search  
Static Conditions**

Method: bishop simplified  
 Factor of Safety: 2.411  
 Axis Location: 142.782, 901.435  
 Left Slip Surface Endpoint: 130.112, 814.991  
 Right Slip Surface Endpoint: 204.335, 839.433  
 Left Slope Intercept: 130.112 822.500  
 Right Slope Intercept: 204.335 839.433

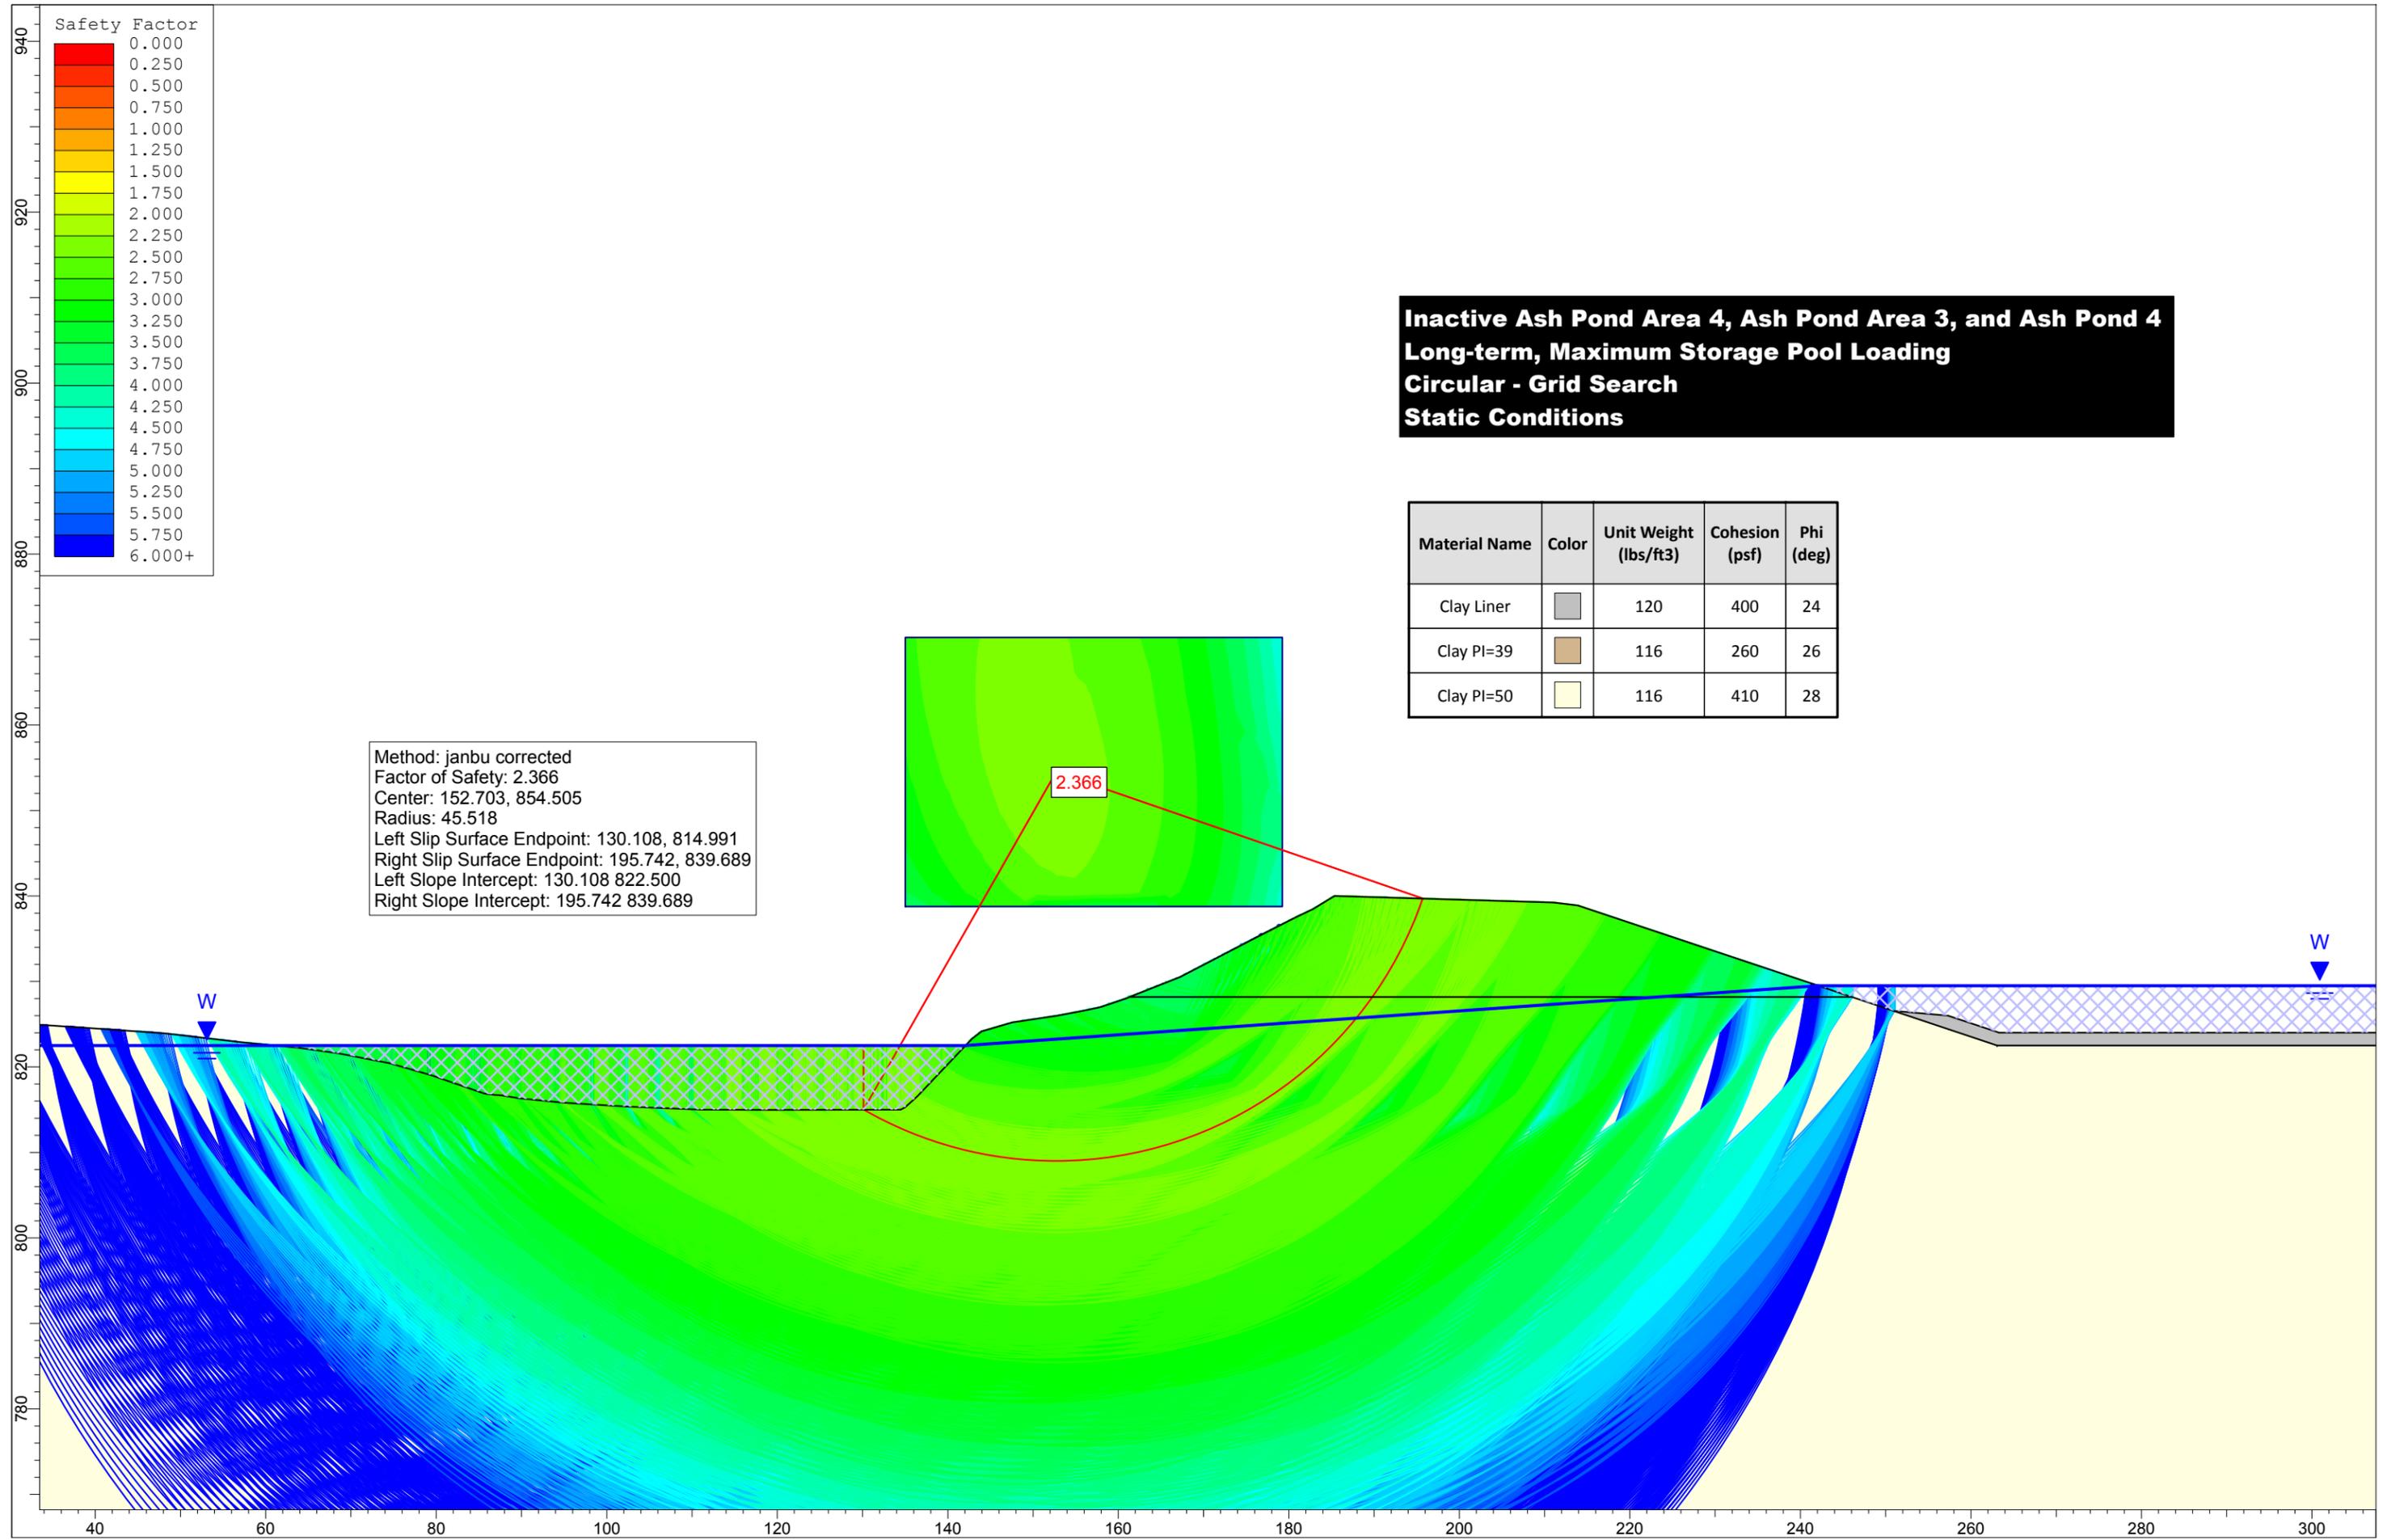
**Inactive Ash Pond Area 4, Ash Pond Area 3, and Ash Pond 4  
 Long-term, Maximum Storage Pool Loading  
 Circular - Grid Search  
 Static Conditions**

Method: janbu corrected  
 Factor of Safety: 2.366  
 Center: 152.703, 854.505  
 Radius: 45.518  
 Left Slip Surface Endpoint: 130.108, 814.991  
 Right Slip Surface Endpoint: 195.742, 839.689  
 Left Slope Intercept: 130.108 822.500  
 Right Slope Intercept: 195.742 839.689

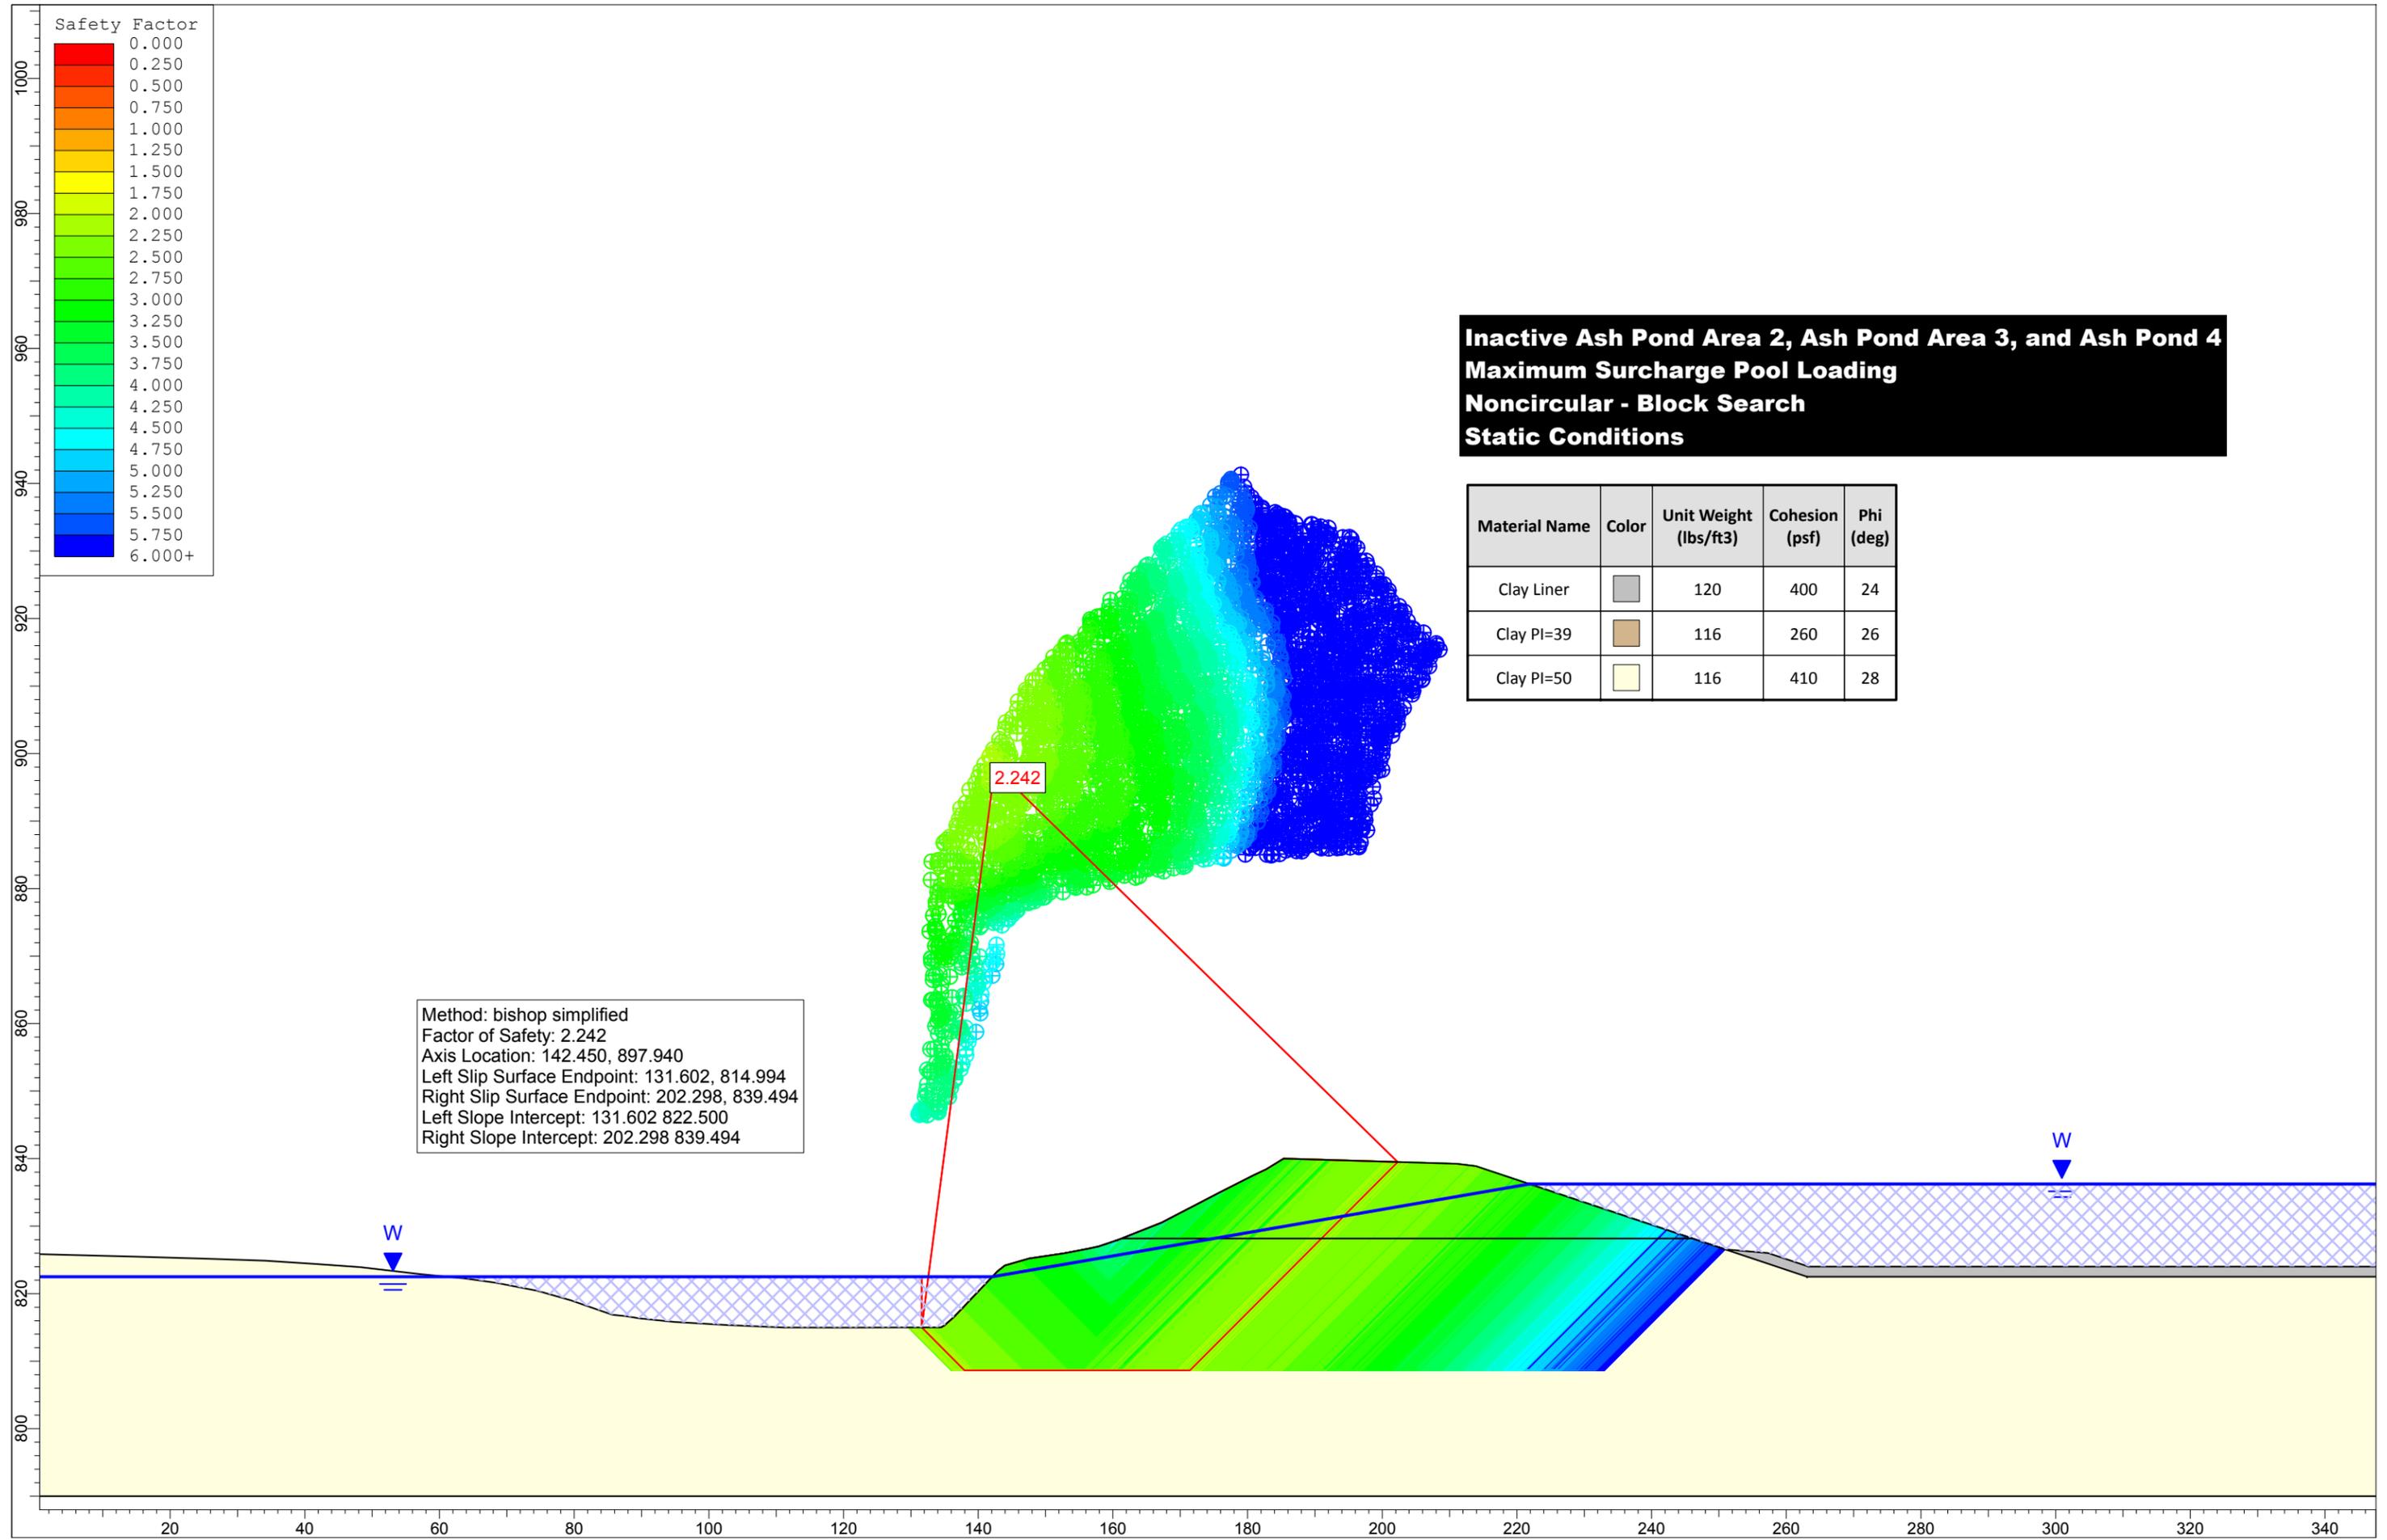
**Inactive Ash Pond Area 2, Ash Pond Area 3, and Ash Pond 4  
Maximum Surcharge Pool Loading  
Noncircular - Block Search  
Static Conditions**

Method: bishop simplified  
 Factor of Safety: 2.242  
 Axis Location: 142.450, 897.940  
 Left Slip Surface Endpoint: 131.602, 814.994  
 Right Slip Surface Endpoint: 202.298, 839.494  
 Left Slope Intercept: 131.602 822.500  
 Right Slope Intercept: 202.298 839.494

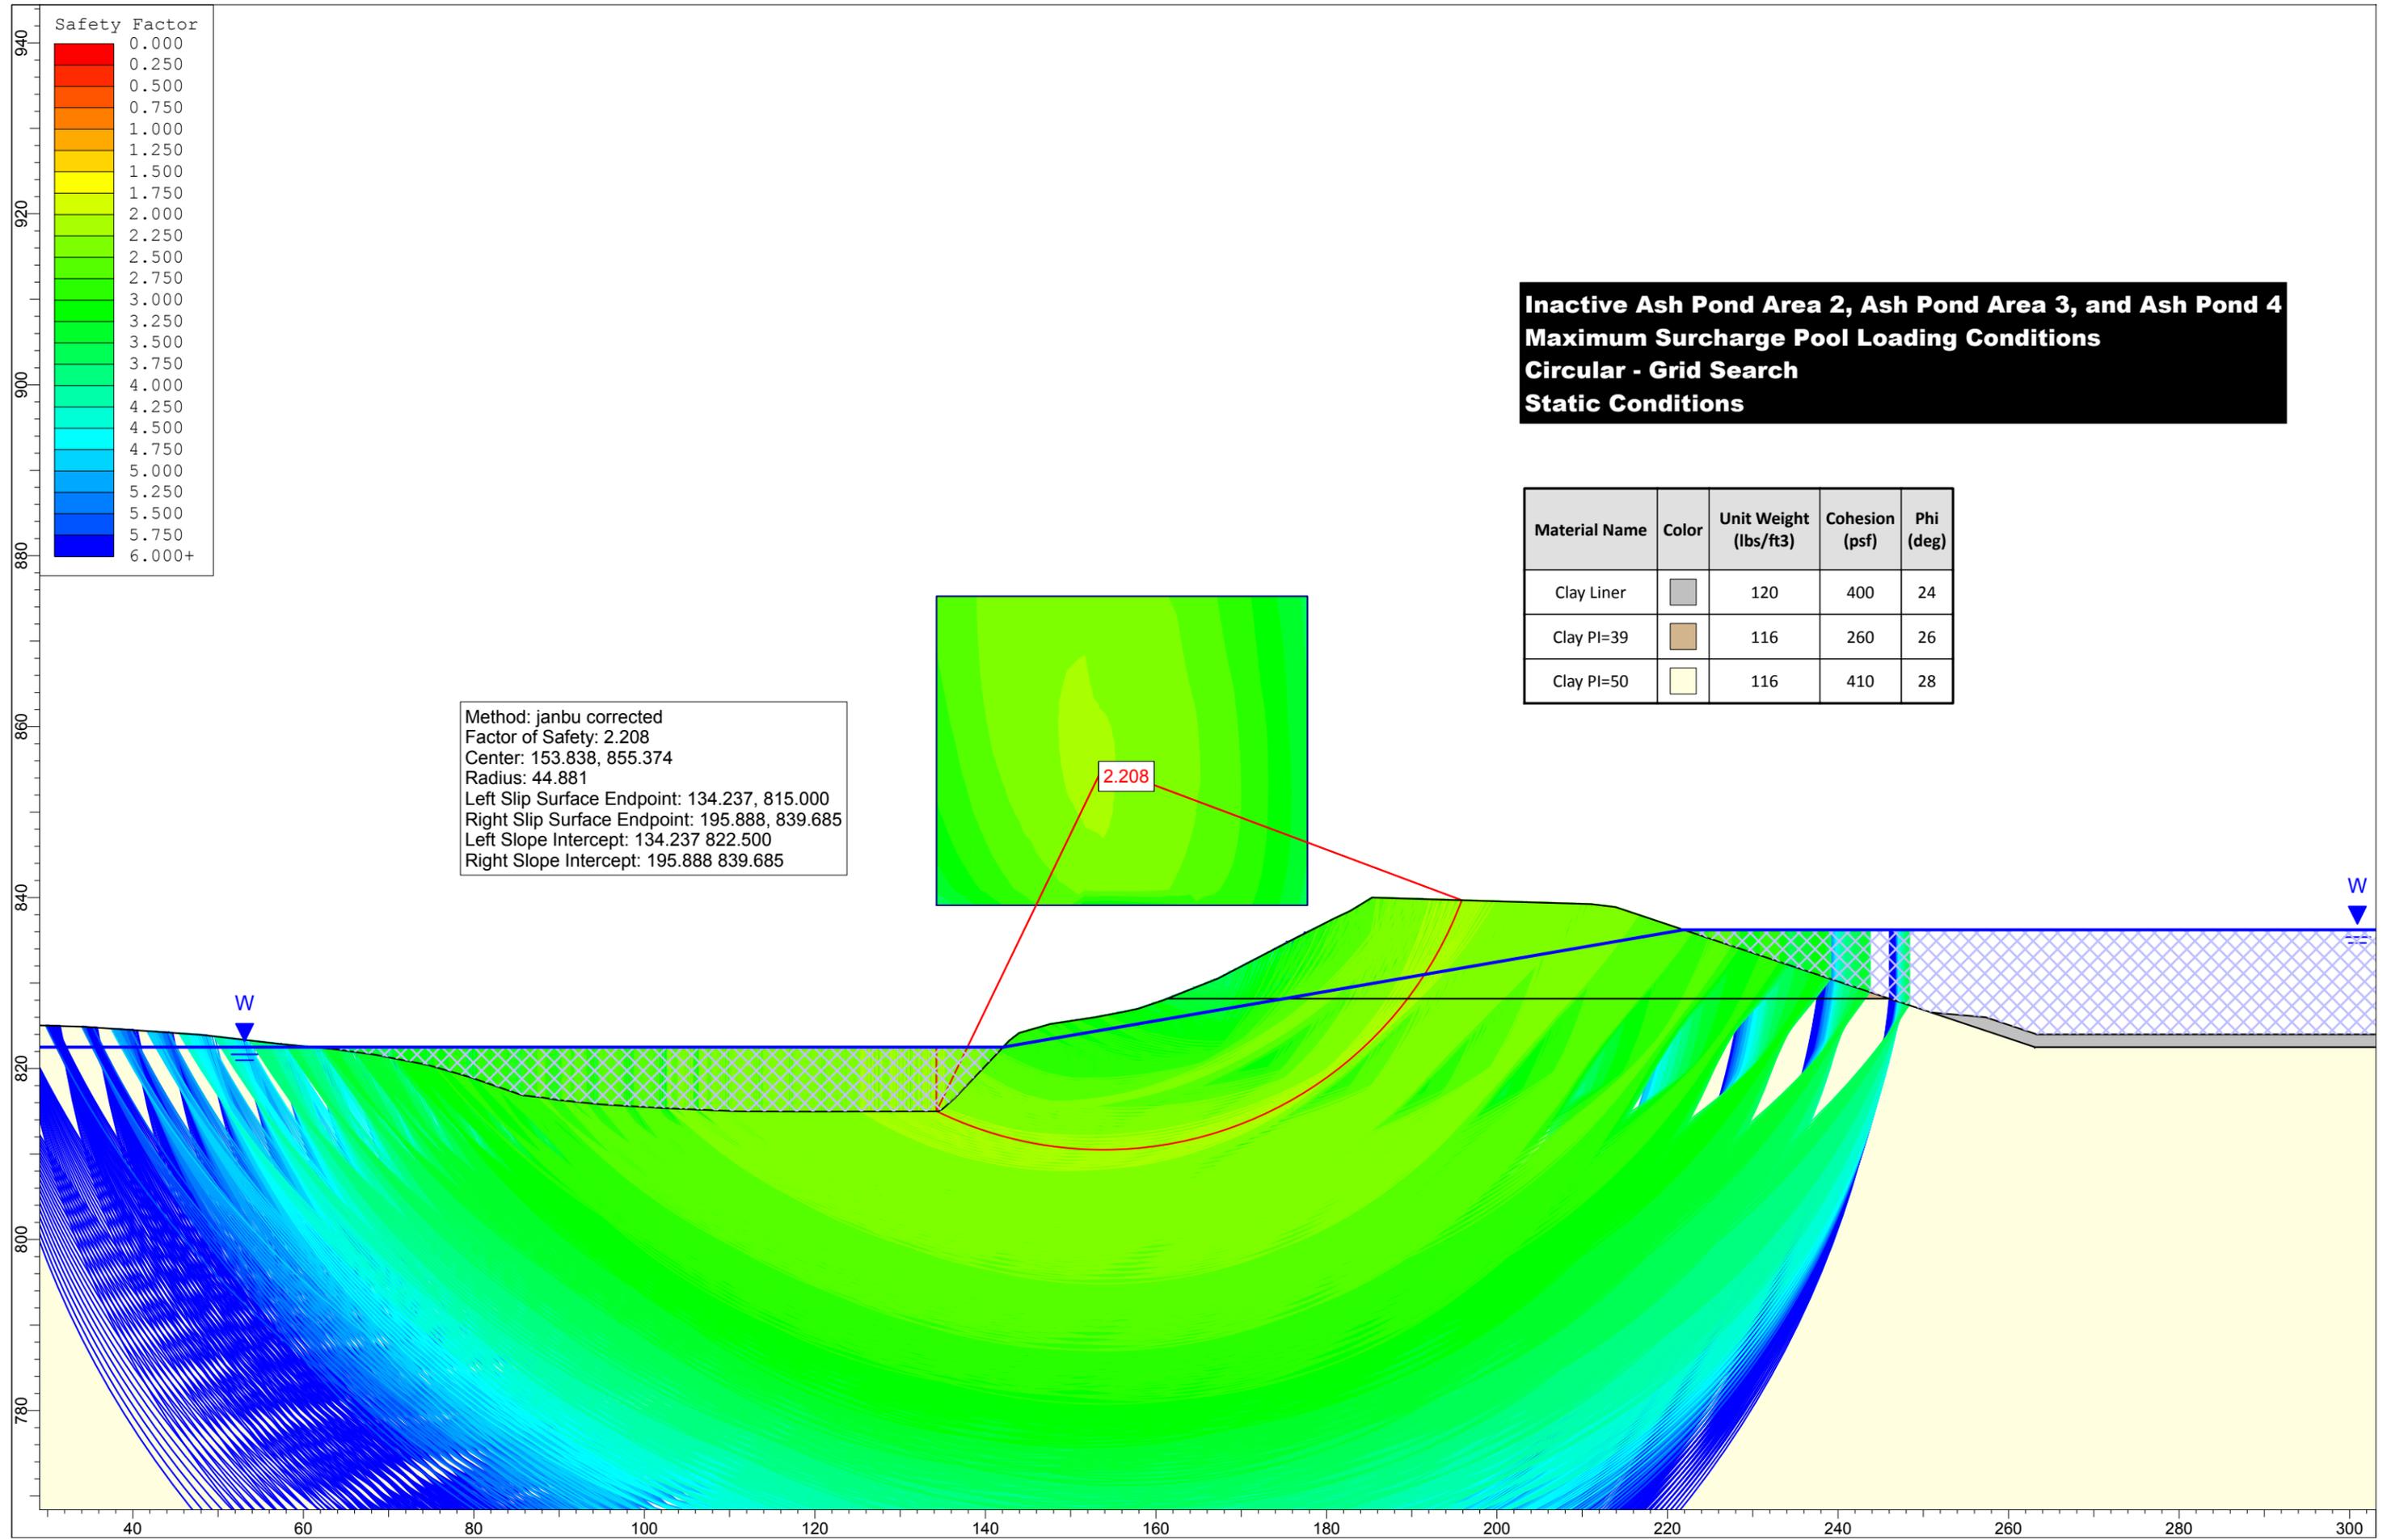
**Inactive Ash Pond Area 2, Ash Pond Area 3, and Ash Pond 4  
Maximum Surcharge Pool Loading Conditions  
Circular - Grid Search  
Static Conditions**

Method: janbu corrected  
 Factor of Safety: 2.208  
 Center: 153.838, 855.374  
 Radius: 44.881  
 Left Slip Surface Endpoint: 134.237, 815.000  
 Right Slip Surface Endpoint: 195.888, 839.685  
 Left Slope Intercept: 134.237 822.500  
 Right Slope Intercept: 195.888 839.685

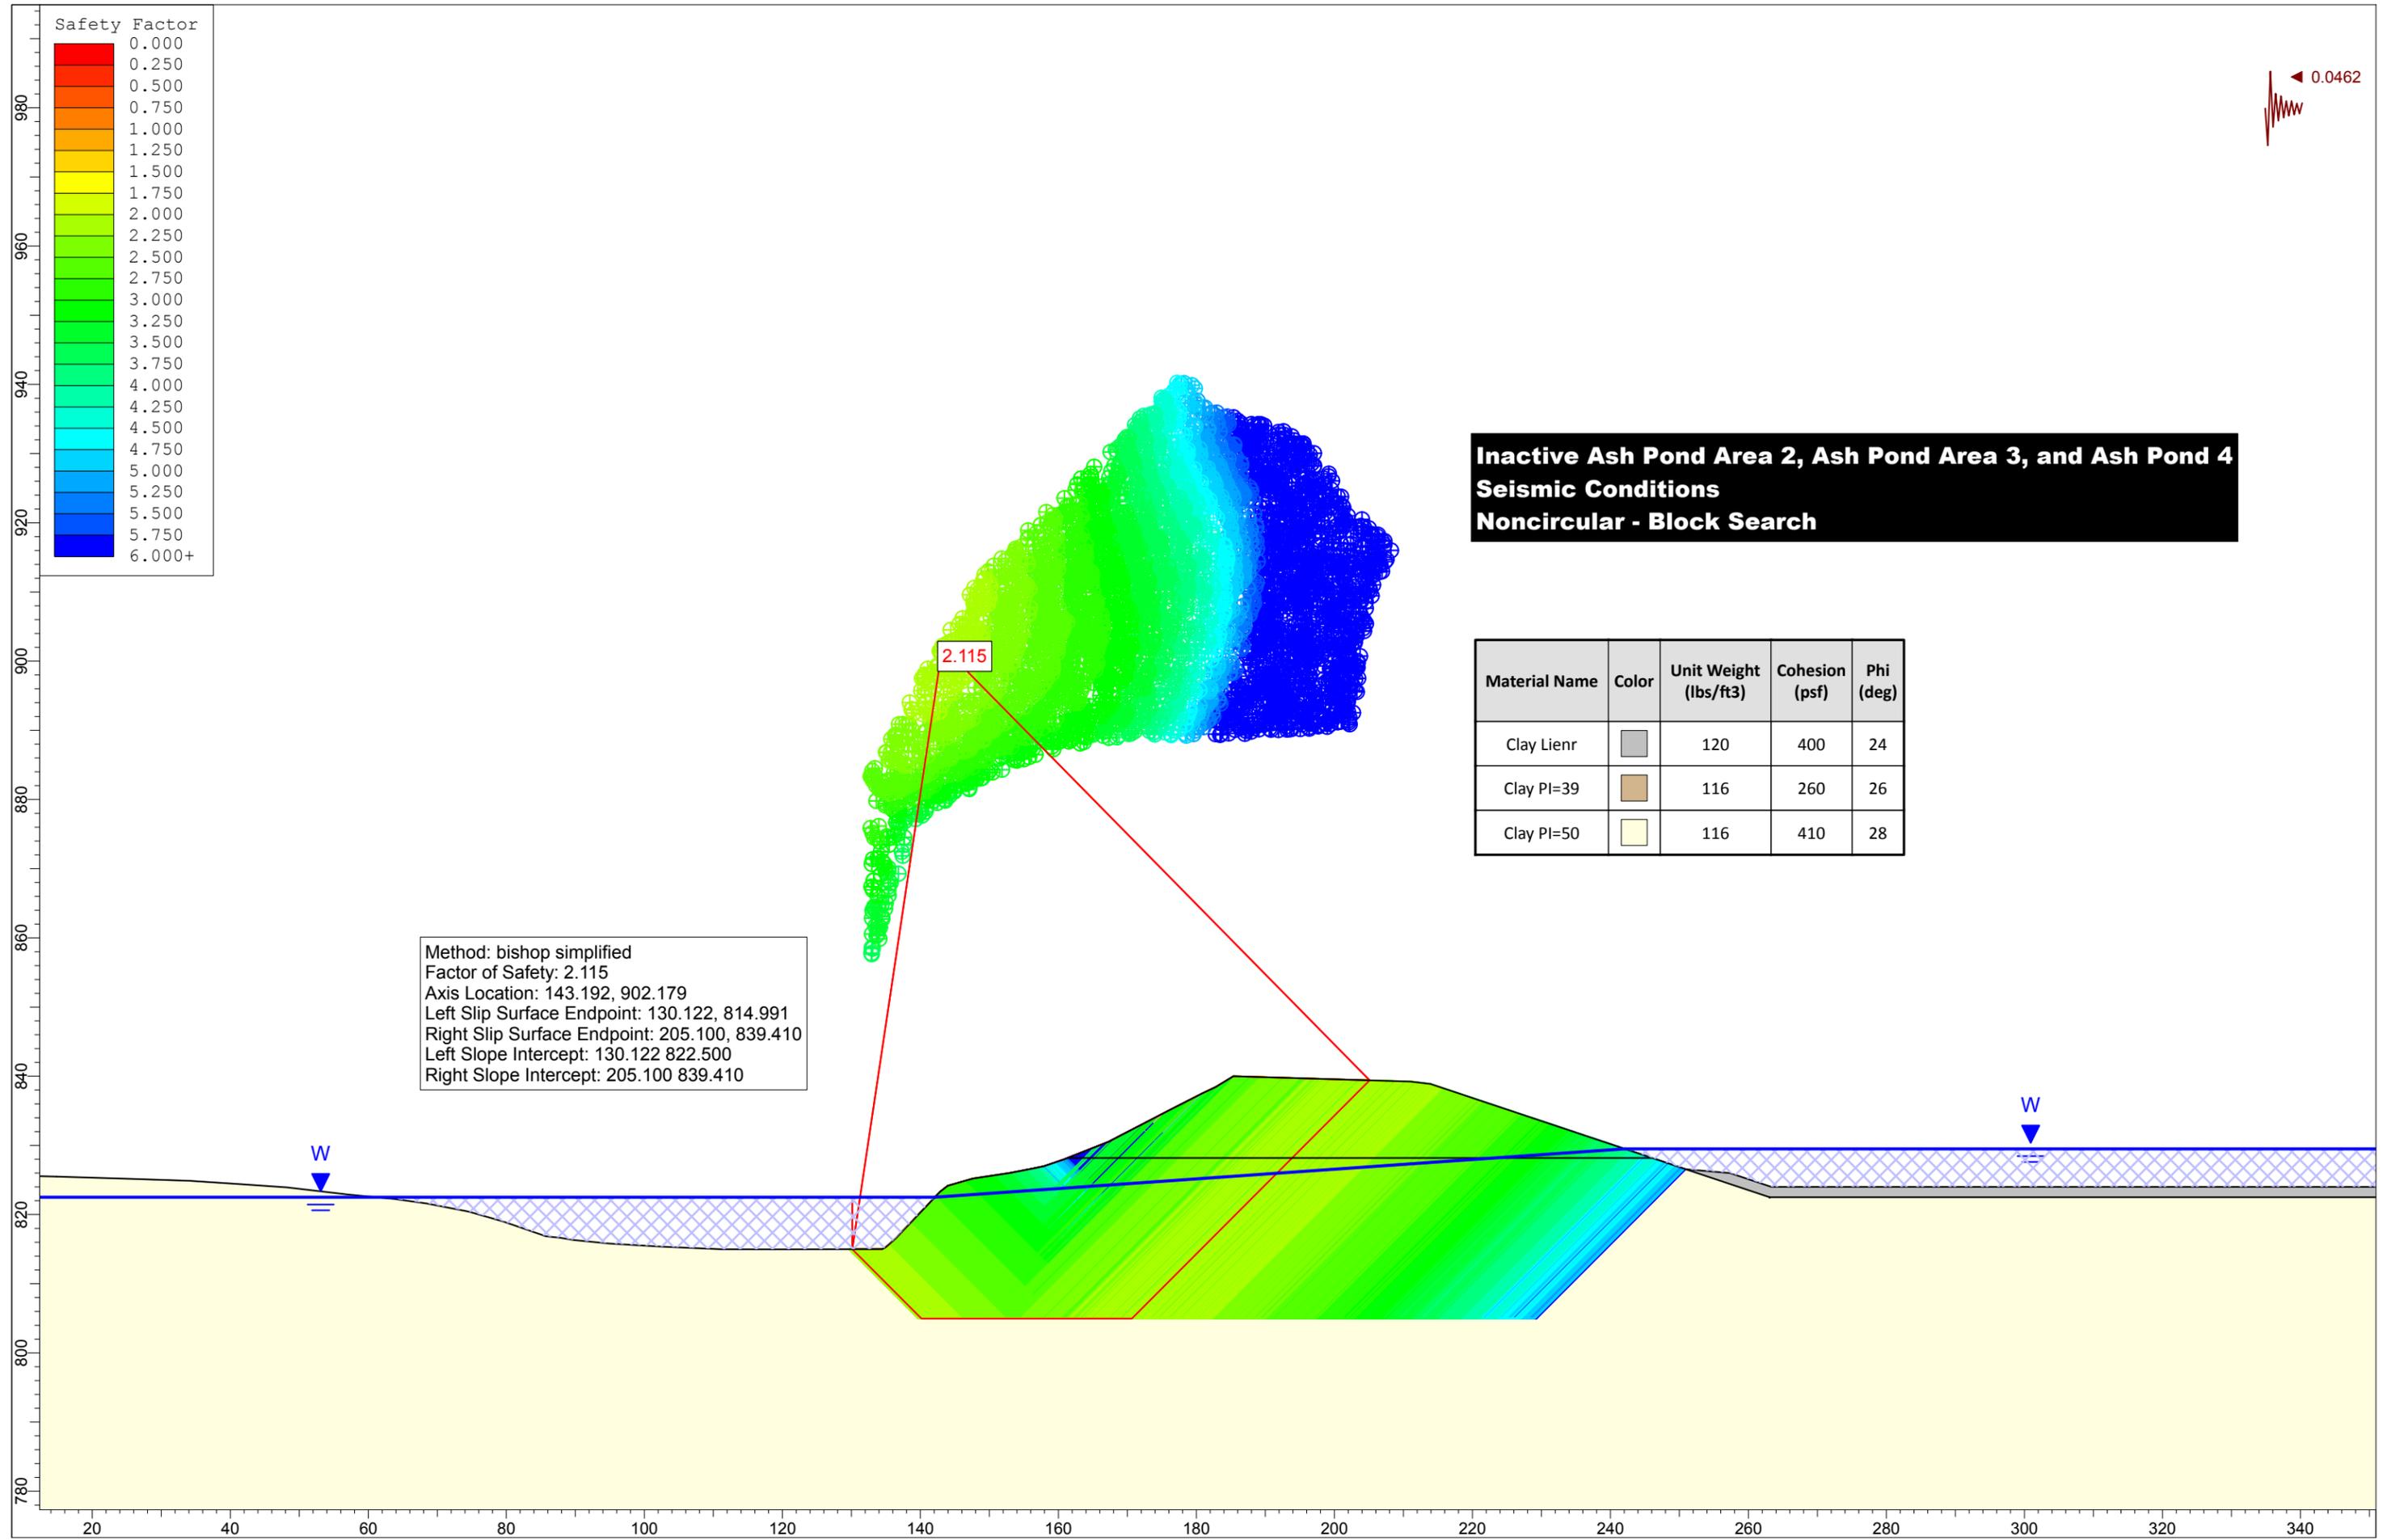
**Inactive Ash Pond Area 2, Ash Pond Area 3, and Ash Pond 4  
Seismic Conditions  
Noncircular - Block Search**

Method: bishop simplified  
 Factor of Safety: 2.115  
 Axis Location: 143.192, 902.179  
 Left Slip Surface Endpoint: 130.122, 814.991  
 Right Slip Surface Endpoint: 205.100, 839.410  
 Left Slope Intercept: 130.122 822.500  
 Right Slope Intercept: 205.100 839.410
