## Initial Safety Factor Assessment Lawrence Energy Center

Inactive Units - Ash Pond Area 2, Ash Pond Area 3,  
and Ash Pond 4

Westar Energy

April 2018

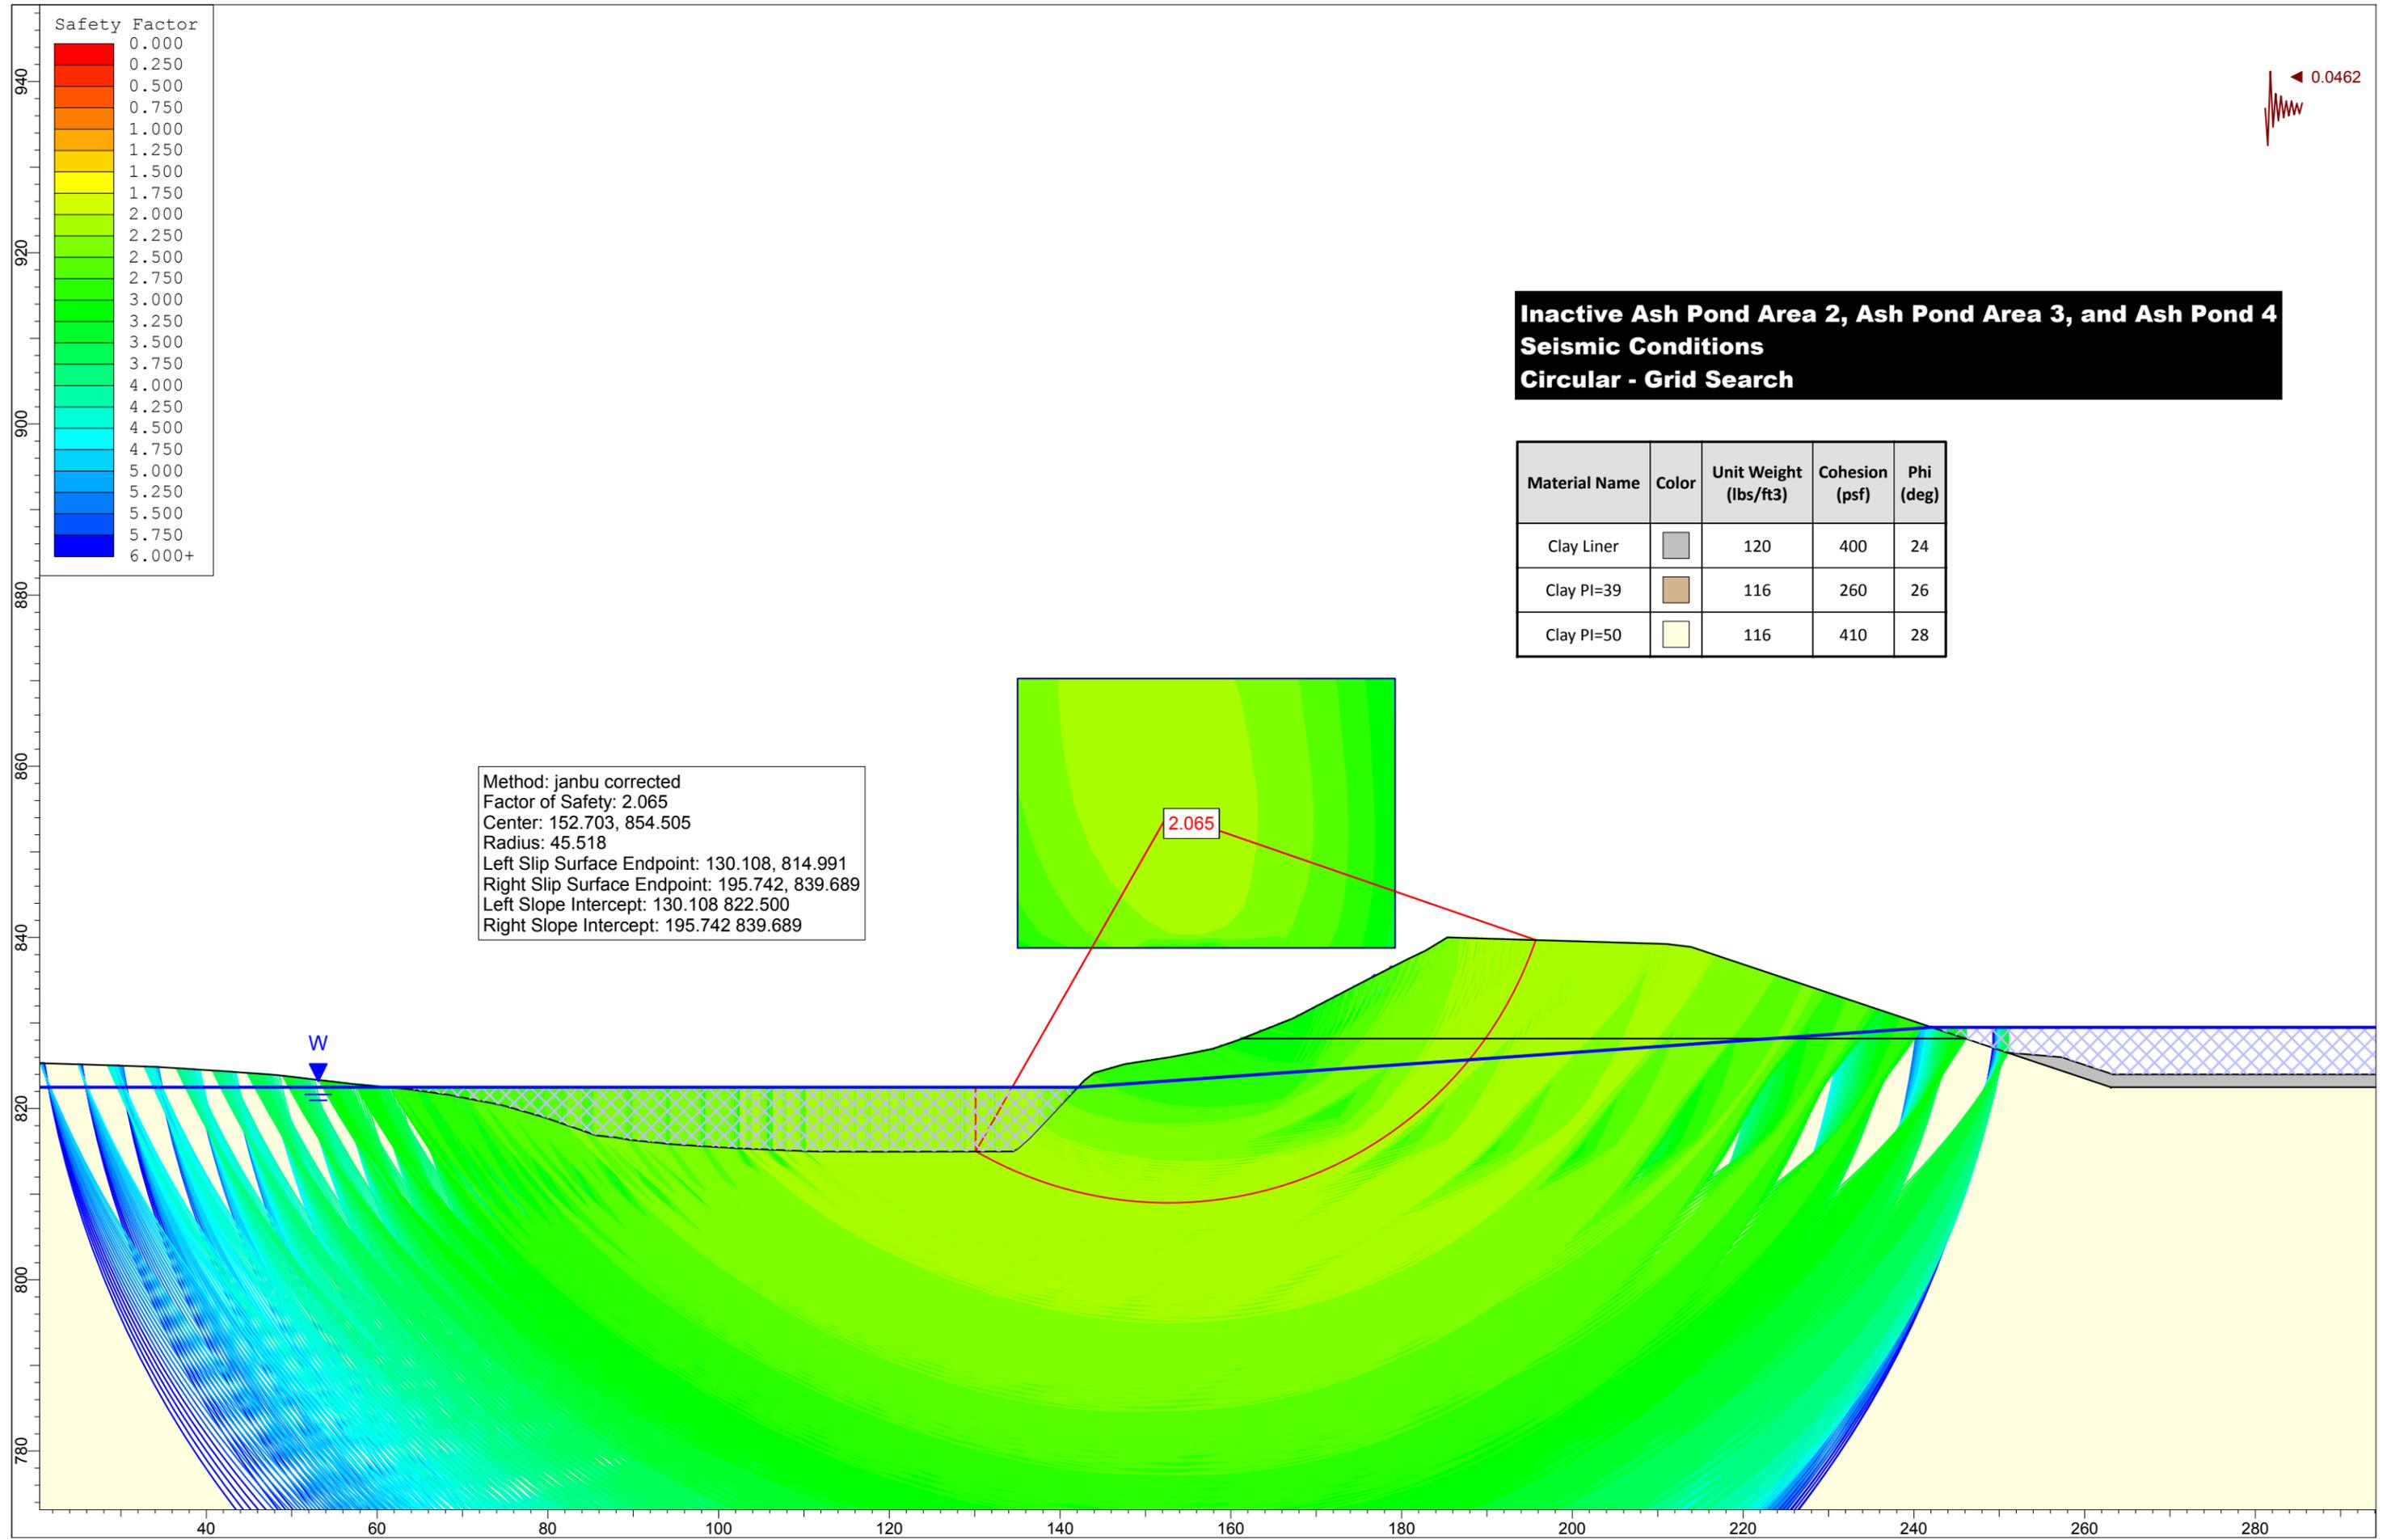
**Inactive Ash Pond Area 2, Ash Pond Area 3, and Ash Pond 4  
Seismic Conditions  
Circular - Grid Search**

2.065

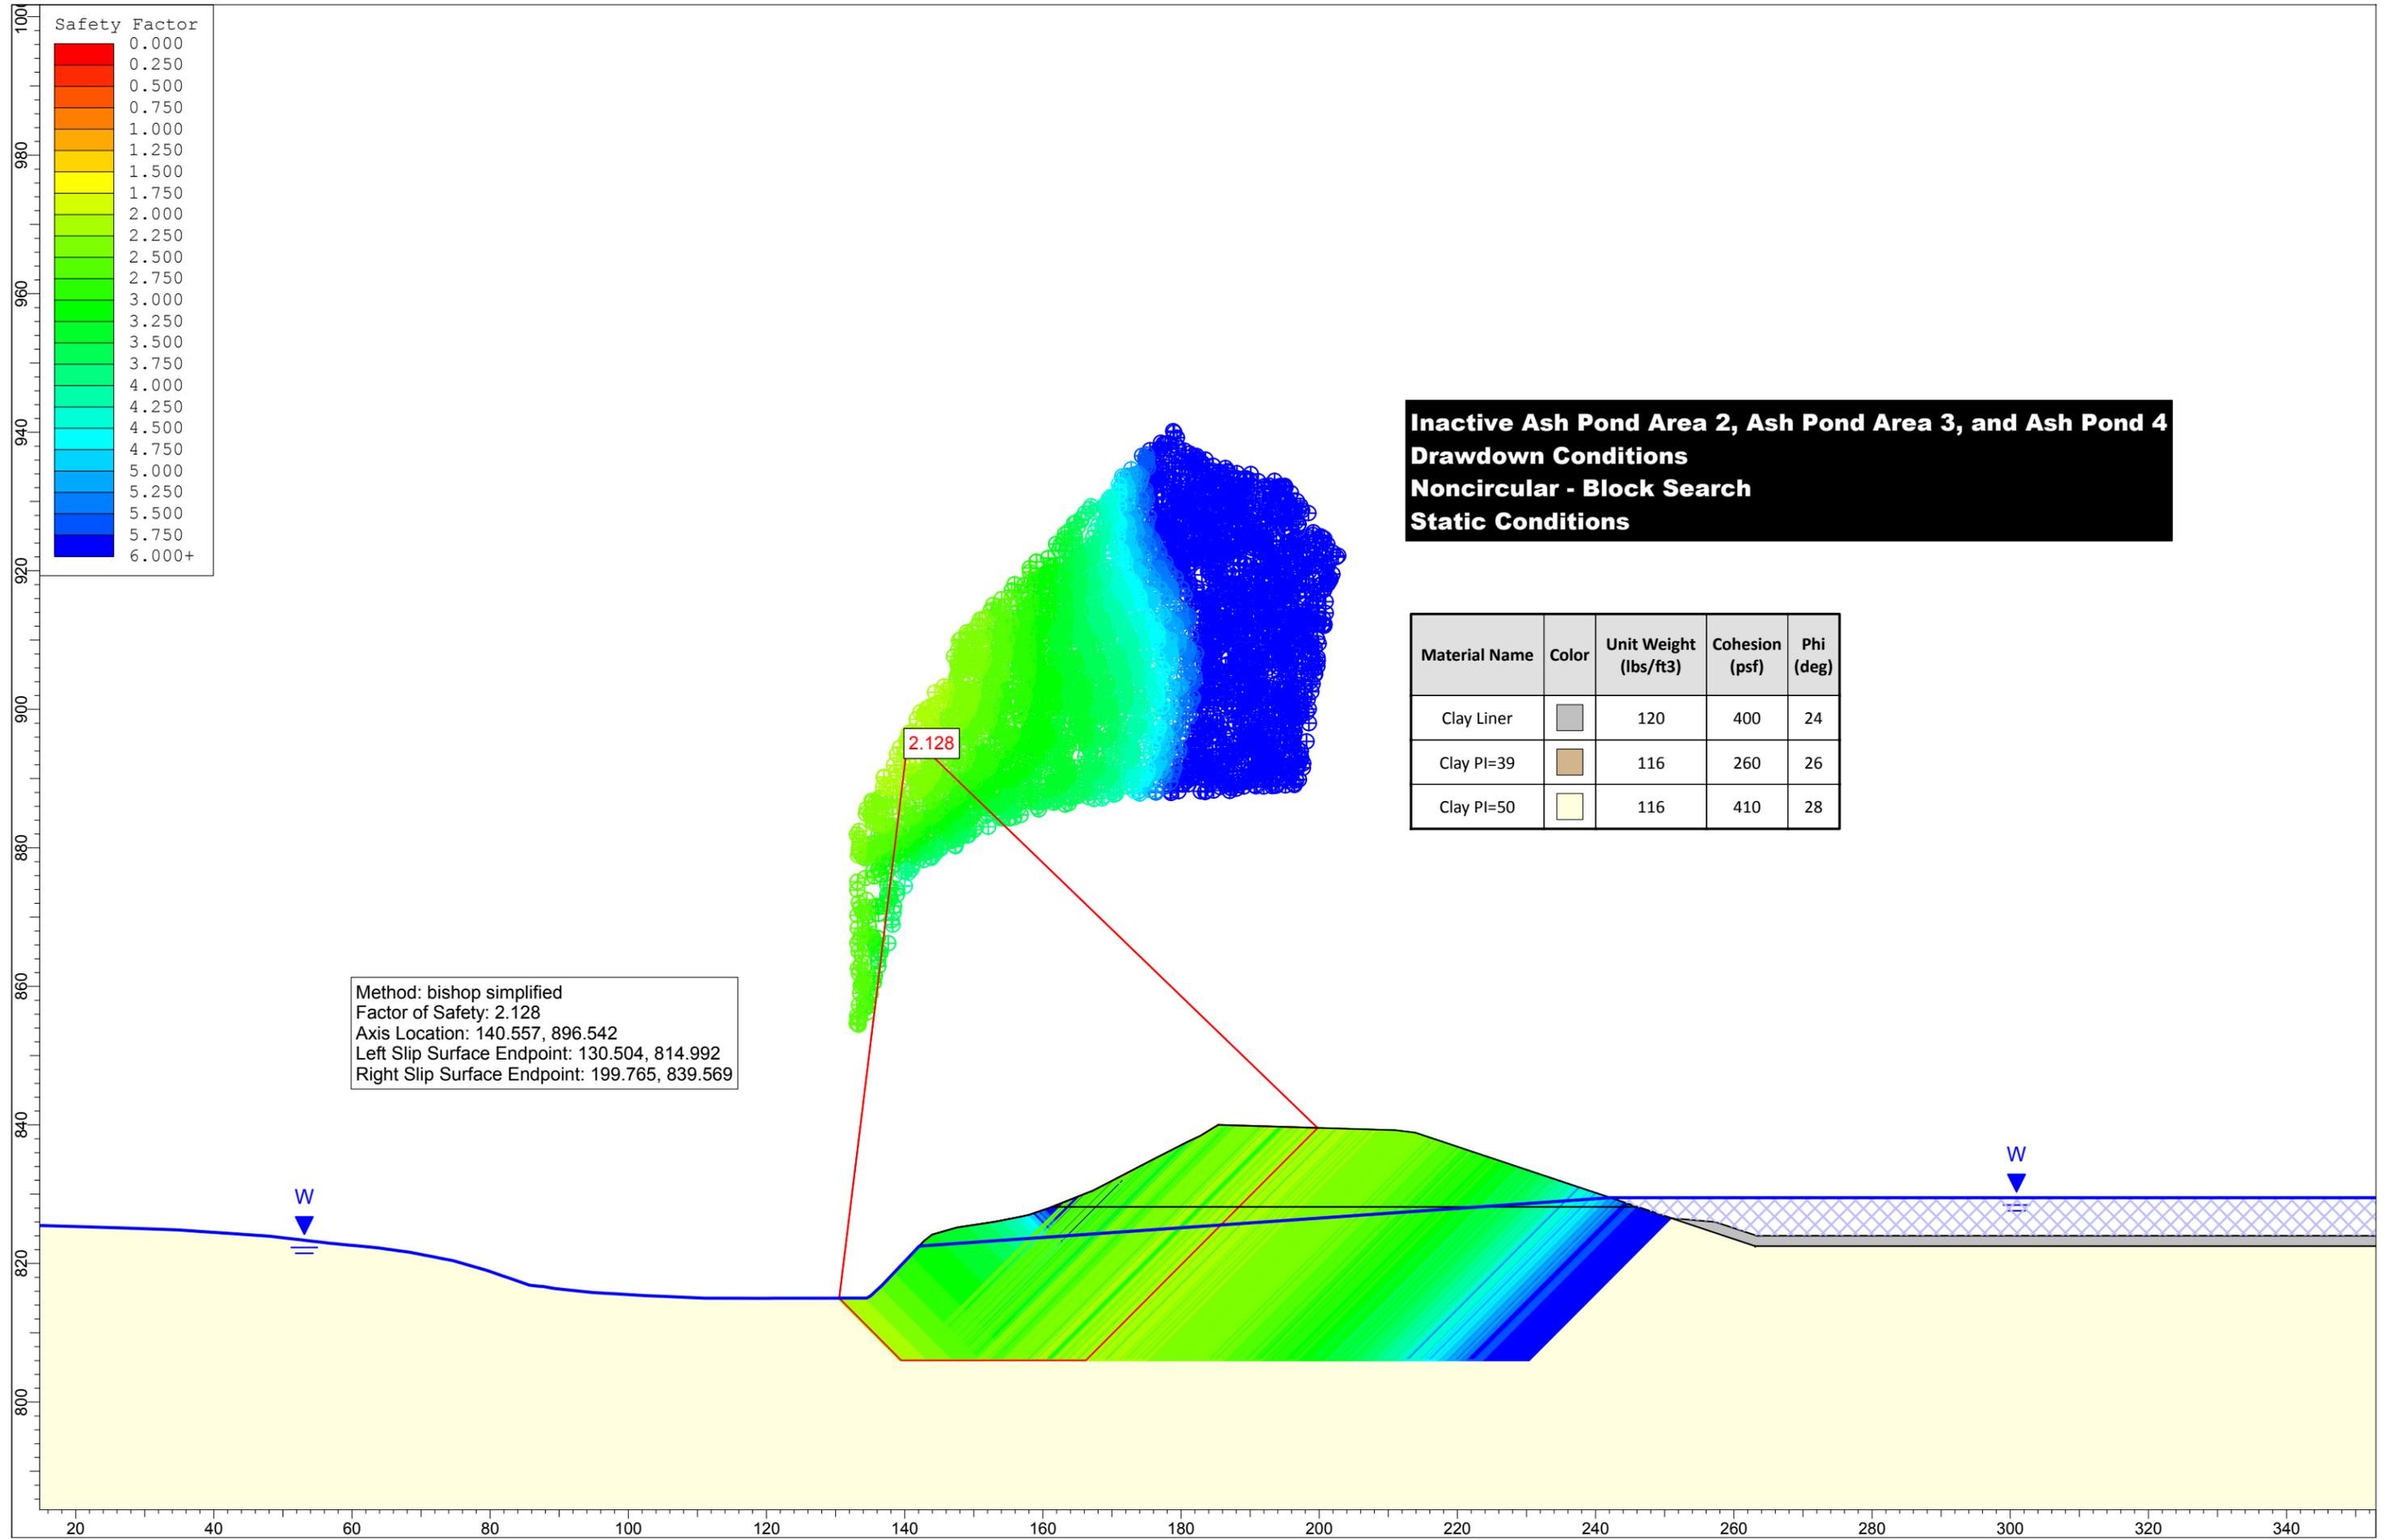
**Inactive Ash Pond Area 2, Ash Pond Area 3, and Ash Pond 4  
Drawdown Conditions  
Noncircular - Block Search  
Static Conditions**

Method: bishop simplified  
 Factor of Safety: 2.128  
 Axis Location: 140.557, 896.542  
 Left Slip Surface Endpoint: 130.504, 814.992  
 Right Slip Surface Endpoint: 199.765, 839.569

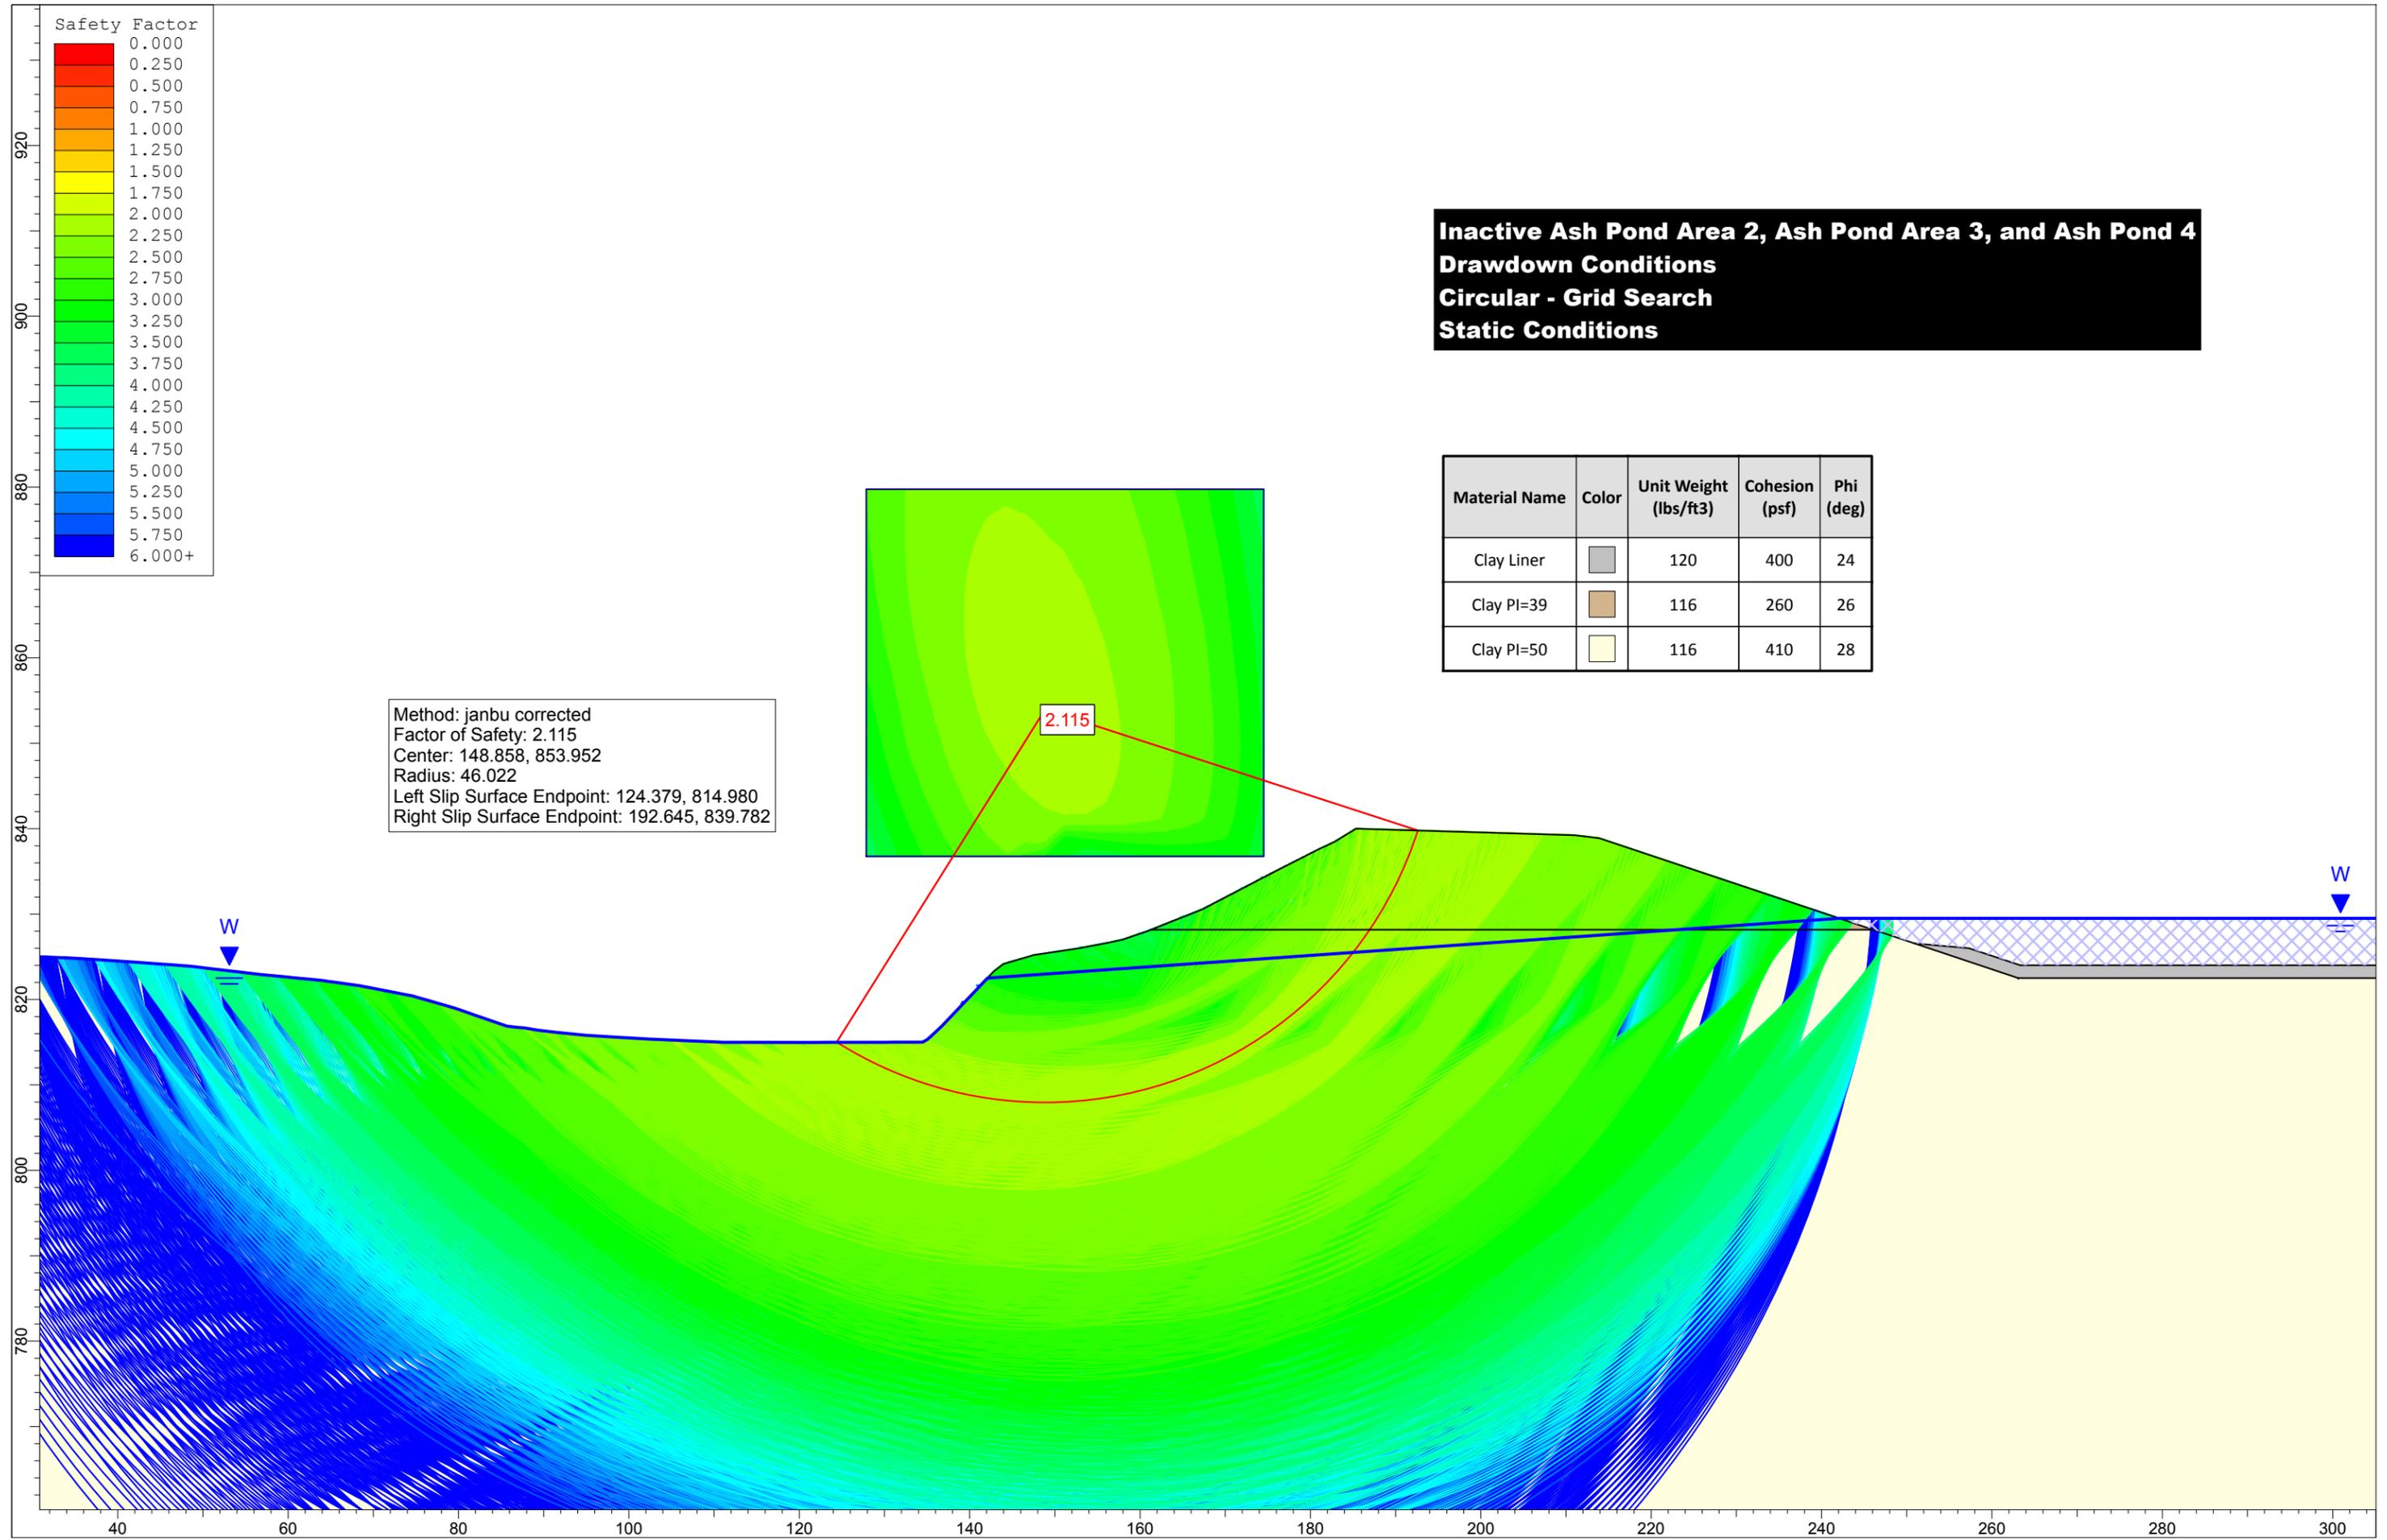
**Inactive Ash Pond Area 2, Ash Pond Area 3, and Ash Pond 4  
 Drawdown Conditions  
 Circular - Grid Search  
 Static Conditions**

Method: janbu corrected  
 Factor of Safety: 2.115  
 Center: 148.858, 853.952  
 Radius: 46.022  
 Left Slip Surface Endpoint: 124.379, 814.980  
 Right Slip Surface Endpoint: 192.645, 839.782
